Electrical Issues Due to Backup Lamps

Leaking Evaporator Core Seal

Incorrect Object Sensor Module Operation

Shifting Conditions Due to Undersized Spacer Plate

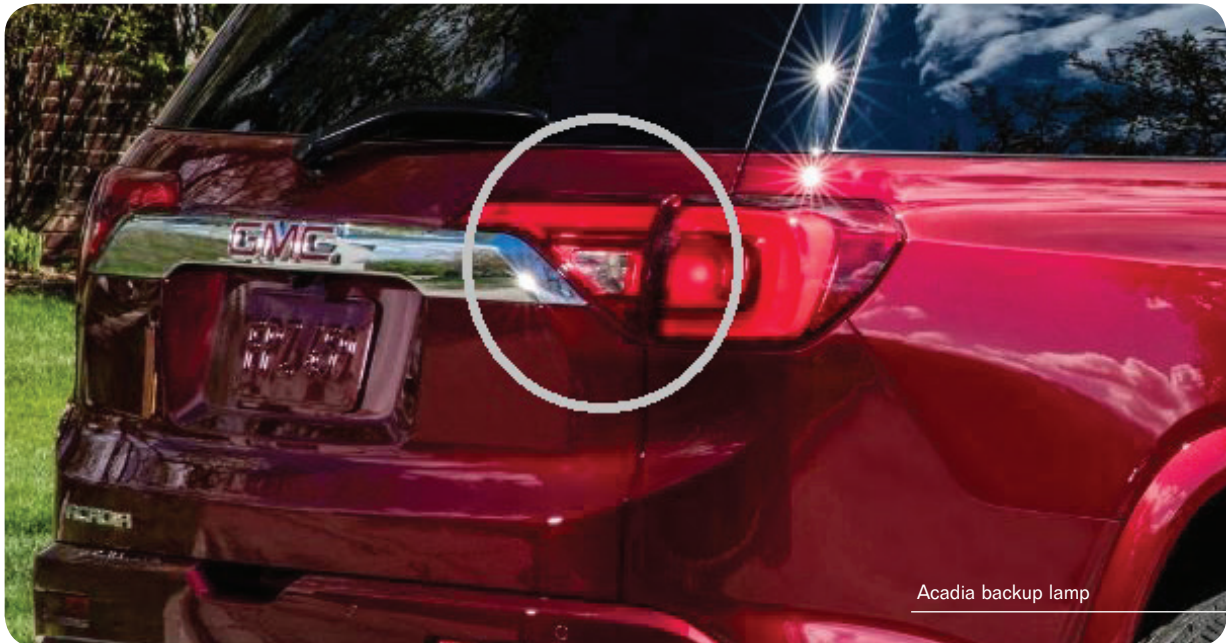
Acadia backup lamp

Some 2017 Acadia (VIN N) and XT5 models may have several electrical issues, including a dead battery, an inoperative Stop/Start system, and instrument cluster and switch backlighting illumination conditions. These conditions may be due to the wrong bulbs installed in the backup lamps.

On 2017 models, incandescent bulbs are used in the backup lamps. In some vehicles, LED lamps may have been installed instead. The Body Control Module (BCM) evaluates the Reverse Lamp circuit to determine bulb outages by applying and monitoring a low voltage signal. Since LED lamps have different electrical properties than incandescent bulbs, the circuit does not operate as expected. The BCM is calibrated for incandescent bulbs and, as a result, may stay awake after the key is off if LED lamps are used, causing the BCM to continuously monitor the circuit, which can lead to multiple electrical conditions.

Check the backup lamps for the installation of the proper bulbs. If LED lamps are found, they should be replaced with incandescent bulbs.

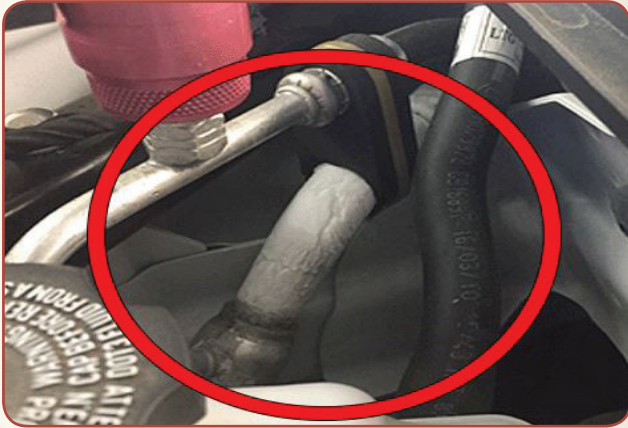
Some 2016-2018 CT6 models may have decreased air flow at the instrument panel outer air vents while the vehicle is moving. The air conditioning evaporator core seal may not be sealing completely, allowing warm air to pass between the evaporator core and housing, which hits the evaporator temperature sensor and causes a false high reading. As a result, the compressor may continue to run and cause the evaporator to ice up.

Ice on evaporator core tube

If this condition is found, replace the seal around the evaporator core. The repair requires the removal of the instrument panel carrier and instrument panel tie bar. Refer to Bulletin #18-NA-052 for more information.

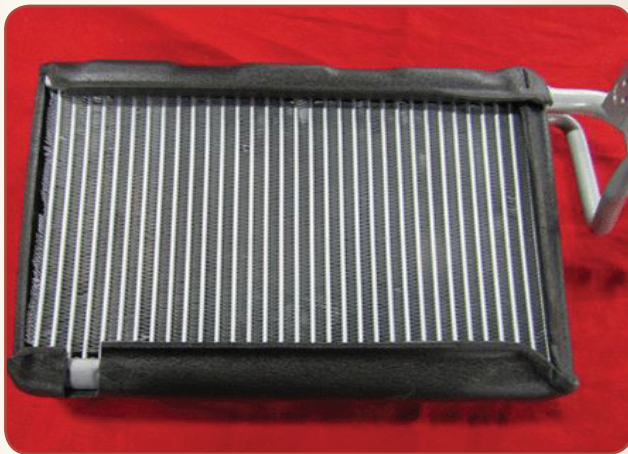
Evaporator core seal around the evaporator core

After installation of the evaporator core seal, also perform the HVAC Actuator Learn procedure in the HVAC control module. Do not operate the climate controls while the HVAC control module is calibrating.

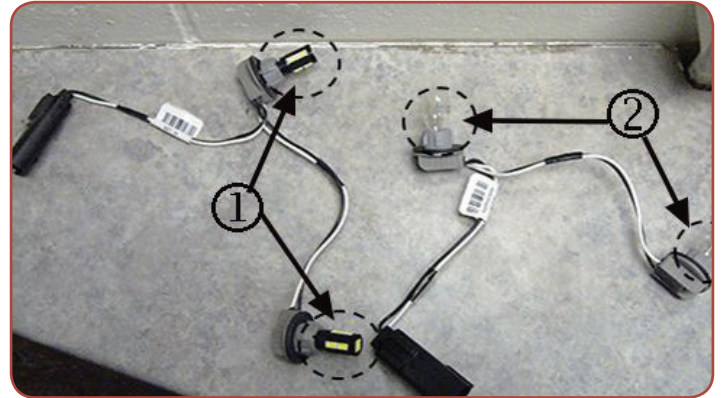
Check for LED lamps (1) and replace with incandescent bulbs (2).

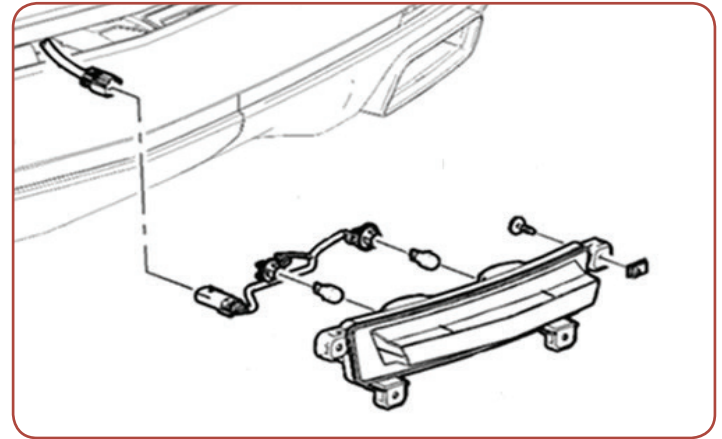
XT5 backup lamp

On XT5 models, the backup lamp assembly is underneath the rear fascia.

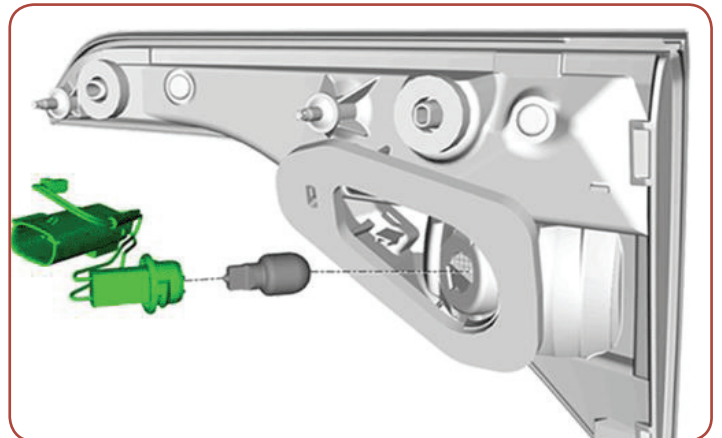
Acadia backup lamp

On Acadia models, the backup lamp is part of the rear signal lamp assembly.

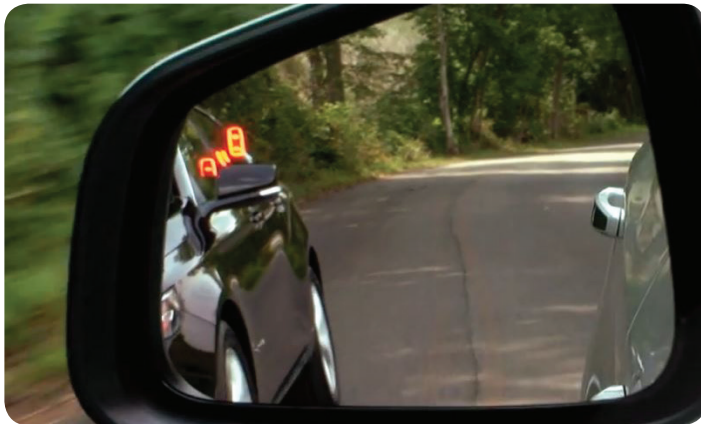
Some 2018 Encore models equipped with Side Blind Zone Alert (RPO UFT, Side Active Safety–Obstacle Detection) may have a warning alert appear in the side mirror when there is not a vehicle present in the side blind zone area.

Warning alert in side rearview mirror

The incorrect notification may be caused by unwanted radar reflection being detected by the Side Object Sensor Module. Most radar reflections may be worse on the driver's side (left side) of the vehicle.

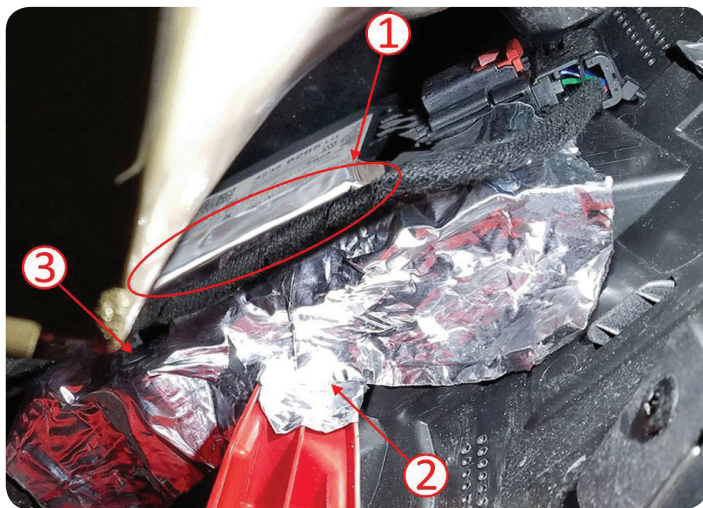
Tape applied to the module (#1), around the reflector mount (#2) and the wiring harness anchor point (#3).

Apply the butyl tape to the bottom of the module and fascia, making sure the area is completely covered, including the wiring harness anchor point.

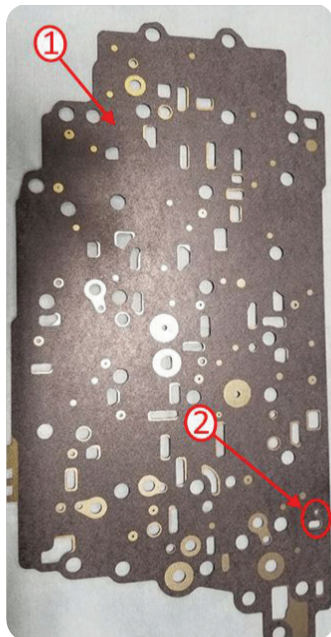
1. Spacer plate
2. Orifice

The shifting conditions may be caused by an undersized spacer plate, located between the valve body and the transmission case as an orifice. As a result, the clutch selector valve moves slowly to release the selectable one-way clutch, which causes a momentary transmission tie-up during the 1-2 upshift.

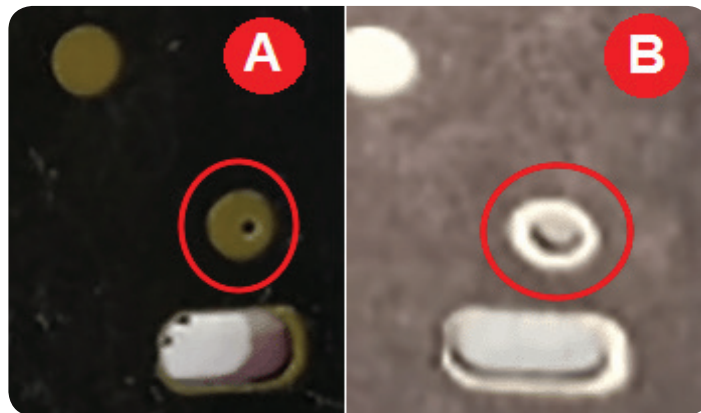
A. 0.5 mm orifice
B. 2.0 mm orifice

Inspect the valve body spacer plate orifice for proper size.

If the spacer plate orifice is 0.5 mm, replace the spacer plate. If the spacer plate orifice is 2.0 mm, continue with the diagnostics outlined in the appropriate Service Information.

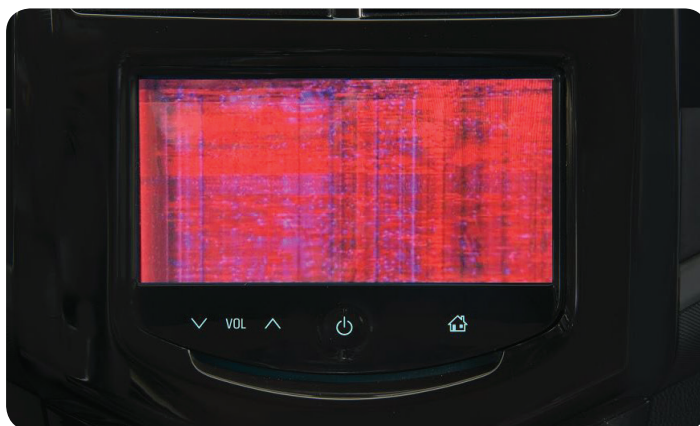
When the Rear Vision Camera is active on some 2018 Sonic models, there may be a distorted, flickering, or rolling screen or the screen may be red/blue or black. In many cases, distortion or blank screen displays are due to signal interruption.

Distorted red/blue screen image

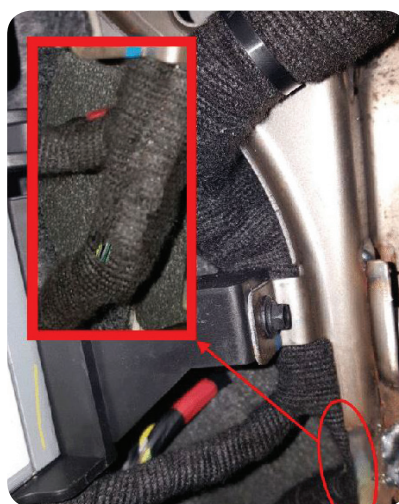
If the rearview camera displays a distorted or colored screen image, check for a pinched instrument panel wiring harness on the passenger-side of the vehicle between the instrument panel carrier and the A-pillar.

Check for a pinched instrument panel wiring harness.

If the wiring harness is pinched or shows signs of damage, repair the harness as needed.
