## All-New 2019 Silverado 1500 and Sierra 1500 Ready to Work

Customer Care and Aftersales

Mid-July 2018

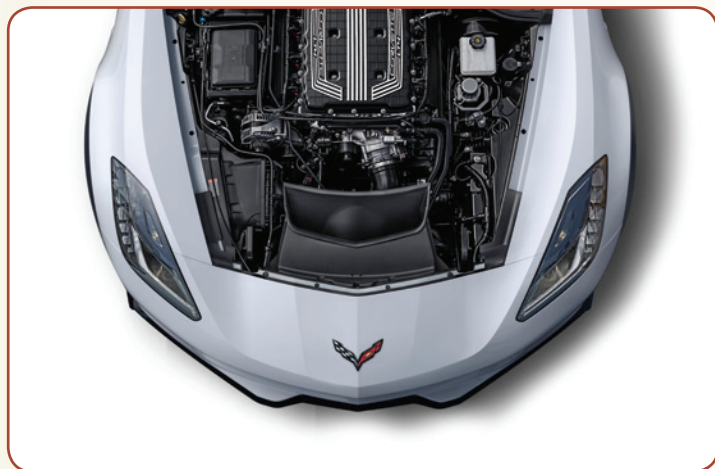
If the vehicle is driven continuously at a high engine speed with the first factory oil fill, silicone sealants in the engine's gaskets may degrade the anti-foaming properties of the oil. This may lead to oil leaking out from the air cleaner assembly due to the oil foaming condition. The oil foam does not affect the engine's durability, but changing the oil at 500 miles will help prevent oil foaming in the future because the silicone sealants are removed with the original oil.

2014-2019 Corvette models equipped with the 6.2L V8 engine (RPO LT1, LT4, LT5) with a dry sump oil system (RPO Z52) require an engine oil change immediately after the 500 mile (800 km) break-in period.

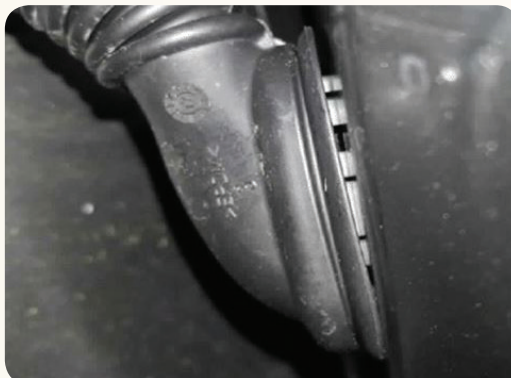
The electrical conditions may be due to water entering the rear compartment area through an improperly installed rear liftgate wiring harness grommet. Water may be bypassing the grommet and running down the harness onto the X400/X401 connectors. Inspect the connectors for corrosion.

Improperly installed grommet

The liftgate and body-side grommets on the left and right side of the liftgate should be checked to ensure the grommets are installed and sealing properly.

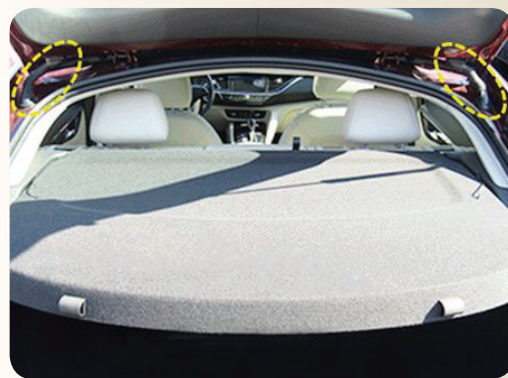
Liftgate grommet locations

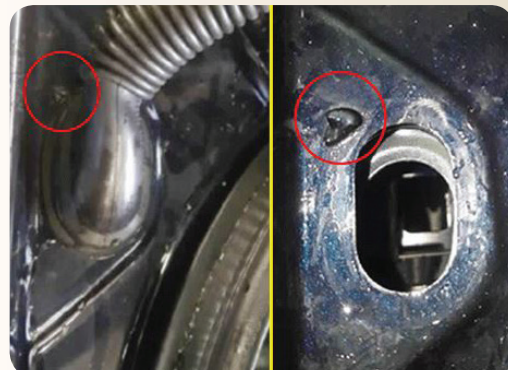
Excess sealant

In addition, look for any inadvertent sealant deposited under the grommet boot sealing surface. If any excess sealant is found, remove it before reinstalling the grommet.
