GM Loan Tool Program

TECH LINK

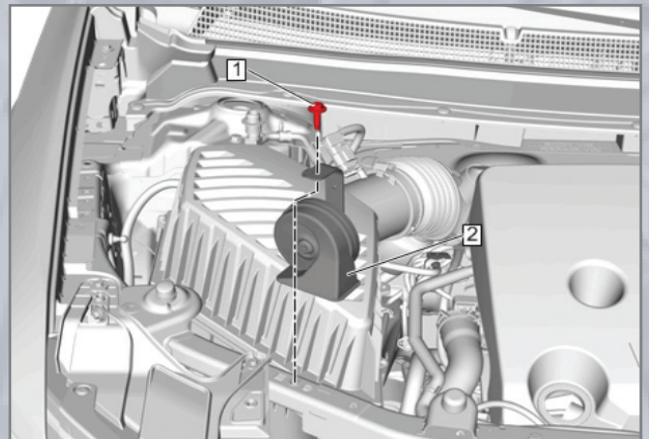
Right-side horn assembly

The horn may sound muffled, distorted or sounds only the high note on some 2018-2020 Enclave and Traverse models. These horn conditions may be caused by a frequency that distorts the horn sound when it reflects off the original horn assembly bracket.

To address the distorted horn sounds, replace the right-side low note horn assembly. Refer to Horn Replacement (Right Side) in the appropriate Service Information. The Intake Air Splash Shield must be removed in order to access the horn assembly.

Refer to Bulletin #19-NA-278 for additional information and part numbers.

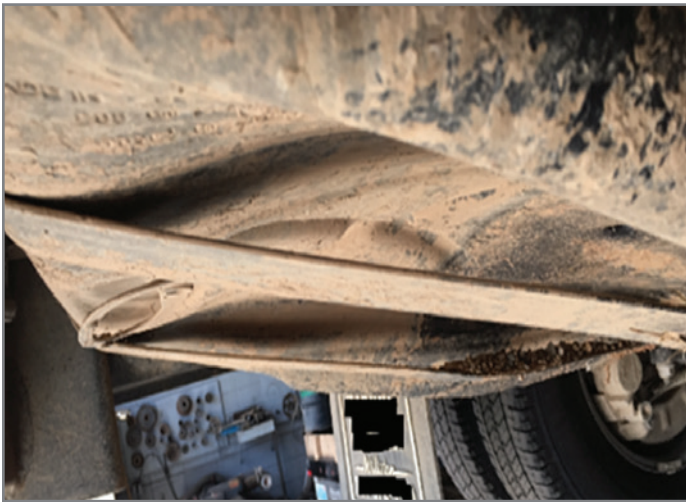
Collapsed rear tank

Some 2015-2018 Silverado and Sierra models and 2019 Silverado 2500/3500 and Sierra 2500/3500 models equipped with the 6.6L Duramax diesel engine (RPOs LML, L5P) and dual fuel tanks (23.5 gallon/89 liter front tank and 40 gallon/151 liter rear tank) (RPO N2N) may have poor fuel transfer or the rear fuel tank may have collapsed.

These conditions may be caused by dirt and debris collecting on the top of the rear tank and plugging the vent, resulting in the fuel tank being pulled into a vacuum and bending the fuel tank fuel pump module.

If these conditions are found, replace the fuel tank and fuel pump module. Refer to Fuel Tank Fuel Pump Module Replacement in the appropriate Service Information.

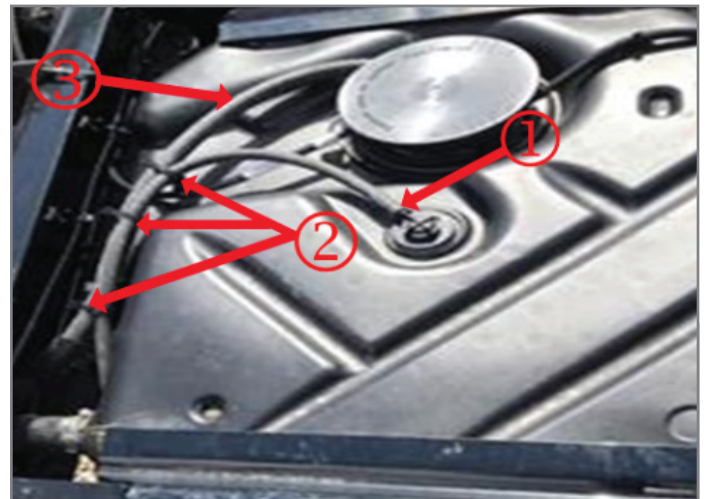
1. New hose added to vent
2. Secure with zip ties
3. Fuel feed line

In addition, to help prevent the vent from becoming plugged again, install a piece of fuel hose to the vent and route it down the fuel feed line. Secure the hose with zip ties.

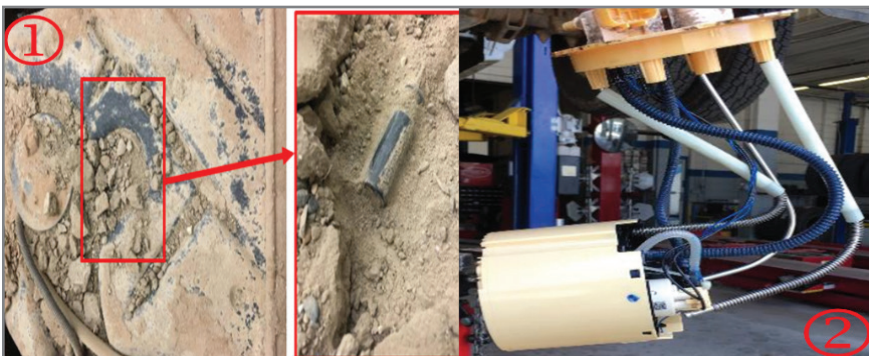
1. Dirt plugging vent
2. Bent fuel pump

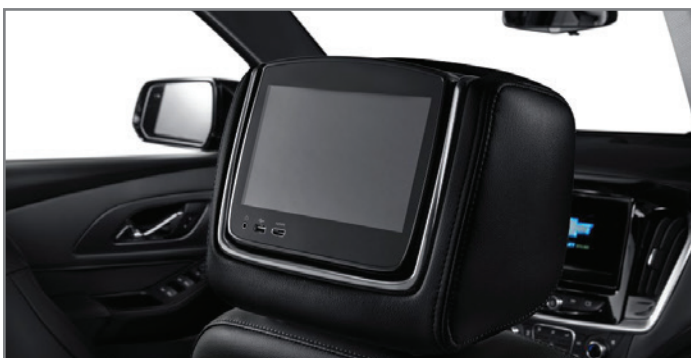
Rear Seat Infotainment system

The Accessory Rear Seat Infotainment (RSI) system on some 2018-2020 Enclave and Traverse models equipped with ventilated front seats (RPO KU9) may power off when the vehicle doors or the liftgate is closed. The cause of this condition may be that the RSI system is powered by the interruptible Retained Accessory Power (iRAP) feed. When the vehicle's Passive Entry Passive Start (PEPS) module searches for the key transmitter when the last door or the liftgate is closed, it momentarily powers down the iRAP feed in order to clear any possible radio frequency interference, which results in the RSI screen powering off.

A new audio player wiring harness to the RSI power feed can be installed to address the screens powering off. The harness assembly will add a second power feed (ignition) to the RSI kit to supply power to the RSI system while the iRAP feed is temporarily unavailable.

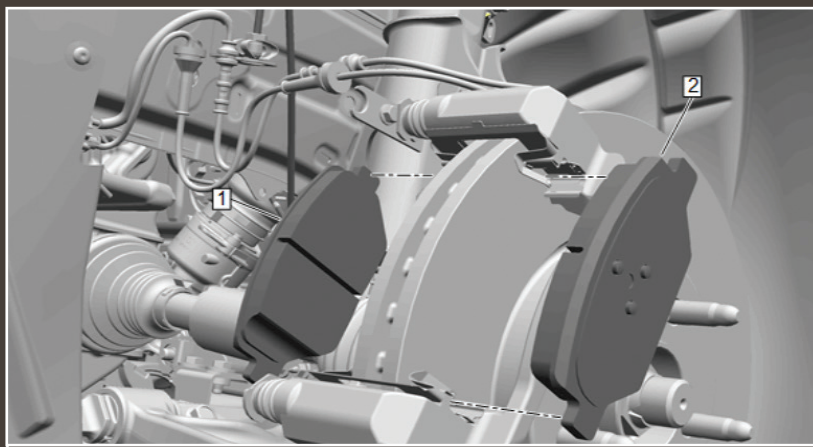
Front brake pads

Some 2020 XT4 models may have a brake squeal sound at low speeds. The front brake pads on some models may be susceptible to producing brake squeal.

Confirm the brake squeal is coming from the front brake pads. If verified, replace the front brake pads with a new design brake pad. Refer to Front Disc Brake Pads Replacement in the appropriate Service Information.

The disc brake pads are adhered to the caliper piston using an adhesive patch and must be separated. Do not insert a pry tool through the bridge window to pry against the piston face, which can damage the brake caliper piston. Loosen the inner brake pad by twisting a screwdriver between the inner brake pad and the brake caliper. Do not allow the screwdriver to touch the brake caliper guide pin seal.

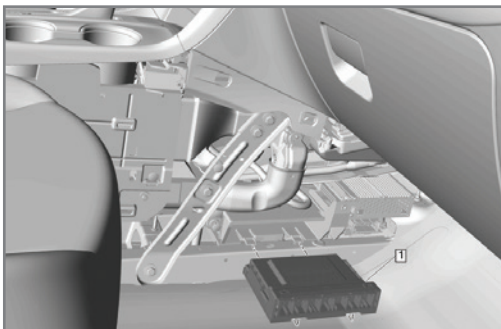
Typical BCM location (Equinox shown)

DTC P0747 may be setting due to the Body Control Module (BCM) not continuing to supply ignition voltage to the Transmission

Control Module (TCM) after engine shut down to allow the modules to perform a power-down self-test. If ignition voltage is not present from BCM connector X4, terminal 22, for a minimum of 15 seconds after the ignition is cycled off, the modules will not complete the power-down self-test. As a result, during engine cranking, the BCM will see data from where the self-test stopped and, typically, will see engine RPMs during cranking, which may set DTC P0747.

After the engine has been running, check if ignition voltage is present at BCM connector X4, terminal 22, for a minimum of 15 seconds from the BCM after the ignition is cycled off. If the ignition voltage is not present for a minimum of 15 seconds, check all BCM power and ground connections. If no concerns are found, replace and program the BCM.
