Power Folding Top

Diagnostic Tips

TECH LINK

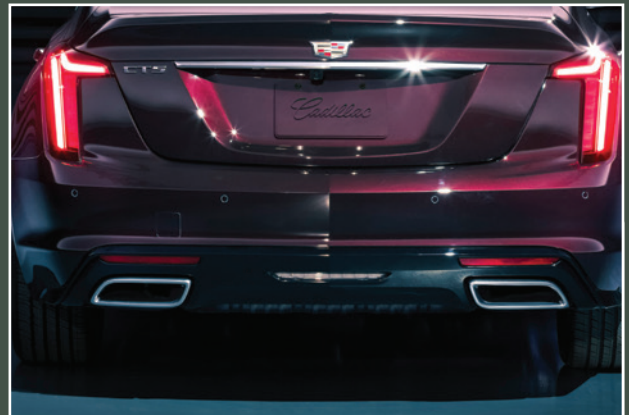
The Park Assist Control Module (PACM) may fall off the Controller Area Network (CAN) bus when other control modules are serviced on some 2020 CT5 models due to incorrect PACM software operation.

When some control modules are serviced — unplugging the Electronic Brake Control Module, for example — it breaks the CAN lines and the PACM does not recover until a power reset/fuse removal takes place. As a result, the PACM completely falls off the bus and no longer communicates. When this occurs, GDS 2 cannot be used to communicate or key provision the PACM.

To recover the PACM, cycle the PACM fuse or perform a battery disconnect.

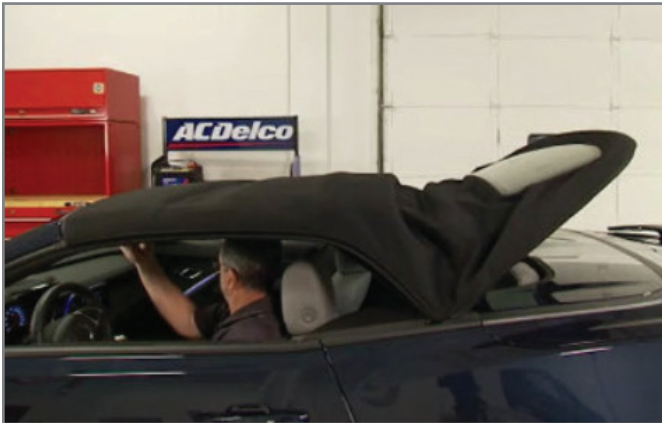
Here's an example on a 2018 Camaro with a folding top that will open but will not close all the way. There is a "Top Not Secure" DIC message, but no DTCs are set. When closing, the top will close properly to the windshield header and the rear stowage compartment lid will lower and lock into position, but the tension bow will not lower. The folding top pump quits working and the top stops moving.

Tension bow that will not lower.

be completed in order. The folding top matrix shows the Camaro has two separate Stowage Compartment Lid Closed Position Sensors for the left and right side of the vehicle, which should read "On" when the lid is closed.

The scan tool sensor data shows that only one of the two sensors reads "On." The Folding Top Control Module will not command the tension bow to lower if both Stowage Compartment Lid Closed Position Sensors are not showing that they are closed and the top will not continue to cycle. In this instance, the next step in diagnosis is to inspect the Right Folding Top Stowage Compartment Lid Closed Position Sensor to determine the cause of the fault.

For more information about power folding top diagnosis, refer to #PIC6378.

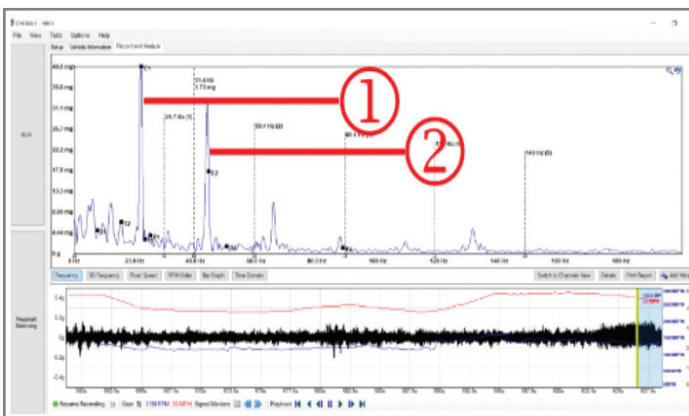
- When vibration was first occurring, there may be a large spike that aligned with E1 and E2.
- After the tone shift, the vibration is no longer directly aligned with E1 and E2.

After first occurrence:
1. E1 spike
2. E2 spike

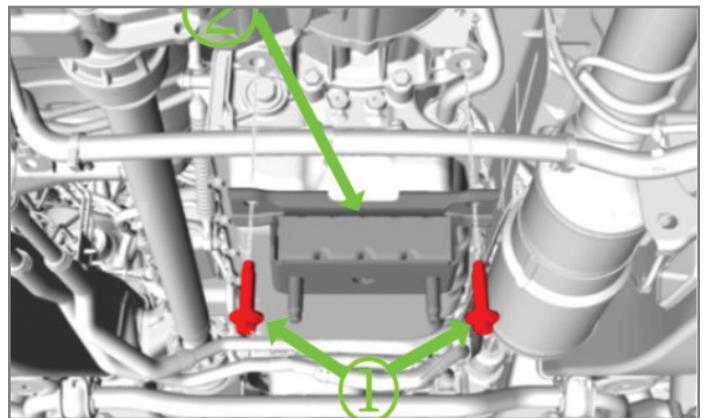
Some 2019-2020 Silverado 1500 and Sierra 1500 models equipped with the 5.3L or 6.2L V8 engine (RPOs L82, L84, L87) may have a vibration or drone sound around 40 mph and 1,200 rpm under a light load. Around 1,200 rpm when Dynamic Fuel Management/Active Fuel Management (DFM/AFM) is operating,

Inspect the transmission mount.

If this vibration is found, remove and inspect the transmission mount for any debris. Clean the mount, reinstall, and evaluate the vibration condition.

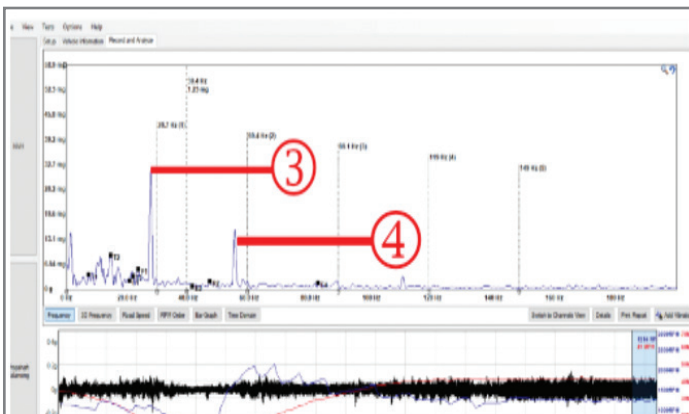
After tone shift:
1. E1 spike
2. E2 spike

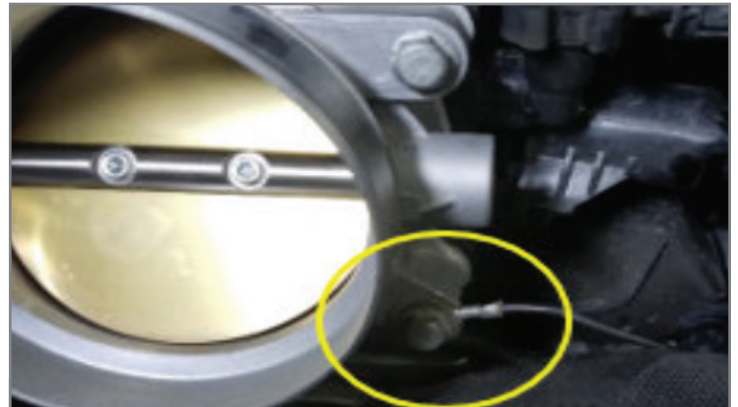
A 2020 Silverado HD or Sierra HD equipped with the 6.6L V8 engine (RPO L8T) may have a rough idle or reduced engine power in very cold climates (-10°F or -23°C). The Check Engine lamp may be illuminated along with DTCs P0123 (Throttle Position Sensor 1 Circuit High Voltage) and P0222 (Throttle Position Sensor 2 Circuit Low Voltage) set. These engine performance conditions may be caused by an internal circuit fault within the throttle body.

Attach the ground wire to the lower-right throttle body fastener.

To install the ground wire, remove the oil cap and engine cover from the rocker cover on the left bank of the engine. Attach one end of the ground wire to the lower-right throttle body fastener with the crimp side of the ring terminal facing the bolt head.

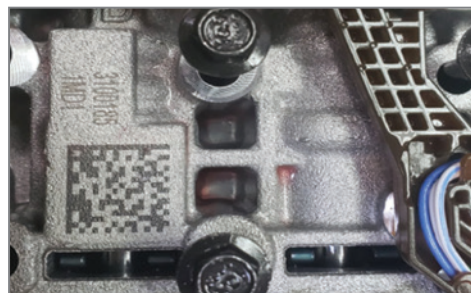
When installing the replacement solenoid body assembly, it may not be possible to perform the shift characterization reprogramming due to the Part Unique Number (PUN) printed on the service solenoid body only having 11 digits.

The PUN for the assembly shown should be WL0Y931001851MD1

If only 11 digits are printed on the service solenoid body assembly, use a QR code reader to obtain the full 16-digit PUN.

the following 5-digit numbers in front of the 11 digits printed on the solenoid body assembly: WL0Y9, WL0Y0, WL4P9, or WL4P0. The first five digits are dependent to where the part was manufactured as well as the calendar year it was built.

For example, the assembly shown should be WL0Y931001851MD1 as this part was manufactured in 2019.
