## GE-52250 PowerSmoke Diagnostic Leak Detector

## TECH LINK

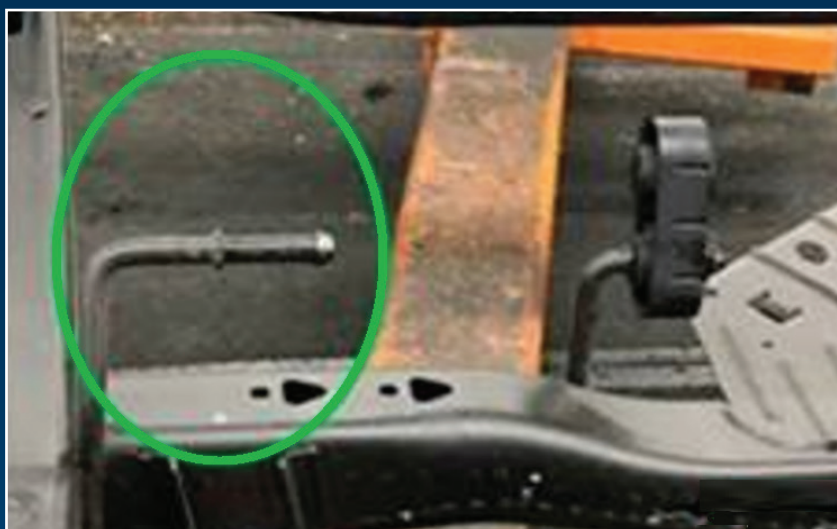
Exhaust isolator and exhaust hangers

The exhaust isolator is no longer installed in order to address a noise concern. However, the exhaust hanger on the frame and the hanger on the exhaust pipe are still in production. The exhaust hanger on the other side of the exhaust pipe near this location is still connected. These changes went into effect at the Fort Wayne assembly plant on June 17, 2020 and are part of the continuous product improvement process. Light-duty trucks with the diesel engine and single exhaust built at the Silao assembly plant have not yet removed the isolator from production.

The exhaust hanger was communicating an exhaust boom due to a structural vibration. Without the isolator connecting the exhaust pipe to the hanger, the boom sound is eliminated. At the same time, it was determined that the hanger is not needed at that location on the exhaust pipe and that durability and the function of the exhaust are unaffected.

If an exhaust isolator is installed on the exhaust pipe and connected to the hanger, the exhaust boom sound may be heard. A warranty claim should not be submitted for installing the exhaust isolator.

A missing exhaust isolator on 2020 Silverado and Sierra models equipped with the 3.0L Duramax diesel engine (RPO LM2) and the single exhaust system (RPO NB5) should not be installed as part of a warranty claim at the dealership.

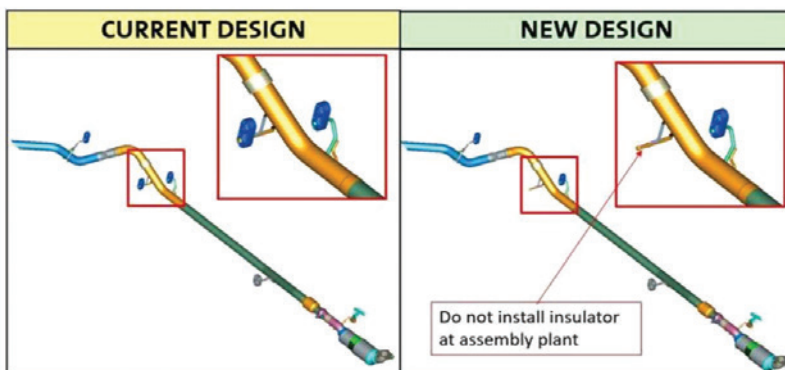
Previous exhaust design (left) and new exhaust design now in production (right).

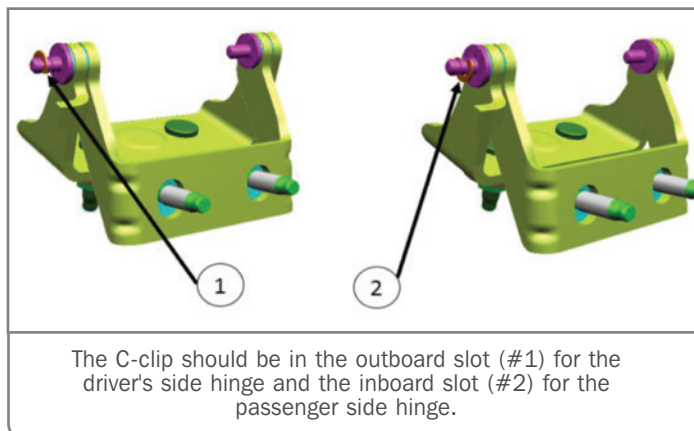
Some 2021 Tahoe, Suburban, and Yukon models may have a rattle sound at the rear of the vehicle. The sound may be from the liftgate or liftglass.

**Hinge Pins** – Open the liftglass and inspect the C-clips on the hinge pins. The C-clip should be in the outboard slot for the driver's side hinge and the inboard slot for the passenger's side hinge. If a C-clip is not in the correct slot, remove it and reinstall it in the correct slot.

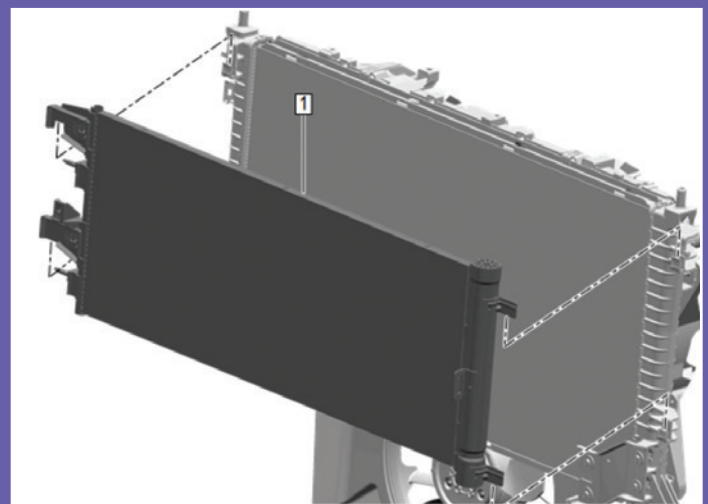
On affected vehicles, the A/C pressures will be lower than normal. For example, the low side may be 15-25 PSI while the high side may be 140-160 PSI. A check of the system for a low refrigerant charge should indicate that the system is full and no leaks should be found.

In addition, a temperature test of the refrigerant lines will show both the inlet and outlet lines at the condenser to be similar and very hot. The temperature across the condenser's cooling fins will be near ambient temperature.

The cause of these conditions could be the A/C condenser internally bypassing due to a mispositioned block off plate. If the block off plate is out of position, the refrigerant does not flow through the condenser's cooling fins. As a result, hot refrigerant entering the condenser bypasses the cooling fins and exits the condenser before the refrigerant is cooled down and returned to a liquid state.

If these conditions are found, the A/C condenser will need to be replaced. Refer to the appropriate Service Information for A/C condenser replacement.

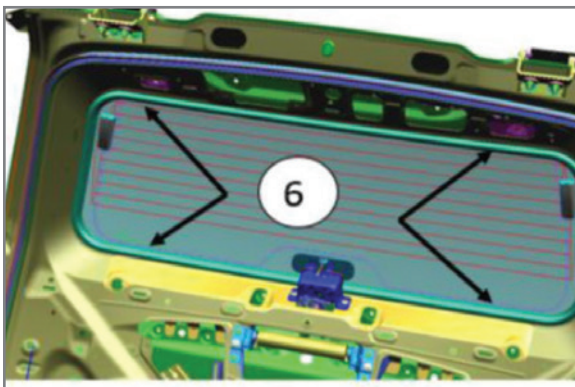
Inspect the liftglass seal.

**Liftglass Seal** – Inspect the liftglass seal to ensure that it is properly seated onto the liftgate flange.

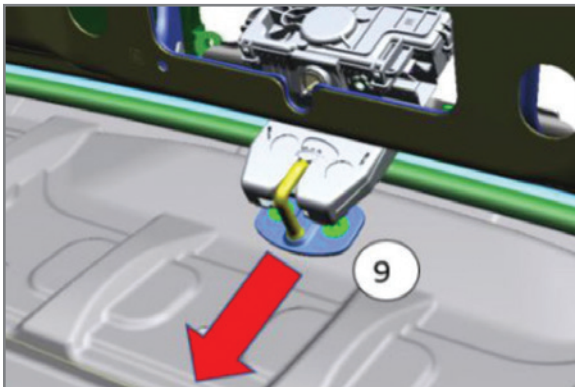
Adjust the striker if there is liftgate movement.

**Liftgate Movement** – With the liftgate closed, push on the bottom of the liftgate. If the liftgate has fore/aft movement, adjust the liftgate striker forward 1.0mm. Also check that the striker is centered in the liftgate latch opening. Refer to #PIT5768 for the procedure to adjust the striker.

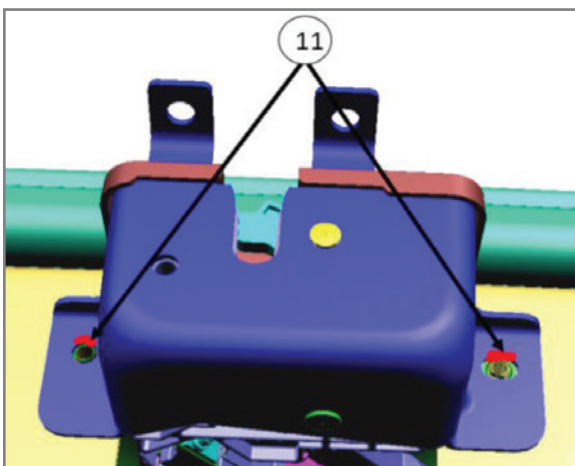
Slot the mounting holes to move the liftglass latch forward.

**Liftglass Latch** – If the rattle sound is still present after making all other adjustments and the sound has been isolated to the liftglass, remove the liftglass latch and slot the mounting holes 1.5mm to move the latch forward. Refer to #PIT5768 for additional information.

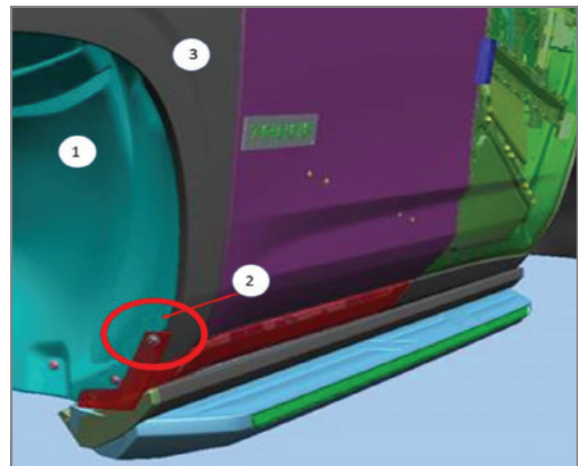
A flutter, rattle or similar wind noise may be heard from either the left front end and/or right front end of the vehicle at highway speeds on some 2021 Tahoe and Yukon models. The sound may seem to be coming from the windshield area.

There may be excessive movement of the left or right front inner wheel well liner, resulting in the flutter sound.

Area of excessive movement (#2) of the wheel well liner

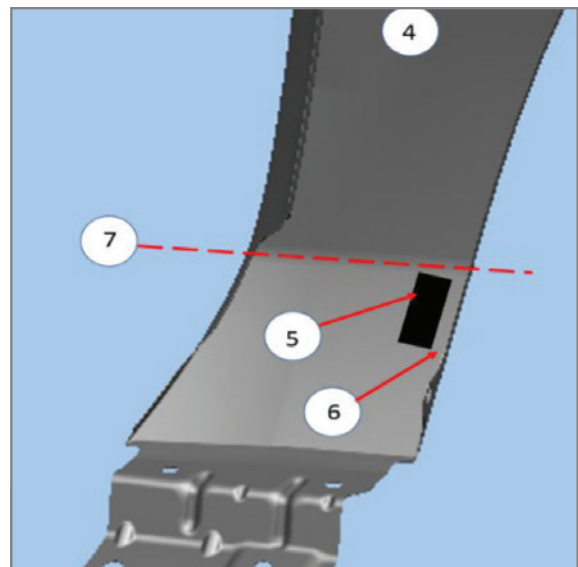
Apply foam/butyl tape (#5) at the fender feature line (#7) and 10mm from the fender flange (#6).

To correct the condition, apply a 1" x 3" x 1/4" piece of foam, or a couple layers of butyl tape, to the inside of the fender.

On the back/inboard side of the fender, the foam or layers of butyl tape should be applied starting at the fender feature line and 10mm from the fender flange. The foam/butyl tape needs to create a cross car interference with the fender liner return flange.
