TECH LINK

GM TechLink is published for all GM retail technicians and service consultants to provide timely information to help increase knowledge about GM products and improve the performance of the service department.

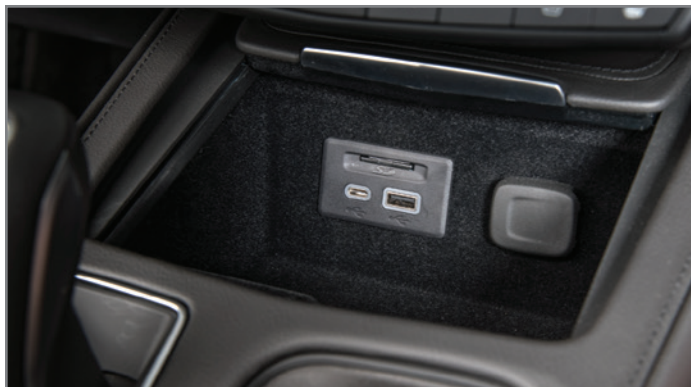
The SD card slot is usually located at the front of the center console.

If the SD card is not ejected properly, the card may not be able to be read by the navigation system the next time the system is used. If anything is being written to the card when it is removed, there is a risk that permanent data corruption may occur.

The SD card must be ejected correctly, similar to how a flash drive must be ejected properly from a computer, in order to remove the card from the card slot without affecting the performance of the navigation system.

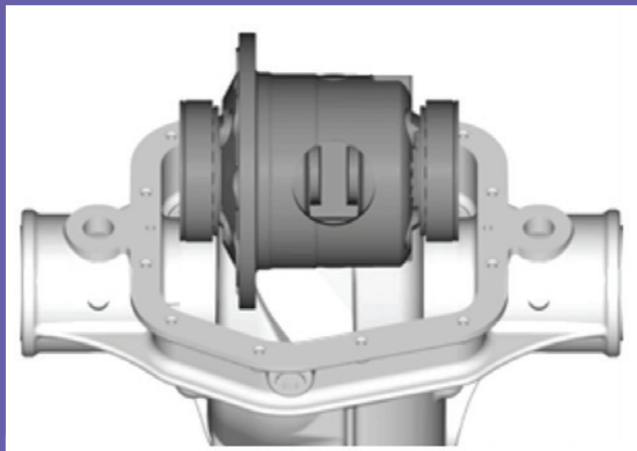
A whining, growling or grinding sound may be heard on some 2017-2019 Colorado and Canyon models during acceleration or deceleration when traveling from 20 mph (32 km/h) to highway speeds. There may be a machining issue that creates a step on the surface of the carrier bearing bore in the rear differential housing. Affected models are equipped with the 2.8L diesel engine (RPO LWN) or 3.6L V6 engine (RPO LGZ) and a 3.42 rear axle ratio (RPO GU6) and were built from start of production to June 17, 2019.

Inspect the surface of the carrier bearing bore in the differential housing.

If these conditions are found, follow the diagnostic information for a rear differential noise in the appropriate Service Information. If the source of the noise is determined to be coming from the rear differential carrier bearings, disassemble the axle assembly and inspect the surface of the carrier bearing bore in the differential housing.

If the mating surface contains machining imperfections or has a step on the surface, replace the axle assembly.

If the bearing mating surface is free of any imperfections, replace the carrier bearings only. Be sure to use the designated special tools listed in the Service Information in order to properly remove and install the bearings.

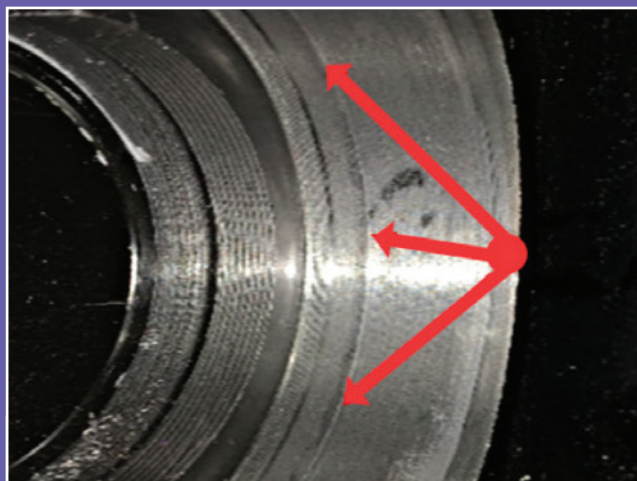
Step on the bearing mating surface

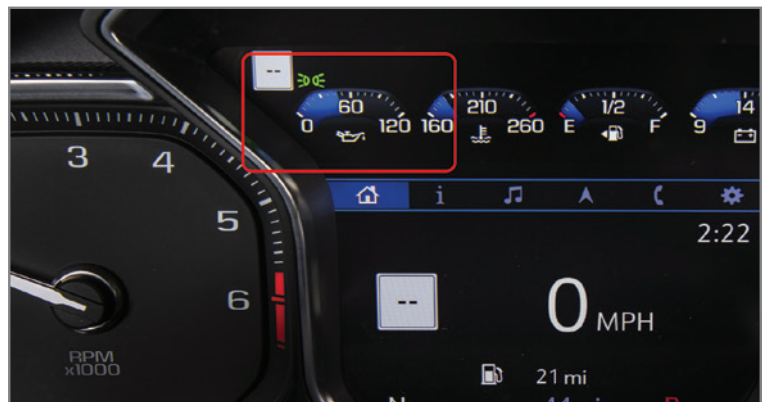
Engine oil pressure gauge

All of these factors play a role in the oil pressure displayed on the engine oil pressure gauge on the instrument cluster. In certain driving conditions, the oil pressure reading may drop or change quickly, which is part of normal engine operation. Some customers may question engine operation if the gauge shows more fluctuation and lower standard operating pressure than on previous models.

Any engine conditions that are outside of the normal operating range and require service will be indicated by a message on the Driver Information Center (DIC). A DTC may set and the oil pressure warning light may or may not illuminate, depending on the engine condition. If a DIC message is not displayed, the engine and the oil pressure gauge are operating as designed and no repairs should be attempted.

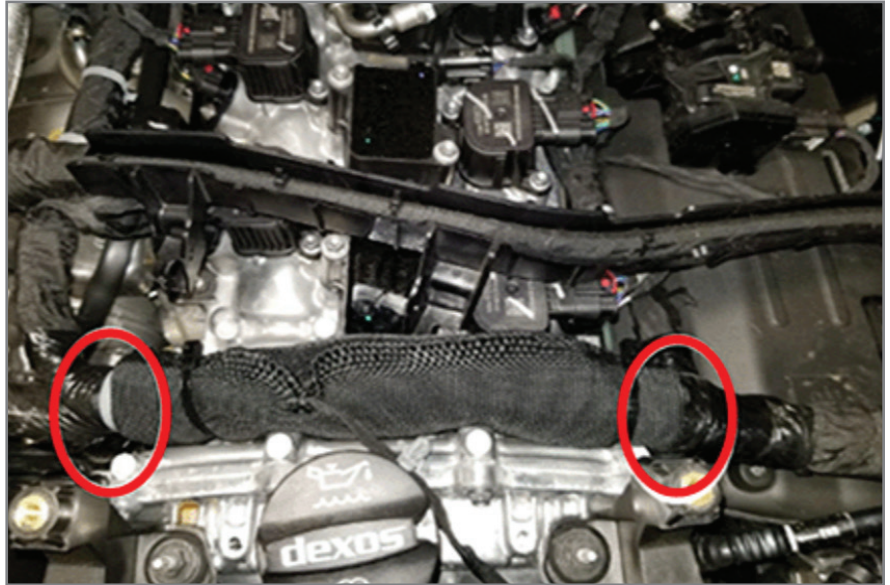
Some 2019-2020 Silverado 1500 and Sierra 1500 models equipped with the 2.7L engine (RPO L3B) may have DTCs P06DA (Engine Oil Pressure Control Solenoid Valve Control Circuit), P06DB (Engine Oil Pressure Control Solenoid Valve Control Circuit Low Voltage), and P06DD (Engine Oil Pressure Control Solenoid Valve Performance) set in the Engine Control Module (ECM). The DTCs may be set due to several potential engine wiring harness conditions, including the wiring harness coming in contact with underhood components.

Possible engine harness routing issue

If the DTCs or other related codes are set, following the diagnostic procedures in the appropriate Service Information for each DTC.

TIP: Do not replace the Engine Oil Control

Solenoid Valve unless instructed to do so in the Service Information diagnostic procedures. Oil Control Solenoid Valves that have been returned under warranty have been tested and inspected with no trouble found.

In addition, perform a pin drag test using the appropriate test terminals as well as validate the Oil Pressure Control Solenoid Valve wiring harness for potential opens or shorts.
