## PROPER Terminal Testing AND DIAGNOSIS

# PROPER Terminal Testing AND DIAGNOSIS

# Delayed Transmission Engagement

# The Importance of Using the Correct Fasteners

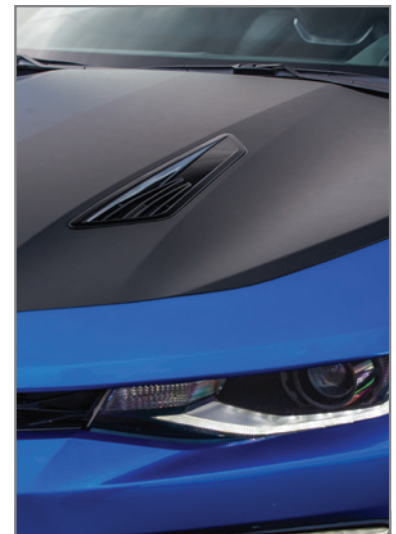
The hood wrap must be altered to accommodate any hood vents or heat extractors.

number hood wrap. In order to accommodate any hood vents or heat extractors, it will be necessary to cut holes in the hood wrap.

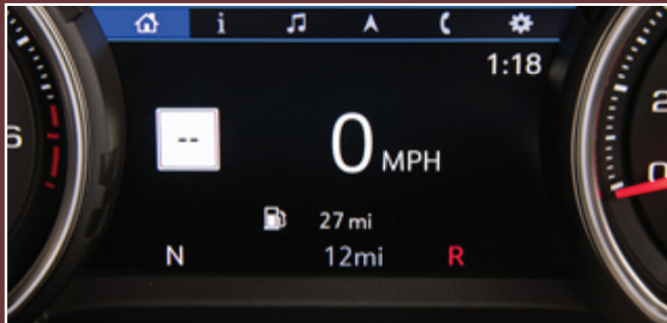
The condition may seem to be delayed gear engagement, a slipping transmission, or delayed engagement followed by a harsh engagement.

Delayed engagement may occur when the transmission is shifted from Park to Reverse or Park to Drive.

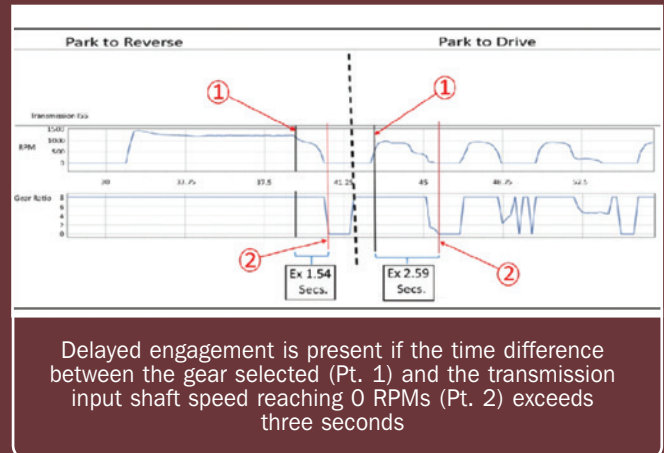
Delayed engagement of Park to Reverse or Park to Drive is present if the time difference between the gear selected (Pt. 1) and the transmission input shaft speed reaching 0 RPMs (Pt. 2) exceeds three seconds.

If engagement time exceeds three seconds, attempt to learn the C3 – Drive and C5 Reverse - Clutch using the following steps:

1. Allow the transmission sump temperature to rise between 20° and 30°C (68° and 86°F). Do not apply the accelerator pedal.
2. Perform 20 Park to Reverse shifts or 20 Park to Drive shifts, releasing the brake pedal with each shift and allowing the vehicle to roll 5-10 feet (1.5-3.0 m) per engagement into gear.

If the learn procedure does not correct the condition, disassemble the transmission and inspect the 1-3-5-6-7 Clutch (C3) for a delay into Drive condition and inspect the 4-5-6-7-8 Reverse Clutch (C5) for a delay into Reverse condition. The respective clutch plates and seals should be inspected for wear and/or damage and repaired accordingly.

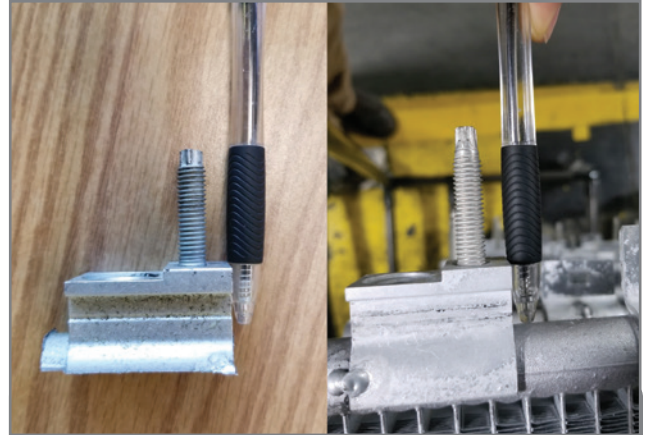
A recent analysis of an air conditioning warranty claim on a 2020 Silverado 1500 with a refrigerant leak led to an unlikely cause. An inspection of the A/C condenser that was replaced showed a stud at the A/C condenser manifold block had been replaced with a different stud that was longer.

The original, correct studs and the new, incorrect stud appeared to be the same length, but the incorrect stud could be driven deeper into the manifold.

Incorrect stud (left) and correct stud (right) in the A/C condenser manifold block.

**Caution: Use the correct fastener in the correct location. Replacement fasteners must be the correct part number for that application.**

Check for the correct fasteners for an application during repairs. Simply choosing fasteners that look similar in size is not a reliable method for identifying the proper fasteners. Always identify the fastener by the part number identified in the repair procedure. Also, always be sure to torque all fasteners to the provided torque specifications.

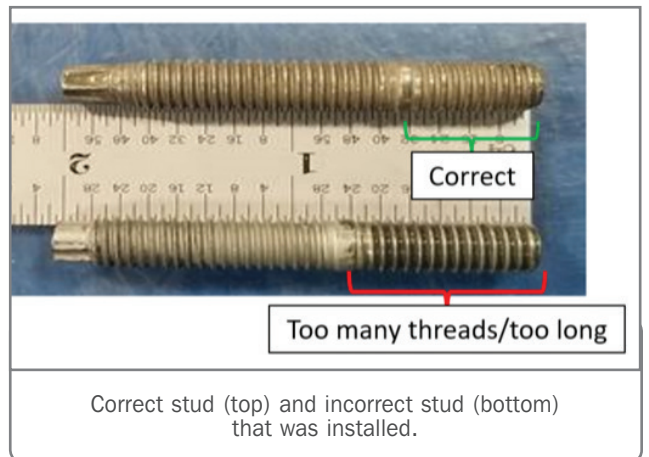
Correct stud (top) and incorrect stud (bottom) that was installed.

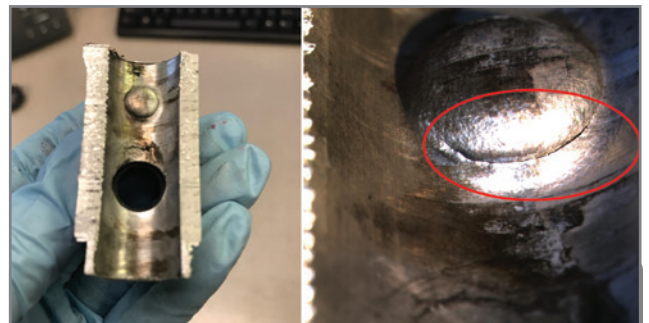
When the incorrect stud was driven into the manifold, it bottomed out in the hole and punched through the condenser manifold, causing a slight crack and, eventually, a refrigerant leak.

Crack leading to refrigerant leak

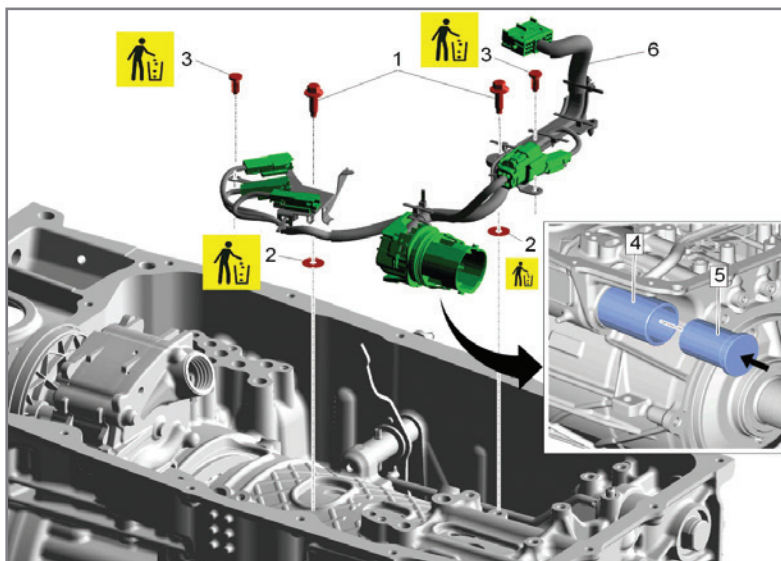
Automatic transmission pass-through wiring harness on the 2020 CT4.

If the transmission range sensor reading is not between 7 – 93%, disconnect and reconnect the pass-through to engine harness connector. If the condition returns after reconnecting, replace the transmission pass-through internal harness.
