October 2020, Volume 22, No. 19

Potential Oil Leak from Camshaft Carrier Gasket

PARTICULATE MATTER SENSOR

Loose Turbocharger Actuator Bolts

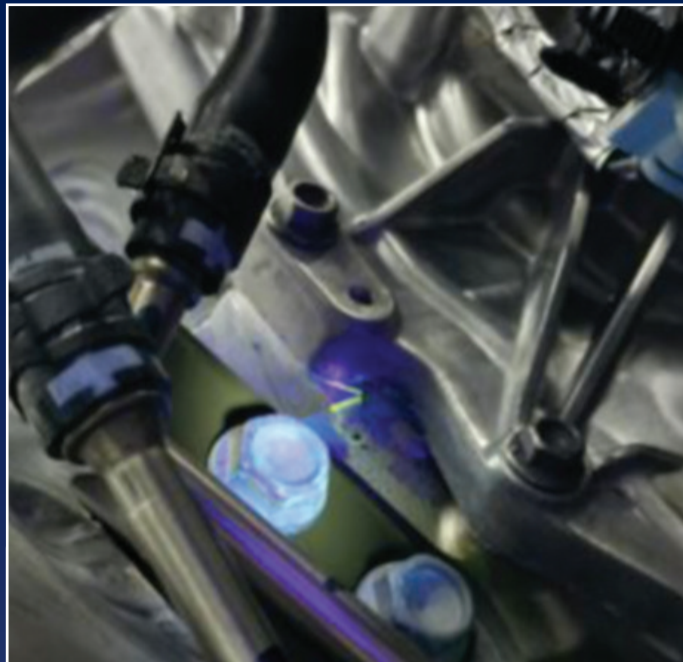
A potential oil leak from the camshaft carrier gasket may be found on some 2019 CT6; 2019-2021 XT4; 2020-2021 Acadia, Blazer, CT4, CT5, XT5 and XT6 models equipped with the 2.0L 4-cylinder engine (RPO LSY). On these engines, there may be an improper amount of sealer applied to the recommended areas of the camshaft carrier gasket T-joint area.

Use a black light to highlight the oil dye.

If the oil leak is isolated to the camshaft carrier T-joint area, reseal the camshaft carrier assembly.

Apply a 5 mm (0.2 in.) bead of RTV at the top and bottom of the new camshaft cover gasket to fill the T-joint.

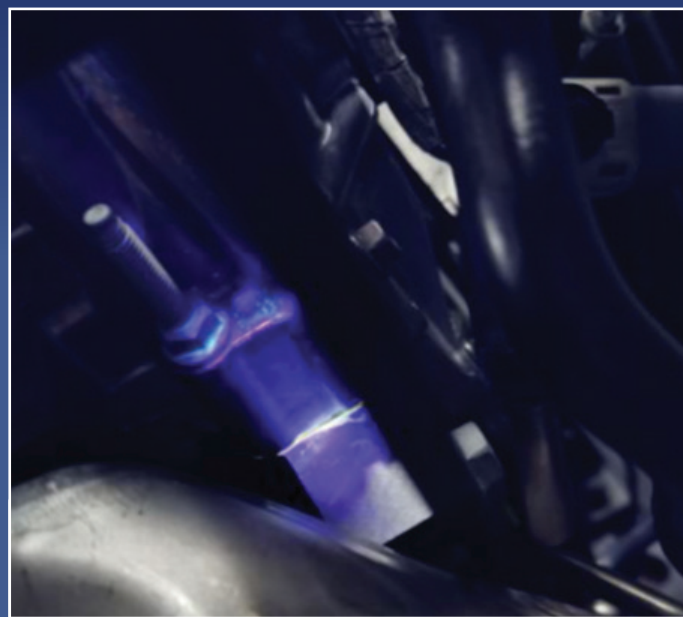
Engine cam carrier T-joint area

Use a black light to highlight the oil dye. Once a leak is confirmed, inspect the front of the engine camshaft carrier T-joint area.

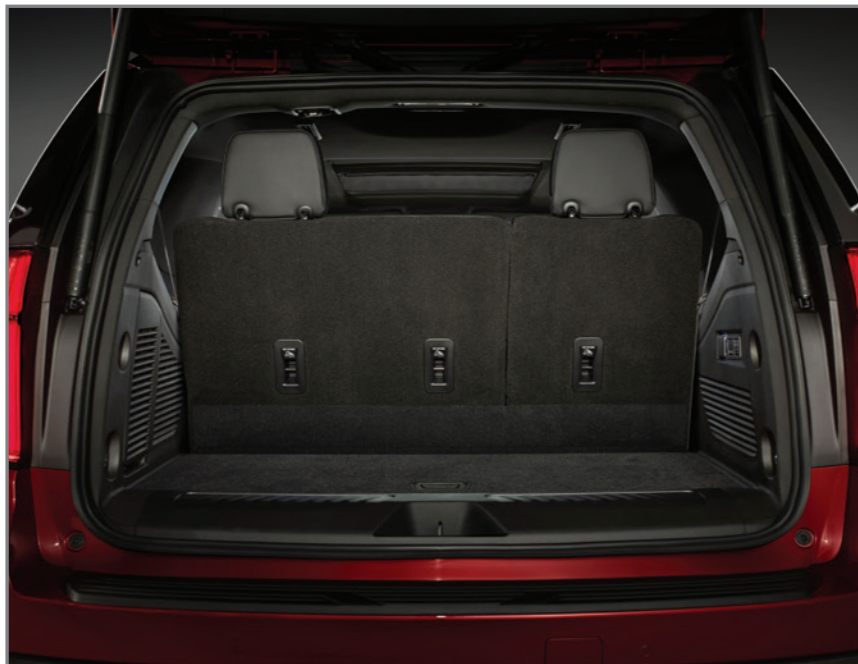
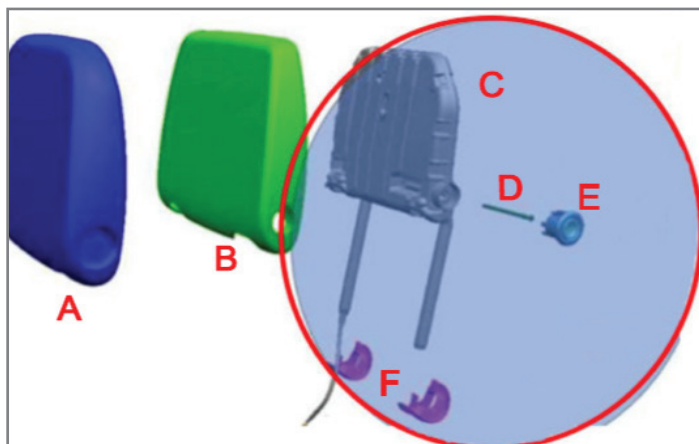
After cycling a 3rd-row seat to the up position on some 2021 Tahoe, Suburban and Yukon model, the headrest may not return to or stay in the upright position. In some cases, if excessive force is used to move the headrest, it may stay in the upright position.

The headrest may not stay in the upright position due to the locking mechanism not engaging inside the headrest. To correct the condition, a headrest service kit is available from the Warranty Parts Center (WPC).

The headrest service kit includes the headrest core (C), pin (D), button (E), and bezels (F). The headrest trim cover (A) and foam (B) are reused.

The headrest service kit includes the headrest core, pin, button, and bezels. The headrest trim cover and foam are reused from the original headrest.

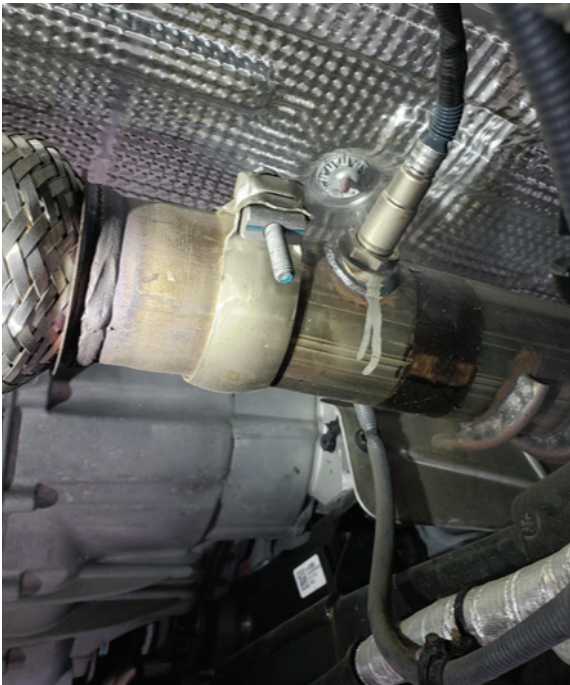
Leaking joint

The particulate matter sensor protection tube performance diagnostic may set a false DTC P1488 (Particulate Matter Sensor Temperature Circuit High Voltage) on some 2020 Silverado and Sierra trucks equipped with the 3.0L Duramax diesel engine (RPO LM2). The Check Engine MIL also may be illuminated.

If the joint shown is leaking, the clamp may have bottomed out before sufficient clamp load was applied to the joint. The clamp should be replaced if this condition exists.

Repair any leaks as needed and replace the particulate matter sensor.

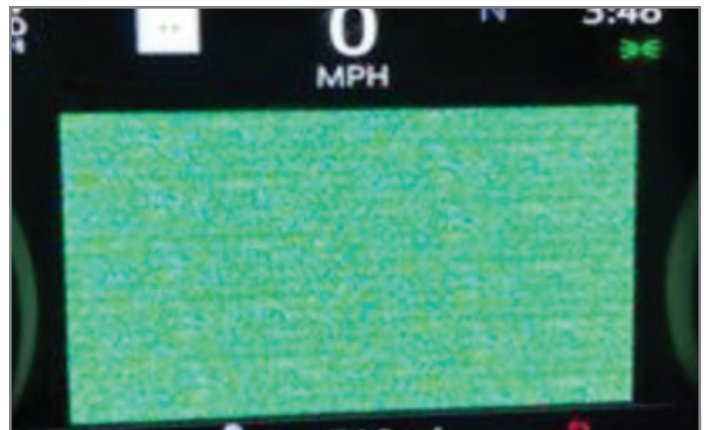
Some 2020-2021 XT5 and XT6 models equipped with Night Vision (RPO UV3) may show a green, pixelated display in the Driver Information Center when Night Vision is selected.

Green, pixelated Night Vision screen

If a green, pixelated screen is shown, inspect the back of the instrument cluster to determine if the black LVDS/USB connector is seated correctly. If the connector is not connected, check the cluster IP harness and install the connector, making sure it is fully seated.

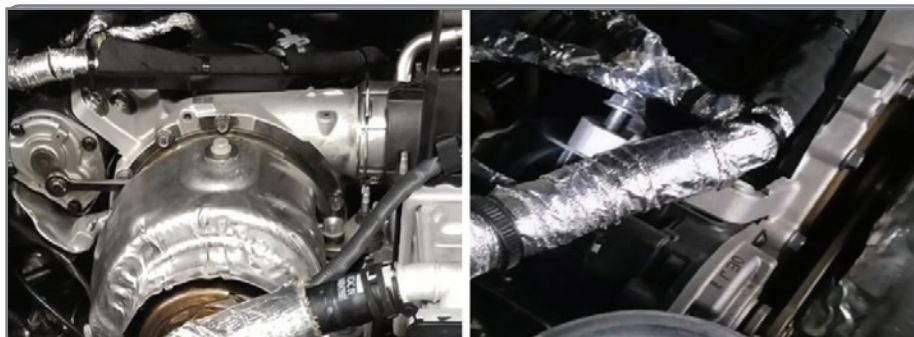
Some 2020-2021 Silverado and Sierra models equipped with the 3.0L turbocharged Duramax diesel engine (RPO LM2) may exhibit a lack of performance along with DTCs P003A (Turbocharger Boost Control Position Exceeded Learning Limit), P0046 (Turbocharger Boost Control Position Performance), P0299 (Engine Underboost) and/or P0234 (Engine Overboost). If these conditions are found, check for loose bolts on the turbocharger actuator.

Turbocharger actuator bolts

If any of the three actuator bolts are not fully seated, the threads may be damaged and the turbocharger should be replaced. The actuator is not available as a service part.
