Battery Condition Prognostics Integrated into Techline Connect

TECH LINK

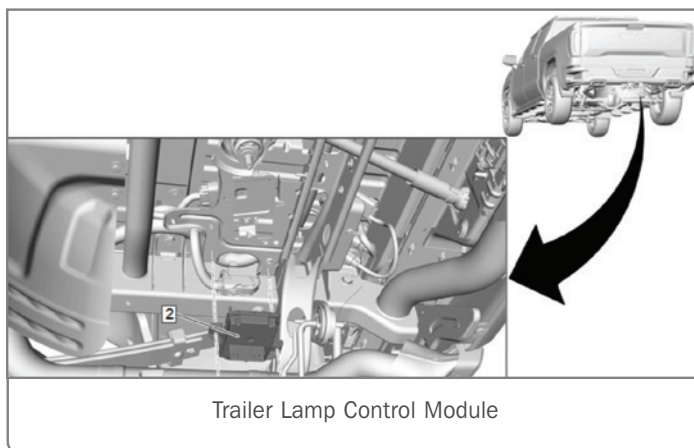
The trailer running lamps may illuminate momentarily and then turn off or may flash when connected to 2019 Silverado 1500 and Sierra 1500 models. When operating a trailer running lamp circuit with more than 7-8 amps of current draw, the trailer lamps will illuminate for a second and then go out or, on trailers with LED lighting, the lamps will flash about once every 10 seconds.

These conditions may be caused by a trailer with incandescent running lamps that may have in-rush current that exceeds the Trailer Lamp Control Module limits for current flow. On trailers with LED lighting, the monitoring voltage may illuminate the LED lights even when the trailer theft deterrent feature is not enabled.

2019 model year trucks equipped with the Trailer Information Indicator (RPO U1D) use the K68 Trailer Lighting Control Module to control all trailer lighting through pulse width modulated (PWM) voltage. The Trailer Lamp Control Module has a current handling capability on the running lamp circuit of about 9 amps. On a trailer with a large number of incandescent lights, in-rush current can exceed 20 amps before it settles back to around 8-9 amps. During this in-rush or "marriage" current period, the Trailer Lamp Control Module identifies the current as an overload and goes into protection mode.

For 2020 model year trucks, a change was made to allow 16 amps of continuous current flow by routing the current through an internal relay in the Trailer Lamp Control Module. 2019 models can be modified to operate in the same way with the use of the 2020 design software and a re-pin of the running lamps to pin 25 using the internal relay to operate the running lamps.

The update requires a terminated lead to be inserted into cavity 25 on the chassis harness X1 connector. Wiring connected to pin 5 on the X1 will need to be cut and reconnected to pin 25. The terminal in cavity 5 will remain, but must be blunt cut and sealed with a closed-end Duraseal splice to prevent water intrusion through pin 5.

To review the service procedure to move circuit 2109 on the Trailer Lamp Control Module from X1 cavity 5 to X1 cavity 25, and program new software from SPS into the Trailer Lamp Control Module, refer to Bulletin #20-NA-198.

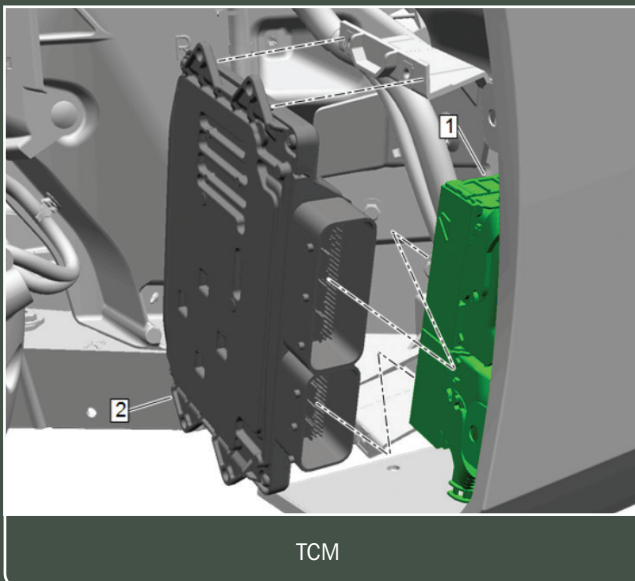
Some 2020 Corvettes may have an illuminated Check Engine MIL and a reduced engine power message on the instrument cluster with no noticeable performance issues. DTCs P1967 (Serial Data Message Safety Performance 1) and/or P1968 (Serial Data Message Safety Performance 2) may be set in the Transmission Control Module (TCM).

These conditions are not a performance issue with the TCM or transmission assembly. A software update is currently being evaluated.

Follow the diagnostics for these DTCs in the appropriate Service Information. If there are other DTCs set in the TCM, diagnose those DTCs first.

If only DTCs P1967 or P1968 are set, do not request a TCM replacement per #PIP5703 (TCM Restriction). Perform the even and odd-related clean procedures in GDS2 and a transmission service fast learn. After completing these procedures, re-evaluate the condition.

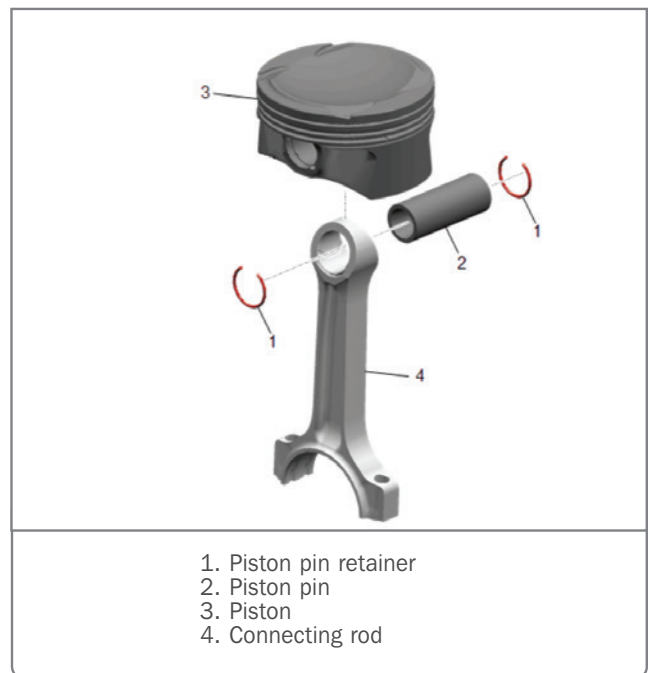
Using the J-39570 Chassis Ears, it may be determined that the sound is coming from the engine block below the cylinder head area. To identify the source of the sound, cancel each cylinder to isolate the affected component.

1. Piston pin retainer
2. Piston pin
3. Piston
4. Connecting rod

A noisy assembly will have a loose feel when the piston is rocked back and forth in the direction of the piston pin axis. It may help to compare to other assemblies in the engine. Replace any loose piston rods/pins to correct the tapping sound condition.

Following the diagnostics in the Service Information for "Lower Engine Noise, Regardless of Engine Speed," remove the piston and rod assemblies. Once the piston/rod assembly is removed, place and hold the rod flat on the end of a workbench. Center the piston/wrist pin in the small end of the rod and rock the piston back and forth along the axis of the piston pin.

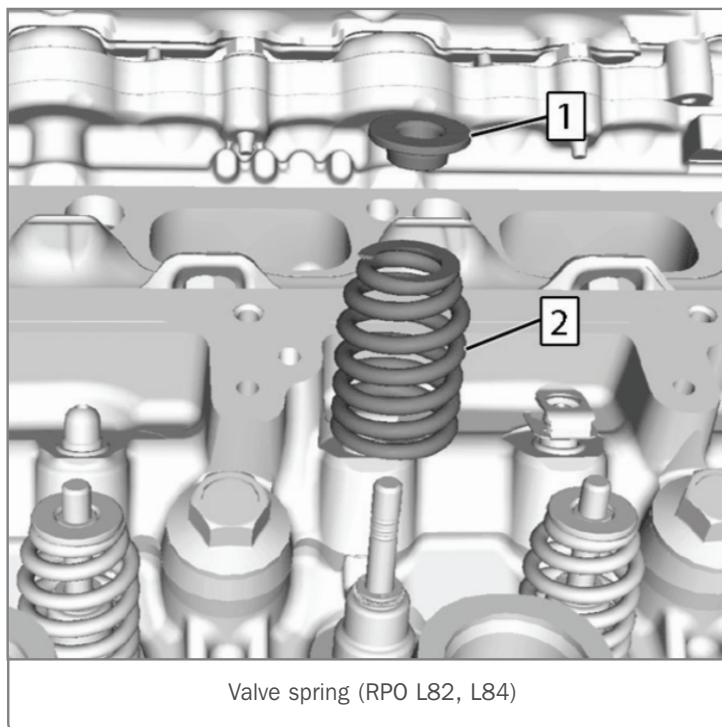
Some 2020 Silverado, Sierra; 2020-2021 Camaro; 2021 Corvette, Tahoe, Suburban, Yukon, and Escalade models equipped with the 5.3L engine (RPOs L82, L84), 6.2L engine (RPOs L87, LT1, LT4, LT2), or 6.6L engine (RPO L8T) may have a misfire and engine noise condition. The Check Engine MIL also may be illuminated along with possible DTCs P0300 (Engine Misfire Detected), P0106 (Manifold Absolute Pressure Sensor Performance), and P0506 (Idle Speed Low). These conditions may be due to a broken valve spring.

If it's determined during an inspection that the engine has a broken valve spring, a cylinder leakage test on the affected cylinder must be performed.

On 5.3L and 6.6L engines (RPOs L82, L84 and L8T) built from June 1, 2020 to October 7, 2020, if cylinder leakage is not observed, replace only the affected valve spring.

On 6.2L engines (RPOs L87, LT1, LT4 and LT2) built from June 1, 2020 to October 7, 2020, if cylinder leakage is not observed, replace all valve springs on both cylinder banks.

If there is cylinder leakage in the engine, perform further diagnosis to determine the extent of the engine damage and the correct repairs required.

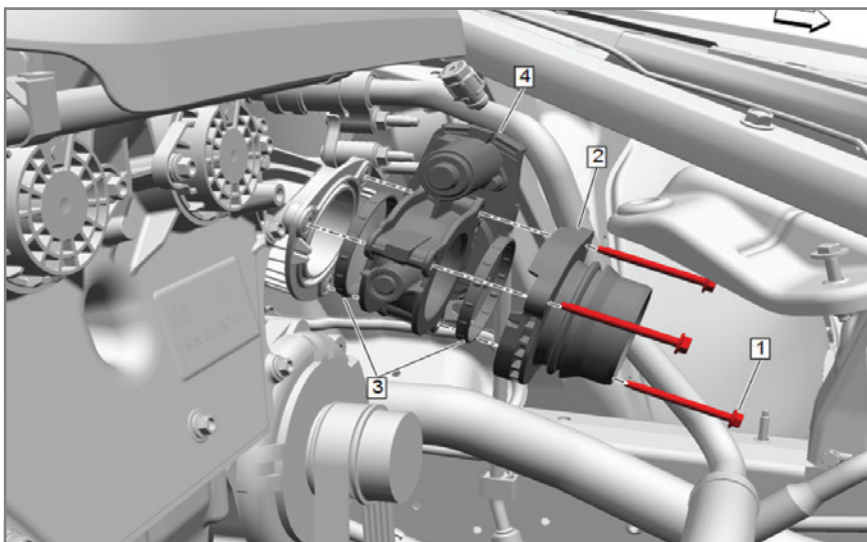
Throttle body assembly

DTC P2101 (Throttle Actuator Position Performance) may be set in history on some 2020-2021 CT5 models equipped with the 2.0L engine (RPO LSY). If DTC P2101 is set, complete all the published diagnostics in the appropriate Service Information for the DTC.

The Throttle Actuator Control (TAC) system is controlled by the Engine Control Module (ECM), which determines the driver's intent based on input from the accelerator pedal position sensors and calculates the appropriate throttle response. The ECM achieves throttle positioning by providing a pulse width modulated voltage to the throttle actuator motor. The throttle blade is spring loaded in both directions, and the default position is slightly open. When the ECM detects a condition with the TAC system, the ECM may enter a reduced engine power mode. DTC P2101 may set if the vehicle battery is weak or the throttle blade is stuck.

Unless the diagnostic procedure in the Service Information leads to replacement of the throttle body assembly for history DTC P2101, do not replace the throttle body assembly. Throttle body assemblies returned for warranty analysis have been inspected and tested with no trouble found.

If the Service Information diagnostics do not isolate a cause for DTC P2101 set in history, clear the code and operate the vehicle under the conditions necessary for running the DTC.
