## GDS2 Transitioning from TIS2Web to Techline Connect

Global Diagnostic System 2 (GDS 2)

# WIRING HARNESS CONDITIONS ON THE 2.8L Diesel Engine

# Damaged Crankshaft Position Sensor and Reluctor Ring

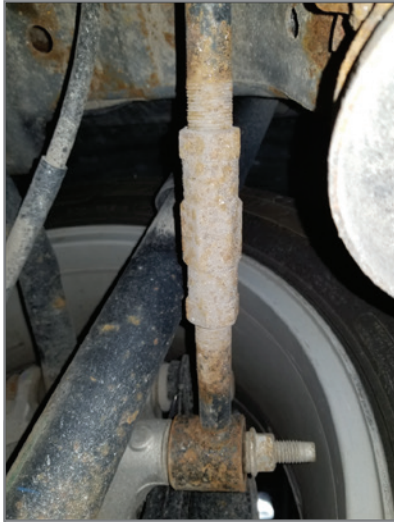
When servicing the rear suspension on 2010-2016 Cadillac SRX and 2011-2012 Saab 9-4X models, the Service Information has been updated recently to require the replacement of both right and left rear toe links if a rear alignment is needed. The original toe links should not be adjusted.

Toe links should not be adjusted.

not be adjusted again. If the rear toe requires alignment later, new rear toe links should be installed followed by a rear toe alignment. When the rear toe links are serviced, always verify that the adjustment link jam nuts are tightened to the proper torque specification.

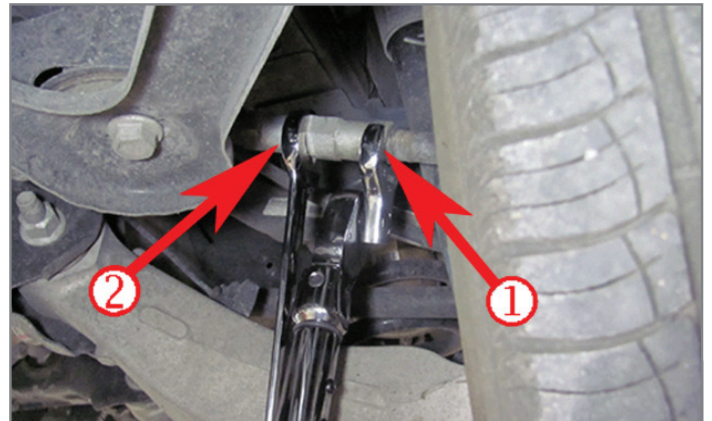
The rear toe links from the supplier are pre-torqued to 20 Nm (14 lb.-ft.), not the final torque specification of 150 Nm (110 lb.-ft.).

1. Crow's foot attachment and torque wrench on jam nut
2. Open-end wrench on adjustment collar

Hold the adjustment collar with a 26mm open-end wrench and verify the jam nut torque using a 26mm crow's foot attachment on a calibrated torque wrench. Check the torque by pulling the torque wrench handle. Tighten to 150 Nm (110 lb.-ft.). Ensure the jam nuts are properly torqued.

- On the driver's side of the vehicle, push the torque wrench toward the rear of vehicle on both the inner and outer jam nuts (the outer link has left-handed threads).
- On the passenger's side of the vehicle, pull the torque wrench toward the front of vehicle on both the inner and outer jam nuts (the outer link has left-handed threads).

Recheck the toe setting and readjust the toe specifications if necessary.

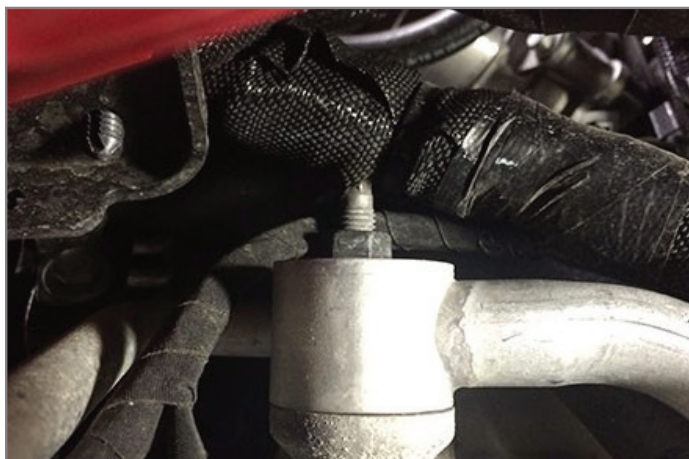
A wiring harness concern with the air conditioning (A/C) compressor, A/C compressor suction and discharge line manifold, A/C line and A/C compressor clutch may cause:

- The Check Engine light to illuminate and DIC messages to be displayed.
- The engine to run rough or a possible extended crank or crank/no start.
- The 4WD warning lamp or StabiliTrak warning lamp to illuminate.
- The oil pressure gauge to read erratically or show no oil pressure.
- The A/C to not cool or blow hot air.
- An open fuse in the Underhood Bussed Electrical Center (UBEC).

Check the engine wiring harness near A/C components.

Complete the diagnostic instructions in the appropriate Service Information for any symptoms or DTCs found. If the diagnosis does not lead to a resolution, check for chafing of the engine wiring harness or connector concerns in the following areas, perform any necessary wiring repairs and reroute the harness.

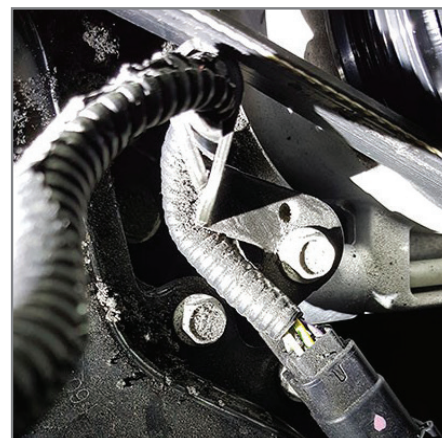
The fan clutch wiring harness support bracket may be out position and allow the harness to rub on the belt, which may cause:

- An engine crank/no start condition or the engine to run rough or misfire.
- The Check Engine light or other warning lamps to illuminate, such as the 4WD warning lamp or StabiliTrak warning lamp.
- The A/C to not cool or blow hot air.

Check the fan clutch wiring harness support bracket.

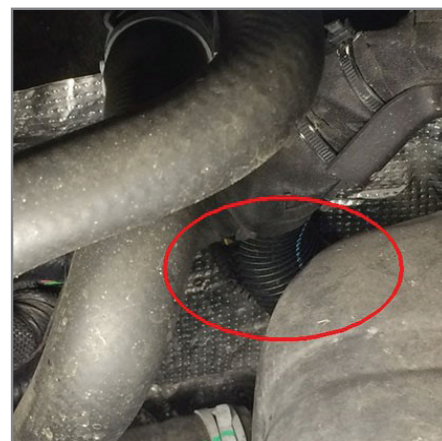
A wiring harness concern near the exhaust heat shield at the right rear of the engine may cause:

- The 4WD warning lamp or StabiliTrak warning lamp to illuminate.
- The Check Engine light to illuminate.
- A Reduced Power message on the DIC.
- An open fuse in the UBEC.

Check for harness damage on the exhaust heat shield.

**TIP:** Refer to Bulletin #16-NA-081 for additional information on harness damage on the exhaust heat shield.

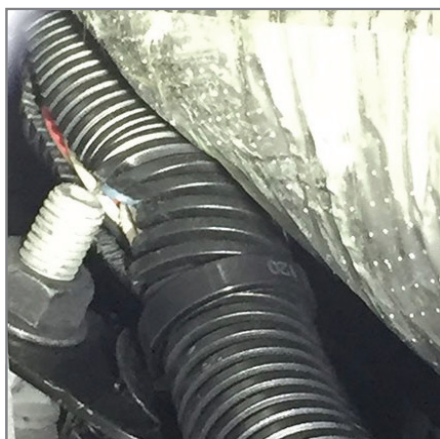
A wiring harness concern with the transmission bell housing bolt/stud area may cause:

- The 4WD warning lamp or StabiliTrak warning lamp to illuminate.
- The Check Engine light to illuminate.

Check the transmission bell housing bolt/stud area for harness damage.

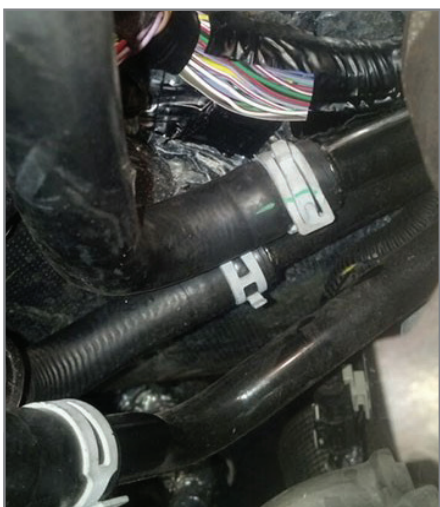
A wiring concern near the coolant pipe and clamp tabs between the engine and cowl may cause:

- The 4WD warning lamp or StabiliTrak warning lamp to illuminate.
- The Check Engine light to illuminate.

The coolant pipe and clamp tabs may wear on the harness.

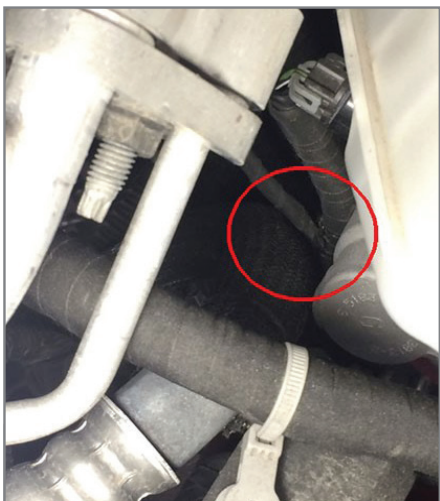
A wiring harness concern in this area may cause:

- The Check Engine light and service brake lamp to illuminate.
- A Low Brake Fluid message on the DIC

Check the brake fluid level switch area for harness damage.

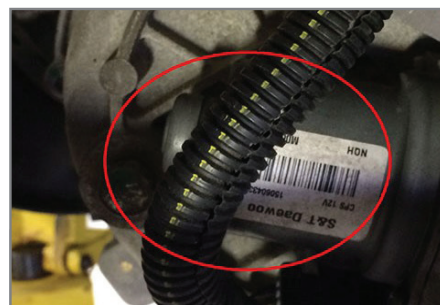
A wiring harness concern in this area may cause:

- The Check Engine light or other warning lamps to illuminate.

Check the harness near the transfer case encoder

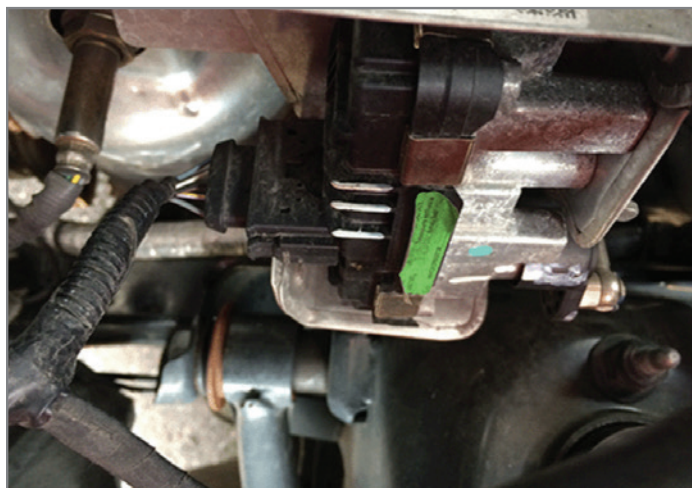
Check the connector at the turbocharger vane position actuator.

Loose terminals or a connector not fully seated at the turbocharger vane position actuator may cause:

- The Check Engine light or other warning lamps to illuminate.
- A reduced power message on the DIC and a low power condition.

For additional information, refer to #PIP5416D.

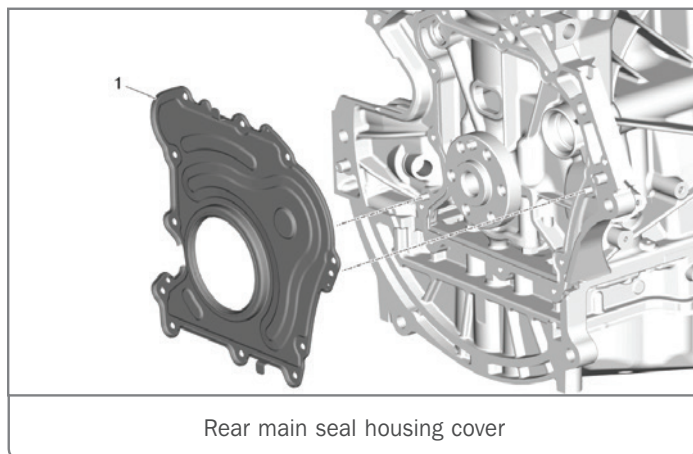
Rear main seal housing cover

If these conditions are present, check for a possible oil leak from the rear of the engine. The engine crankcase pressure may have increased to abnormal levels due to an internal restriction in the cam cover PCV channel, causing the rear main seal housing cover to balloon and make direct contact with the crankshaft position sensor reluctor ring.

If the crankshaft position sensor is damaged, remove the crankshaft position sensor reluctor ring and inspect the rear main oil seal housing. If the crankshaft position sensor reluctor ring has cut through the rear main oil seal housing, there may be metal contamination in the engine oil, requiring engine replacement.

If the crankshaft position sensor reluctor ring has not cut through the rear main oil seal housing, replace the crankshaft position sensor, reluctor ring, rear main oil seal housing, and camshaft cover.

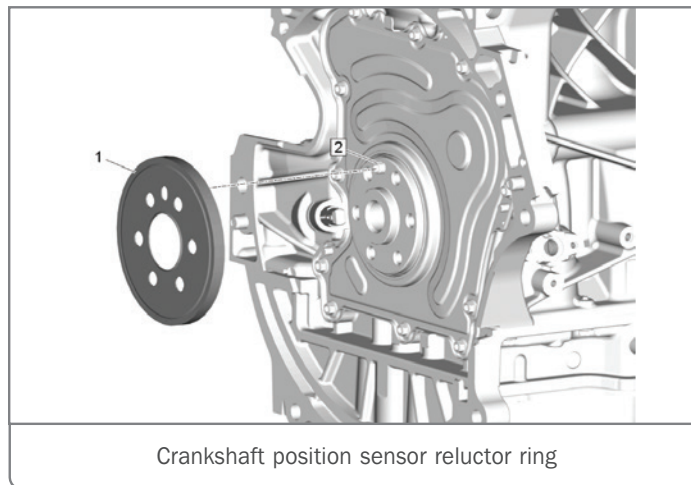
Crankshaft position sensor reluctor ring

Some 2020-2021 Encore GX and 2021 Trailblazer models equipped with the 1.2L engine (RPO LIH) may have a no start condition and DTCs P0335 (Crankshaft Position Sensor Circuit) and P0336 (Crankshaft Position Sensor Performance) set in the Engine Control Module.

Remove and inspect the crankshaft position sensor for any damage. If the crankshaft position sensor is not damaged, continue with diagnostics as outlined in the appropriate Service Information.
