UNEVEN OR LEANING AIR RIDE ADAPTIVE SUSPENSION

<i>Uneven or Leaning Air Ride Adaptive Suspension</i>	<i>2</i>
<i>Rear Axle Clunk Sound</i>	<i>5</i>
<i>Sunroof Drain Hose Extensions</i>	<i>6</i>
<i>Exhaust Charge DTC Diagnostics</i>	<i>7</i>
<i>Knock Sensor Inspection</i>	<i>7</i>
<i>Installing a Rearview Camera Kit</i>	<i>9</i>
<i>Transmission Shift Conditions</i>	<i>10</i>

TECH LINK

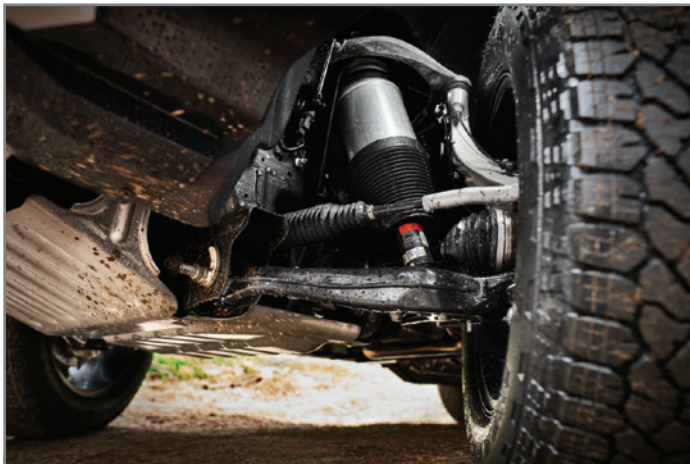
Air Ride Adaptive Suspension air spring

The air springs may become over- or under-inflated if one or more of the air lines is not fully seated into an air spring or air manifold block assembly, causing the suspension trim height conditions to occur.

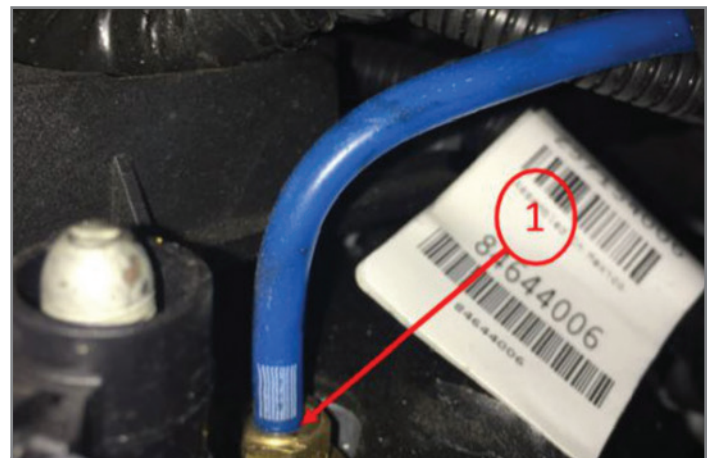
Space between the marking and the fitting indicates the air line is not fully seated.

If the air line at the air spring is not fully seated, the white marking will not be going into the fitting and there will be space between the marking and the fitting.

Inspecting each air line to ensure that the white marking goes into each fitting at the four air springs and manifold valve block will help in determining the cause of a low, high or uneven suspension condition. If an air line is not fully seated, push the air line into the fitting until it bottoms out and the white marking is going into the top of the fitting. In most cases, there is no need to loosen the air line fitting to fully seat the air line.

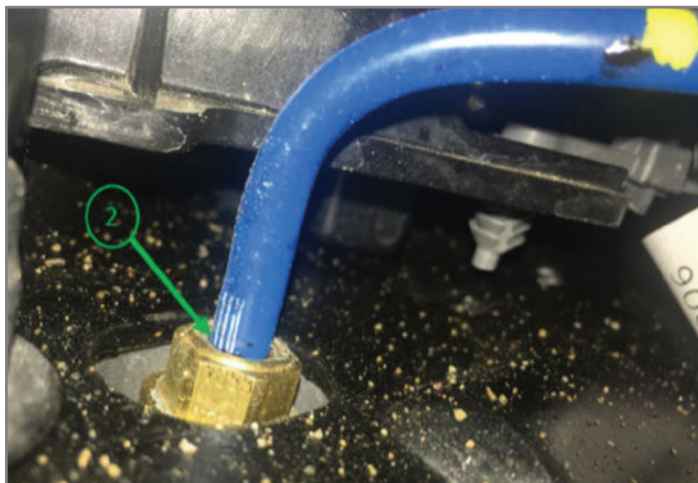
Since the seating of the air fittings is critical for proper operation, there are white marks on each air line to indicate when the air line is fully seated. The air line has to be inserted into the air fitting until it bottoms out and the white marks on the air line are going into the fitting. At least part of the white marking must be in the top of the fitting.

The white marks on the air line must go into the fitting.

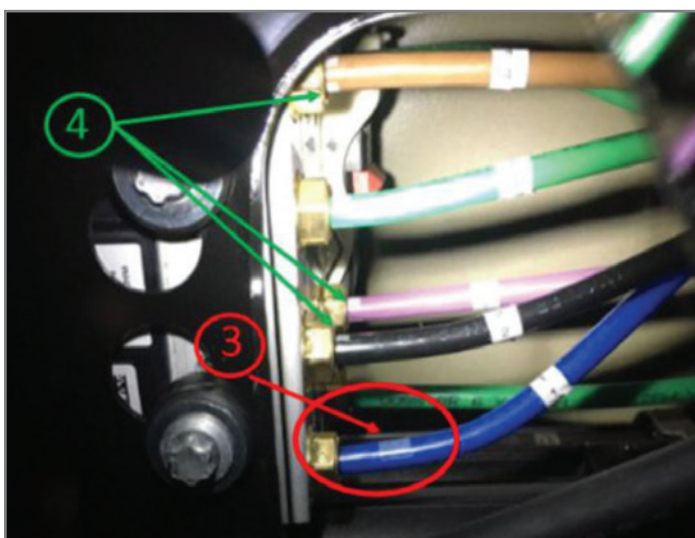
At the air manifold block, the air lines must be fully seated in the same manner, indicated by the white markings going in the top of each air line fitting. The blue air line shows an example of a line that is not fully seated with the white marking not going into the air line fitting.

The white marking shows the blue line is not fully seated into the air manifold block.

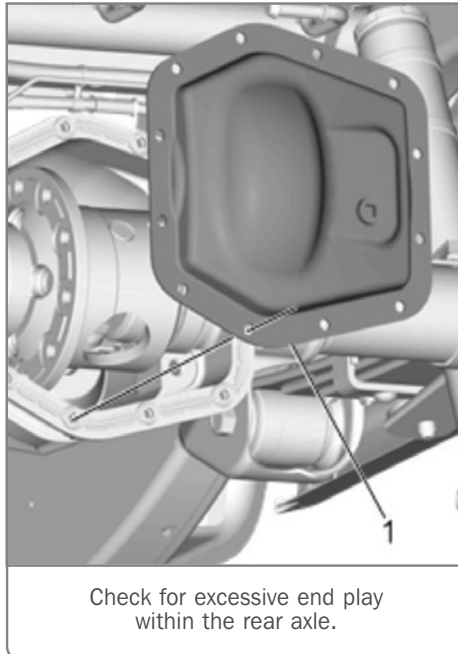
Some 2015-2021 Colorado and Canyon models may have a clunking sound heard from the rear axle area when driving over railroad tracks and/or entering or exiting parking lots and driveways. The sound may be caused by excessive axle shaft end play.

If the sound only occurs when the brake pedal is not applied, check for excessive end play within the rear axle. The C-locks on the axle shaft may require replacement.

Check for excessive end play within the rear axle.

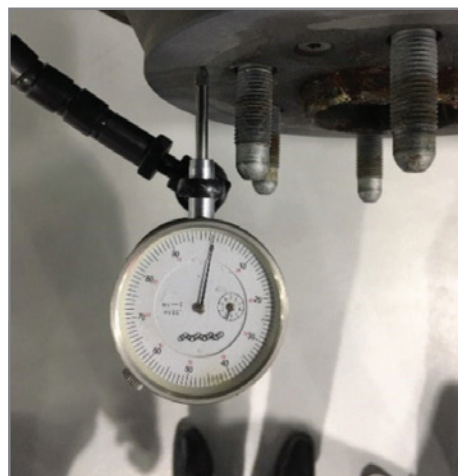
Use a dial indicator to measure endplay of the rear axle.

of the rear axle by pushing and pulling on the brake rotor and axle shaft. If end play measurement is at 0.32 mm (0.0126 in.) or greater, the service C-locks can be installed without interference (review Bulletin #20-NA-156 for an exception on the G80 locking rear axle). If end play is less than 0.32 mm (0.0126 in.), the service C-locks may be installed; however, if the axle shaft and differential are at the low end of the tolerance, interference may occur.

If end play exceeds 1.05 mm (0.0413 in.), the end play is out of specification. Refer to appropriate Service Information for further drive line diagnostic procedures.

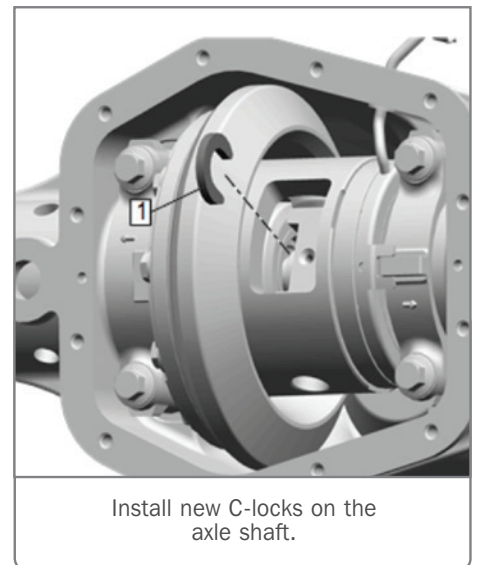
The production C-locks have a thickness specification of 5.18 mm to 5.26 mm (0.204 in. to 0.207 in.) while the service C-locks have a thickness specification between 5.42 mm and 5.50 mm (0.213 in. to 0.216 in.).

To access and install new C-locks if needed, remove the rear brake rotors and rear axle housing cover. Use care not to damage the axle seal when pushing the axle shaft inwards. Be sure to tighten the pin lock bolt to specification.

Install new C-locks on the axle shaft.

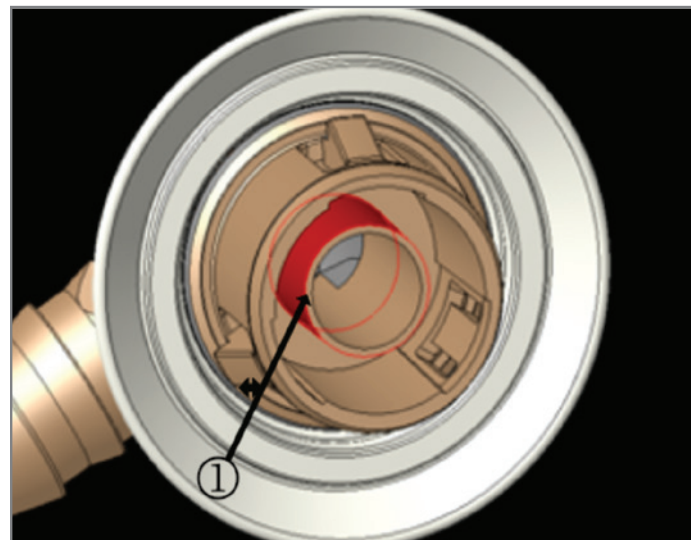
There may be a gurgle or sloshing sound heard on some 2021 Tahoe, Suburban, Yukon, and Escalade models equipped with a panoramic sunroof (RPO C3U). The sound may be coming from both front-right and front-left sunroof drain hose areas.

If the sound is heard, check the condition of the sunroof front drain hose grommets where they exit in the plenum. The pressure in the plenum may potentially be too high to allow water to exit as designed.

It may be necessary to add drain hose extensions to both right and left side drain hoses. The extension hoses will attach to the existing sunroof front drain hose grommets in the plenum behind the air inlet grille panel underhood and exit out of the plenum drain valves on the side of the vehicle.

Ensure the drain hose (#1) is installed perpendicular to the grommet

Tie straps should be used to secure the extended drain hose.

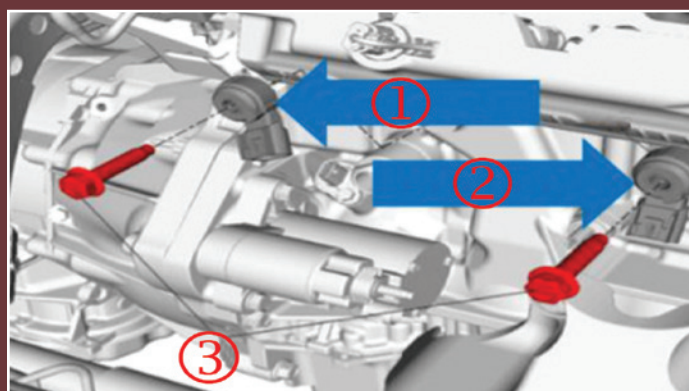
1. Knock sensor #2
2. Knock sensor #1
3. Bolts for knock sensors

A wiring harness condition or loose knock sensor bolt may be found on some 2020 Camaros with the 2.0L 4-cylinder engine (RPO LTG). The Check Engine light may be illuminated along with DTC P0331 (Knock Sensor 2 Performance) set in the Engine Control Module.

If there is a knock in the engine, inspect for a loose knock sensor #2 bolt using the appropriate size tool to measure torque.

Apply torque to the fastener in the tightening direction until it just begins to move and record the peak torque/breakaway torque on the repair order. (Breakaway torque spec \geq 10 Nm).

- Check for any moisture or water intrusion and/or deposits on the knock sensor #2 terminal or wiring harness connectors.
- Check the block mating face for any thread damage (uniformity) or debris, or any other abnormality, including the knock sensor #2 bolt thread.
- Check knock sensor #2 and the block surface for any rust (red rust or white powder).

Use air to clean any residual foreign material from both the bolt and hole threads before reinstalling the existing knock sensor.

Do not replace the knock sensor unless there is physical damage or improper performance found with the part.

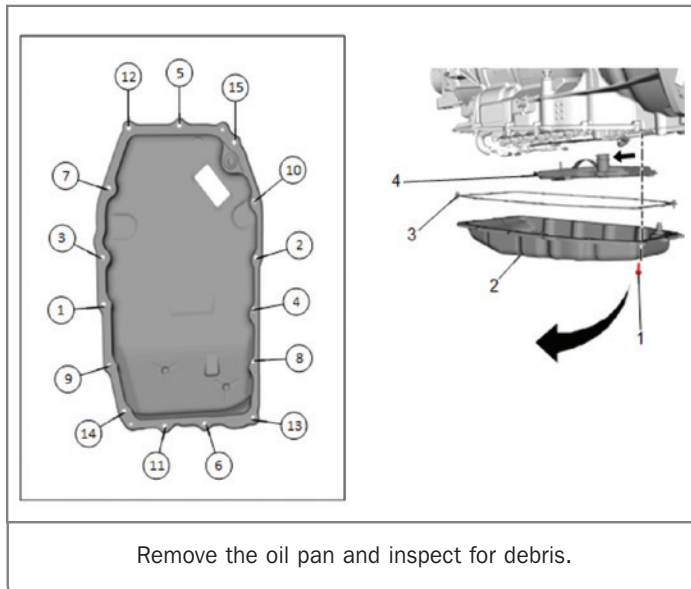
Some 2020 Silverado and Sierra models equipped with the 8-speed automatic transmission (RPO MQE) may have a slipping or improper shifting condition or may have defaulted to only one gear. DTC P0796 (Transmission Control Solenoid Valve 3 Stuck Off) also may be set.

If these conditions are present, the transmission oil pan should be removed and inspected for debris. If the pan is clean, replace the control valve body.

If there is evidence of failed clutch material, the transmission should be removed and inspected. Complete a cost comparison to determine if the transmission should be repaired or replaced.

Any repairs should include the control valve body replacement.
