Programming Radio Software

TECH LINK

GM TechLink is published for all GM retail technicians and service consultants to provide timely information to help increase knowledge about GM products and improve the performance of the service department.

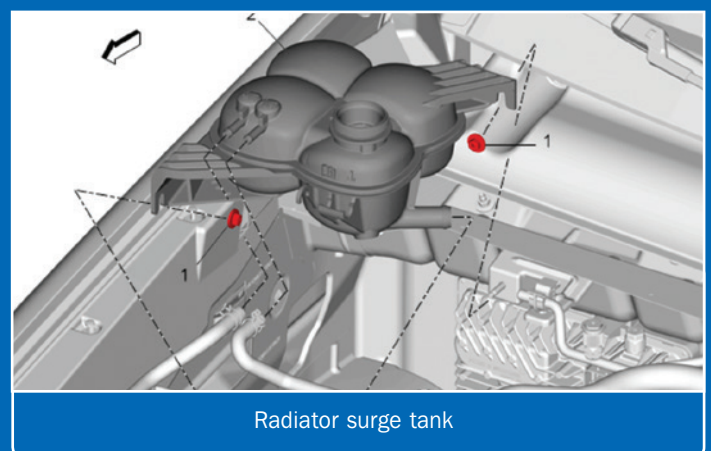
A water rush or gurgle sound from the heater core at the center of the instrument panel on some 2015-2019 Colorado and Canyon models may be caused by air ingestion in the cooling system.

If the water rush or gurgle sound is heard, replace the radiator surge tank on vehicles from Start of Production (SOP) to the VIN breakpoint listed in Bulletin #19-NA-007. 2019 and later model year vehicles produced after the VIN breakpoint already have the new surge tank.

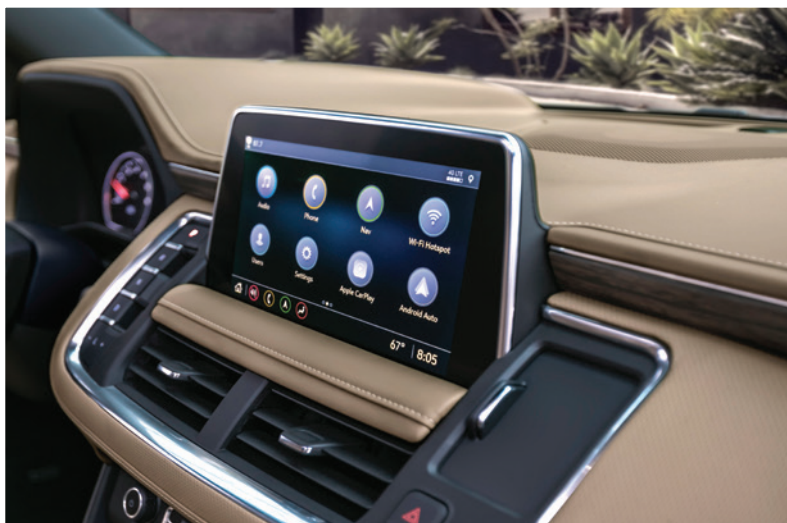
A ghost or phantom touch, where random touch inputs occur on the infotainment screen display, and/or the infotainment display is non-responsive to touch immediately after having been cleaned, wiped, or disinfected may occur on some 2019-2021 Buick, Cadillac, Chevrolet and GMC models equipped with infotainment system RPOs IOS, IOT, IOU or IOV. The phantom touch or non-responsive conditions may last the entire ignition cycle. After the radio has gone through a sleep cycle, the conditions are no longer present.

These infotainment display conditions may be caused by the presence of liquid or certain physical touch during the boot-up sequence that can corrupt the display boot-up for that ignition cycle, causing false touch input or no touch input to be received until the radio can reboot.

When cleaning and disinfecting the infotainment display, always have the infotainment system turned on. Wait for the vehicle brand splash animation to complete. Using a clean towel, apply the cleaner or disinfectant on the towel. Do not spray any cleaner directly on the infotainment display. Wipe the display surface with the towel. Be sure to always dry the display to ensure there is not any liquid, debris, or streaks on the display.

After cleaning the infotainment display, if the phantom touch or non-responsive conditions are present, turn off the ignition, disable Retained Accessory Power (RAP), and allow the system to go to sleep (at least three minutes). Verify the conditions are no longer present. If the issue persists, check that the display is thoroughly clean and completely dry before allowing the system to go into sleep mode again.

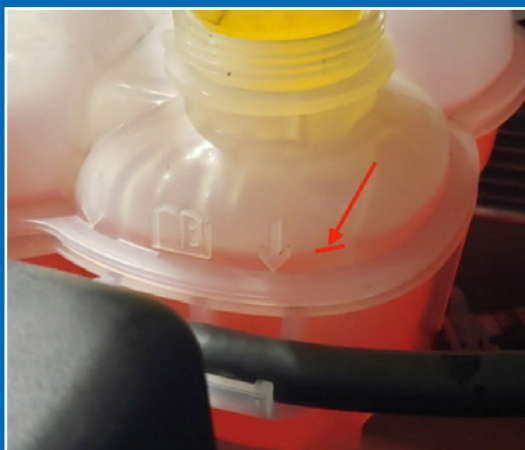
The coolant in the surge tank should be 150 ml over the factory fill line.

coolant level. The coolant in the surge tank should be 150 ml over the factory fill line, as shown in the graphic.

air from the heater core using the Vac-N-Fill method because the radiator cap and heater core are at about the same height. If the sound persists, raise the front of the vehicle with a hoist until the radiator cap is above the cowl after adding the additional coolant to the surge tank. Remove the radiator cap and run the engine for an hour. Run the throttle up to approximately 1500 RPM three or four times during the hour.

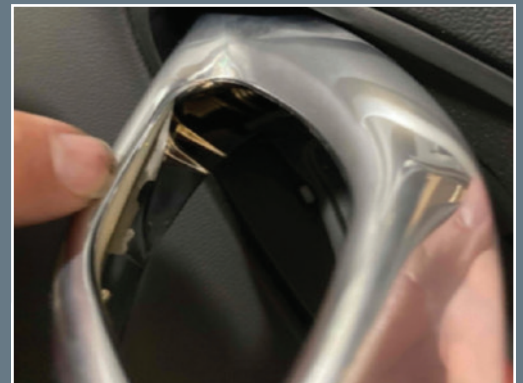
The chrome may be starting to peel off the interior door handle on some 2016-2020 Camaro models. The chrome separation may be noticed at the parting line of the handle.

Interior door handle chrome separation

If the chrome trim is starting to peel, the interior door handle should be replaced. The front side door trim must be removed to access the door handle. Also disconnect the electrical connectors from the inside handle.

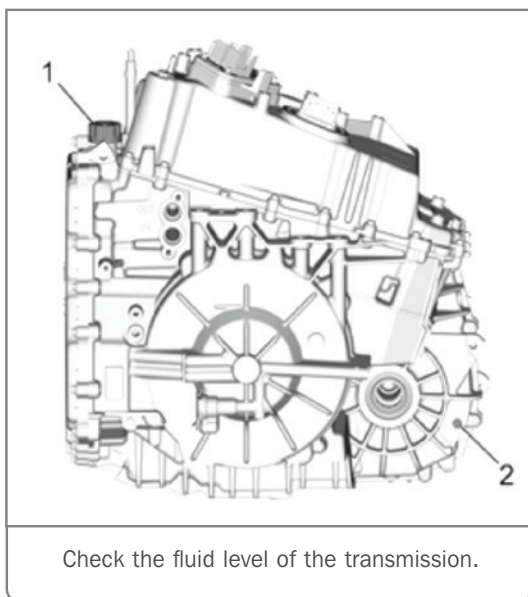
A Speed Limited or Reduced Propulsion Power message may display on the Driver Information Center (DIC) along with reduced power on some 2016-2019 Volts. The message may display for a brief time only. When the message clears, full propulsion power is restored. No DTCs will be set.

The vehicle may have reduced power if the transmission fluid is low.

transmission fluid level is low, it may result in reduced power. If the fluid level is low or a leak is found, follow the appropriate Service Information to complete the repair. Possible points of fluid leaks include the control valve body cover, transmission case, torque dampener and differential housing, and vent.

If there is a brief reduced power condition with related DIC messages displayed, inspect the transmission for fluid leaks and verify the fluid level. The 5ET50 transmission has a fluid fill cap and a fluid drain plug.

TIP: The transmission fluid level must be checked when the transmission fluid temperature is at 113–131°F (45–55°C). If the transmission fluid temperature is not in this range, operate the vehicle or allow the fluid to cool as required. Setting the transmission fluid level with fluid temperature outside this range will result in either an under- or over-filled transmission.
