Updated PAINTED ALUMINUM WHEEL Refinishing Guidelines

Updated Painted Aluminum Wheel Refinishing Guidelines 2

GM TechLink is published for all GM retail technicians and service consultants to provide timely information to help increase knowledge about GM products and improve the performance of the service department.

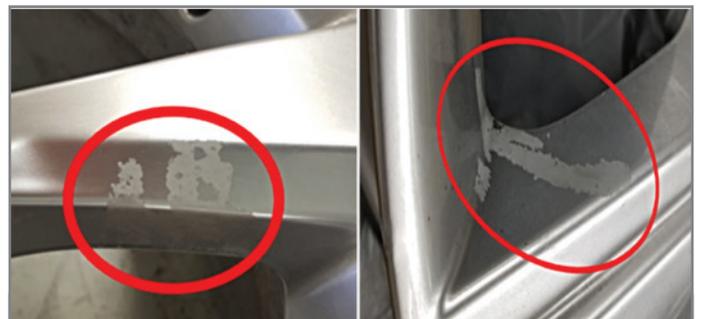
It is the dealership's responsibility to inspect the wheel for peeling paint, paint runs, debris in paint, and other conditions that warrant refinishing. The wheel condition must not be deeper than what can be sanded or buffed-off (less than 2 mm deep) or a larger area than 3 x 1 inches. In addition, if there are up to three issue areas on the wheel, and the three areas in total do not

Paint run condition warrantable by refinishing.

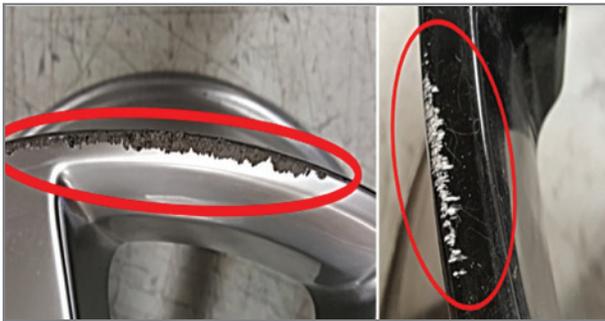
Wheels must be visually inspected for cracks. If cracks are found, the wheel cannot be refinished. Flange cracks caused by road hazard impact damage as well as bent rim flanges should not be refinished under warranty. Other road hazard damage, such as scratches or curb scrapes, also are not warrantable repairs.

Damage from curb scrapes are not warrantable repairs.

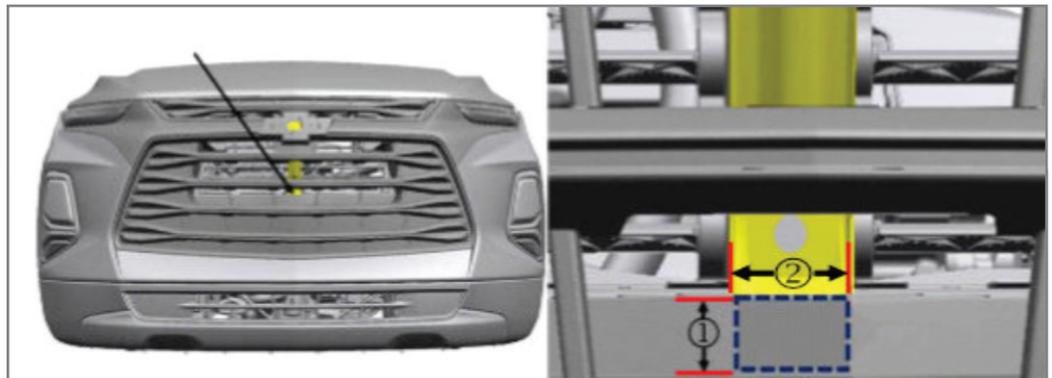
2020-2021 Blazers equipped with the 2.0L engine (RPO LSY) may have a humming or vibration sound coming from the front of the vehicle when driving at speeds over 50 mph (80 km/h). The sound may be caused by the aero shutters being closed at highway speeds.

When the airflow traveling through the front fascia grille opening hits the closed shutter panels, the air behind the grille opening becomes turbulent. The buildup of air turbulence causes the energy absorber foam to start vibrating and moving up and down, which may result in the foam making

intermittent contact with the lower grille close-out panel and causing it to flutter.

When the panel flutters, it vibrates against the fascia, creating the humming sound. The sound may be heard in the passenger compartment when driving at highway speeds and, in some cases, a vibration may be felt through the shift knob or steering wheel.

Trim the foam block and insert it between the close-out panel rear vertical wall and center fascia support bracket.

The foam block has a depth of approximately 25 mm (1 inch) and a width of approximately 35 mm (1.4 inches). It should be trimmed to a height of 25 mm (1 inch).

Insert the foam block between the close-out panel rear vertical wall and the center fascia support bracket by reaching through the grille opening on the vehicle. It is not necessary to remove the front fascia in order to install the foam block.

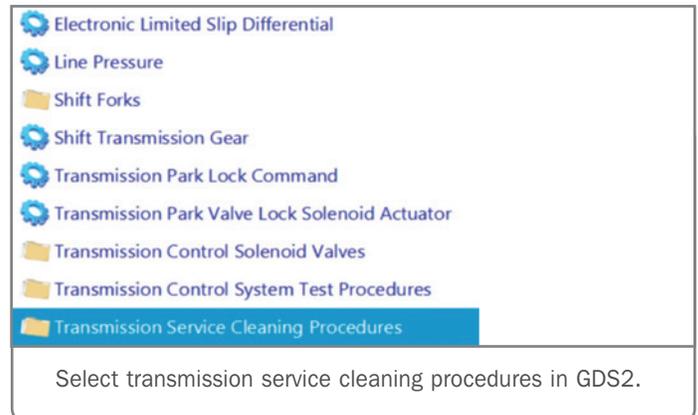
Some 2020-2021 Corvette models may have multiple DTCs set in the Transmission Control Module (TCM). The DTCs may be caused by an internal transmission solenoid or switch sticking due to debris in the DCT TR-9080 transmission (RPO M1L). Based on the DTCs that are set, GDS2 should be used to perform the appropriate solenoid cleaning procedure.

Select the transmission cleaning services that correspond with the DTCs set. Not all cleaning procedures listed need to be performed.

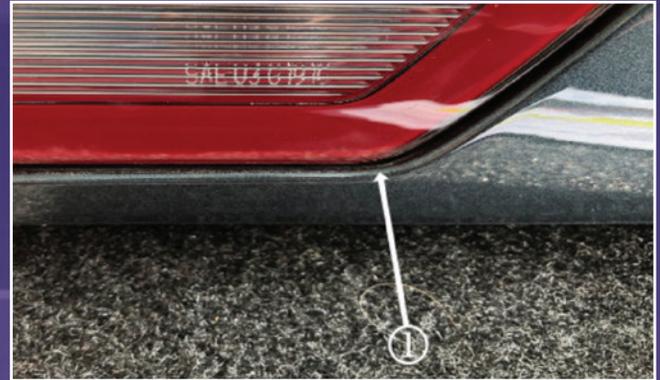
A pop sound may be heard coming from the rear roof of the cab area on some 2019-2020 Silverado 1500 and Sierra 1500 models and 2020 Silverado 2500HD/3500HD and Sierra 2500HD/3500HD models, built prior to August 3, 2020. The pop sound, which may be heard more often when the cab body is heated or cooled by changing ambient temperatures, may be caused by interference between the Center High Mounted Stop Lamp (CHMSL) and the body of the roof-mounted spoiler.

As these parts expand and contract with changes in ambient conditions, there may be a stick-slip condition that generates the sound. A slight wear mark may be seen in the spoiler paint on some examples.

Interference at the CHMSL and body of the roof-mounted spoiler.

To create more space between the CHMSL and the spoiler, foam tape should be applied between the CHMSL and the lower corners of the spoiler body following the repair procedure in Bulletin #21-NA-018.

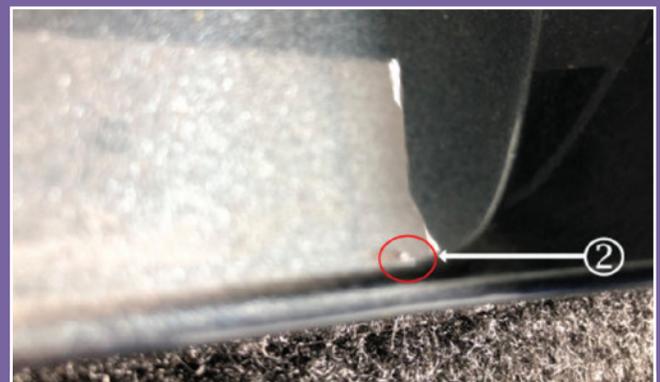
A wear mark may be seen in the spoiler paint.

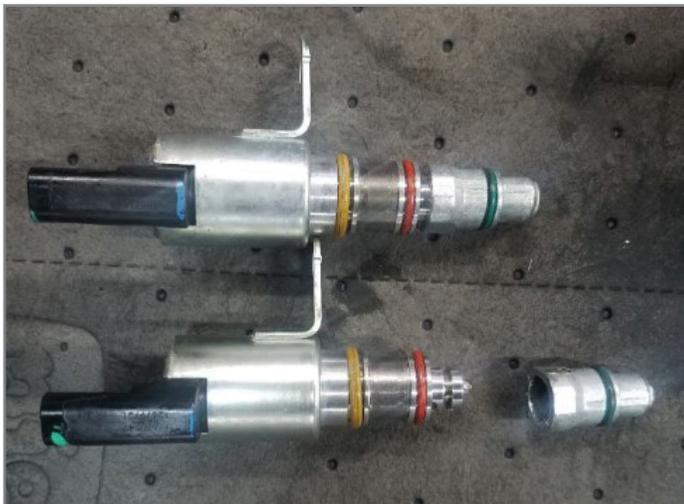
A complete solenoid, top, and a broken solenoid, bottom

During service, the AFM solenoid may come out of the cover with the end broken off, which does not allow the new solenoid to be installed completely in the camshaft cover. Compare a new solenoid with the current solenoid to ensure the solenoid is still intact. Be sure to check the cover for any broken components where the bottom may have been pulled apart.

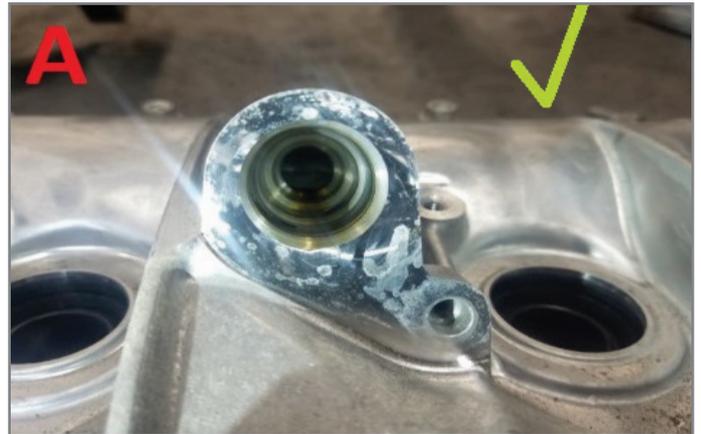
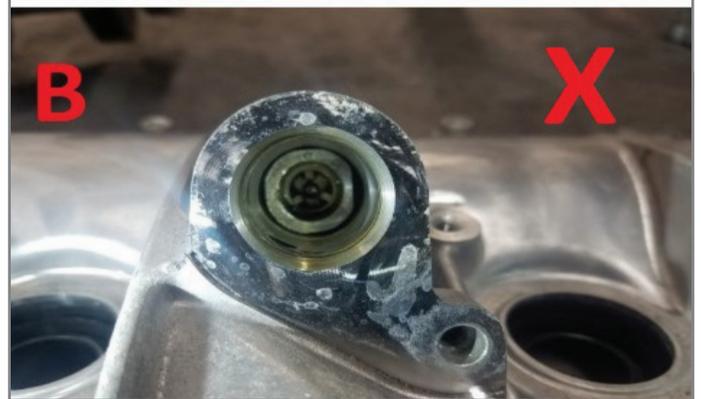
Inside the camshaft cover with the solenoid removed, look for the end of the solenoid stuck in the bore. A solenoid stuck in the bore can usually be easily removed using a pick tool or a pair of transmission snap ring pliers. The solenoid will only be held in the bore with the O-ring.

A. Clean bore
B. End of solenoid stuck in the bore

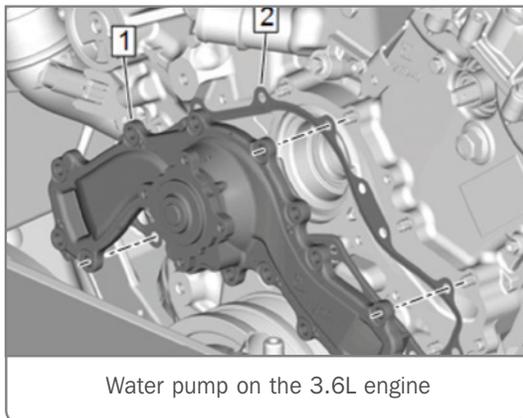
A drive belt squeak or engine noise from the front of the engine may be noticed on some 2016-2019 ATS, CTS, Camaro; 2016-2020 CT6; 2017-2019 LaCrosse, Acadia; 2017-2021 XT5, Colorado, Canyon; 2018-2020 Regal; 2019-2021 Blazer; and 2020 XT6 models equipped with the 3.6L engine (RPO LGX) or 3.0L engine (RPO LGW), built prior to October 30, 2020. DTC P0324 (Knock Sensor System Performance) also may be set in the Engine Control Module.

The drive belt squeak or engine noise, which may not be present at the time when the vehicle comes into the dealership, may be caused by the water pump. If the water pump condition is bad enough, the engine will pick up the knock noise.

If a noise is heard or there is a difference when removing the belt, replace the water pump. After installing a new water pump, check to ensure the engine noise or belt squeak has been eliminated.
