## Replace, Don't Repair, Coaxial Cables

# Replace, Don't Repair, Coaxial Cables

GM TechLink is published for all GM retail technicians and service consultants to provide timely information to help increase knowledge about GM products and improve the performance of the service department.

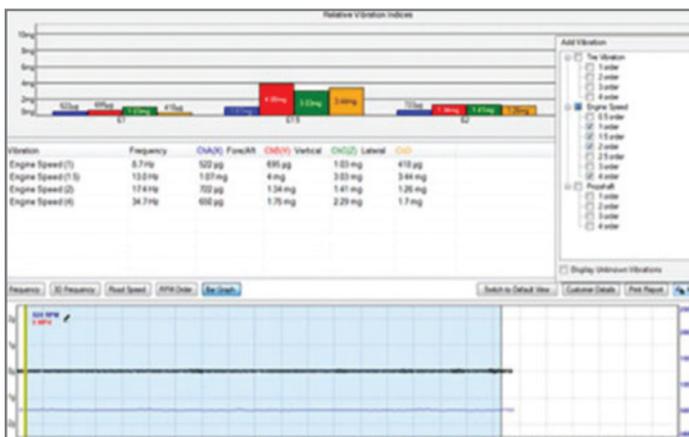
Perform an analysis using the PicoScope with a single axis sensor or a tri-axis sensor to measure the vibration disturbance frequency at the seat track. If the measurement is above the acceptable threshold, perform the Engine and Transmission Mount Settling Process covered in #PIP5798.

Measure the vibration disturbance frequency using the PicoScope.

Any engine mount-to-frame bolts removed during this process must be replaced with new bolts. Both the left-hand and right-hand engine mounts need to be seated to the vehicle frame at the same time to ensure the best alignment. Do not use an impact wrench. Torque the new bolts to specification in sequence.

If the disturbance frequency measurement does not improve after completing the settling process, replace the powertrain mounts. Before replacing engine mounts, check that the exhaust system is not bound up and that the rear transmission mount is clear of any debris and not damaged. Either of these can result in a higher than normal PicoScope measurement.

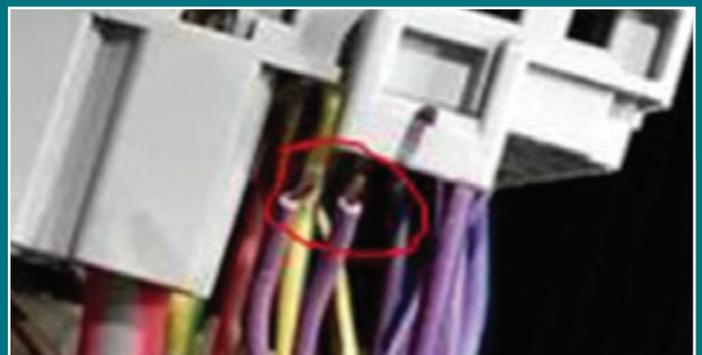
Some 2019-2021 Silverado and Sierra models equipped with the 5.3L V8 engine (RPOs L82, L84) or 6.2L V8 engine (RPO L87) may have an illuminated Check Engine MIL and DTC P1682 (Ignition 1 Switch Circuit 2) set in the Engine Control Module (ECM) as an active or history code. DTCs P0101 (MAF Sensor Performance), P0689 (Engine Controls Ignition Relay Feedback Circuit Low Voltage), P16A7 (Engine Controls Ignition Relay Feedback Circuit 2) or P16BC (Engine Controls Ignition Relay Feedback Circuit 3) also may be set. In addition, the vehicle may have previously had the Mass Air Flow (MAF) sensor replaced due to DTC P0101. These conditions may be caused by a compromised connection within the Underhood Bussed Electrical Center (UBEC) connector X3 at position H6, which can result in DTCs P1682 and P0101 setting together.

Poor connection of the dual crimp wire.

If the dual crimp wire has a poor connection, repair the wire. Refer to Repairing Connector Terminals in the appropriate Service Information.

If the dual crimp wire does not show any signs of a poor connection or if there is no trouble found with any wire-to-terminal connections, continue diagnosing the DTCs before replacing the MAF sensor.

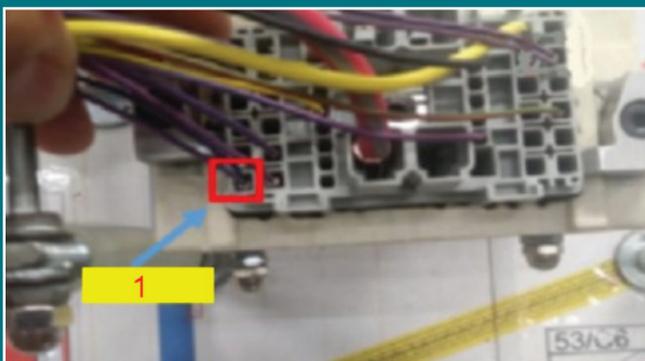
Dual crimp wire in the H6 pin (#1) in the X3 connector.

Do not replace the MAF sensor if these DTCs are set. Inspect the wire-to-terminal connections inside the X3 connector at the UBEC assembly for signs of a marginal connection or loose wires, especially the dual crimp at location X3-H6.

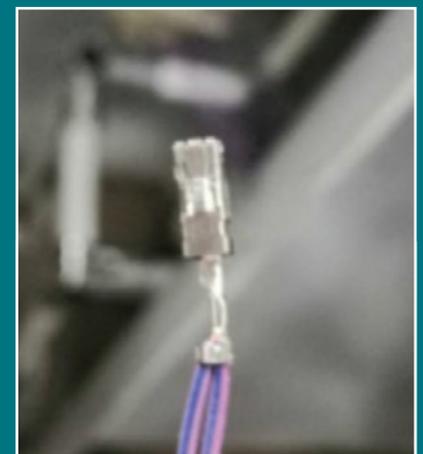
Dual crimp wire without any signs of a poor connection.

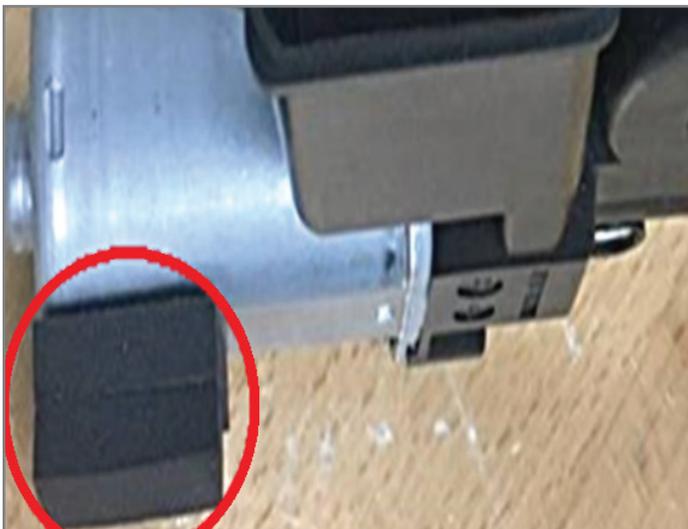
The front windows may drop enough to cause wind noise on some 2018-2021 Equinox and Terrain models. After driving the vehicle while the infotainment system is at a high volume or music with high bass has been played, the windows may lower by approximately 1/4 inch (6 mm) or more. There also may be an Open Then Close Driver Window message displayed on the Driver Information Center.

The window may be lowering as a result of the window motor losing memory due to speaker vibration. It can occur with high volume or high bass use. If this condition is present, install foam between the window motor and the inner door panel to dampen any motor vibration/resonance. As shown, the foam is in the correct location in relation to the motor housing; however, the repair will have the foam applied to the inner door panel, not the motor housing.

Install foam to dampen any motor vibration/resonance.

To make the repair, remove the front door trim panel and move the water deflector in order to access the window motor casing. Use a dense, adhesive-backed, foam block that has a depth of 1/2 inch (12 mm) and is 1 inch square (25 mm).

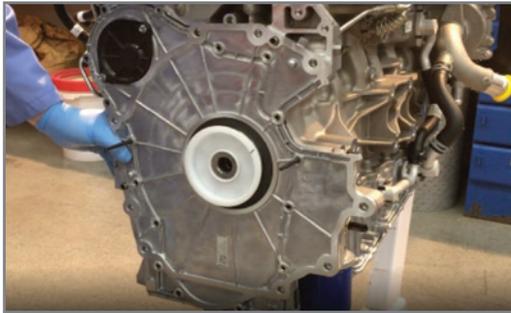
Timing chain lower cover

Some 2020-2021 Silverado, Sierra; 2021 Tahoe, Suburban, Yukon and Escalade models equipped with the 3.0L diesel engine (RPO LM2) may have an oil leak concern and DTC P06DD (Engine Oil Pressure Control Valve Performance) may be set. These conditions may occur if the rear main oil seal has moved or is severely shifted out of position in the timing chain lower cover.

If these conditions are found, replace the timing chain lower cover, which comes with a seal already installed.

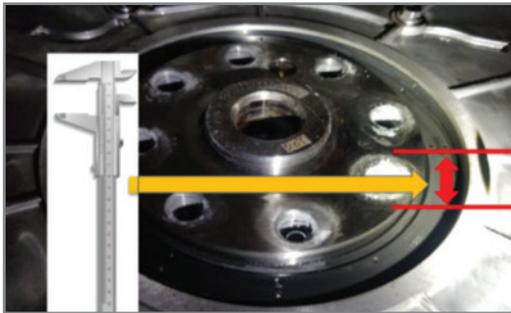
If the seal is tilted out of position, use a caliper and record the depth where the seal is pushed in prior to removing the rear cover. Also place an indexing mark on the seal and

Use a caliper and record the depth where the seal is pushed in prior to removing the rear cover.
