Bolt EV

Battery Cell Inspection

GM TechLink is published for all GM retail technicians and service consultants to provide timely information to help increase knowledge about GM products and improve the performance of the service department.

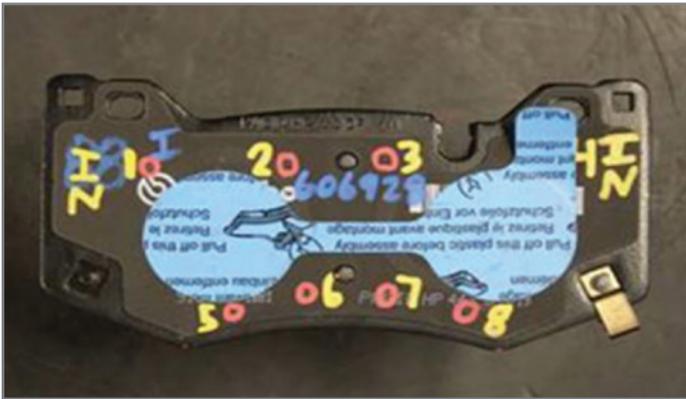
When removing the front brake pads on some Z51-equipped vehicles, a piece of double-sided tape that secures the front brake pads firmly to the caliper pistons may be noticed. As shown, the blue area is the peel-and-stick double-sided tape.

The blue area is the peel-and-stick double-sided tape.

To apply the copper paste correctly, the pads must be removed from the calipers. Note that for the pads to be removed from the front calipers, the calipers must be removed from the front knuckles. Remove as much of the remaining tape residue as possible before applying the paste as directed in the bulletin.

Once the copper paste has been applied to the front brake pads, reinstall them into the calipers. It's not necessary to replace the front brake pads during this service because of the double-sided tape.

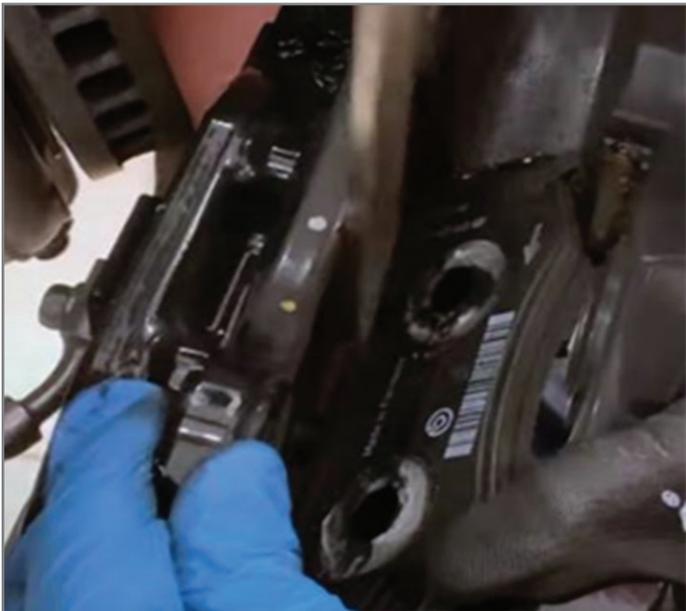
An example of the front brake pads once they are separated from the caliper pistons.

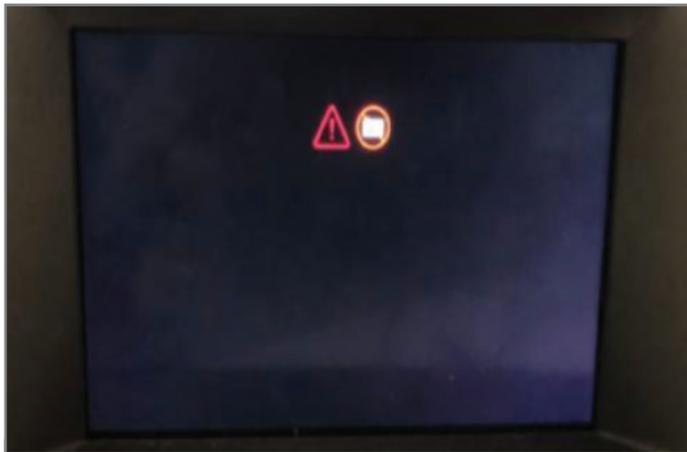
The infotainment screen on some 2020-2021 XT5, XT6 and Acadia models may intermittently show a black screen with red triangle and red camera icons when the vehicle is in Reverse. The black screen may be the result of the crimping of the coaxial cable connectors to the cable, which causes an excessive resistance that interrupts the video signal.

Black screen with red triangle and red camera icons

Once the condition is verified, there are several different repair procedures depending on the vehicle and model year. For complete repair information, refer to Bulletin #21-NA-048.

For vehicles that show there is excessive resistance in the coaxial cable, the coaxial cable must be replaced.

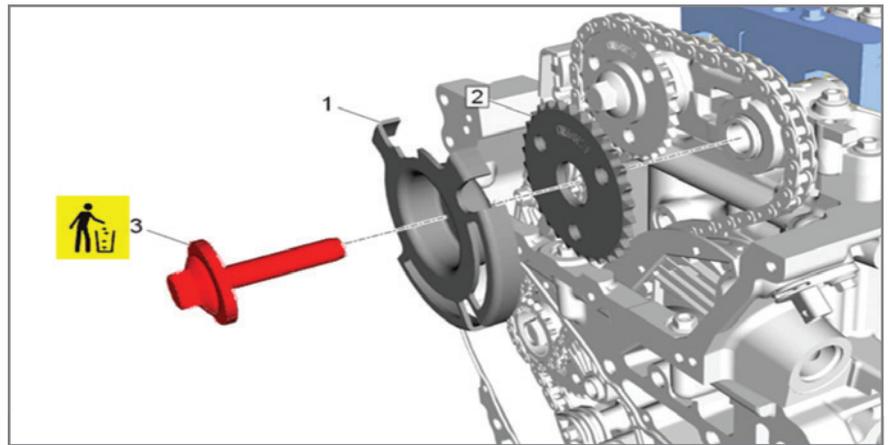
Camshaft position sensor exciter wheel (#1)

If these conditions are present, the camshaft position sensor exciter wheel, or trigger wheel, may be damaged. Remove the camshaft position sensor and use a bore scope to inspect for a bent exciter wheel on the camshaft. It will be necessary to roll the engine by hand, up to two revolutions, to inspect each wheel segment.

If the camshaft position sensor exciter wheel is bent, it should be replaced. If the wheel is not damaged, follow the appropriate Service Information diagnostics for an intermittent crank/no start condition.

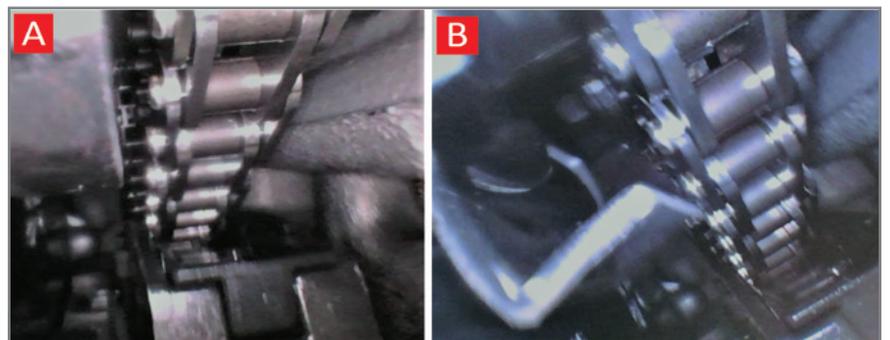
Shown is a normal exciter wheel (A) and a bent exciter wheel (B). The damaged wheel may or may not make contact with the timing chain.

Normal exciter wheel (A) and a bent exciter wheel (B)

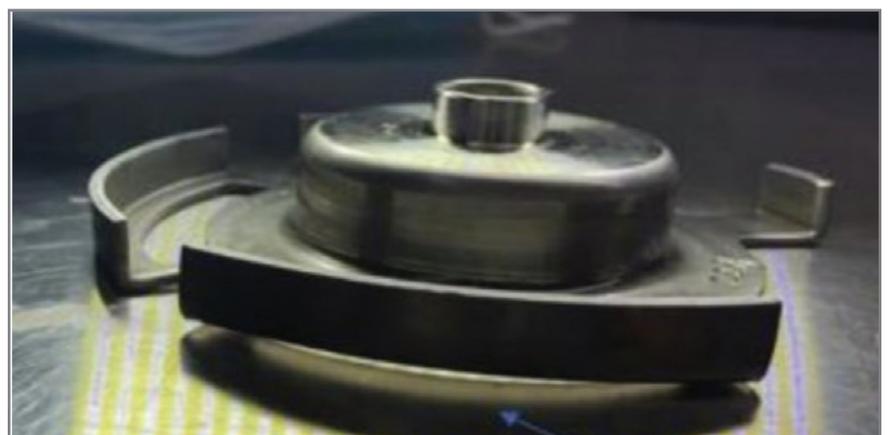
There may be an intermittent extended crank or intermittent crank/no start condition on some 2020-2021 Silverado, Sierra; and 2021 Tahoe, Suburban, Yukon, and Escalade models equipped with the 3.0L diesel engine (RPO LM2). DTC P0341 (Camshaft Position Sensor Performance) may be set in the Engine Control Module.

Bent camshaft position sensor exciter wheel.
