## New 9T65 Transmission

### Replacement Pilot Program Bulletin Information

## TECH LINK

GM TechLink is published for all GM retail technicians and service consultants to provide timely information to help increase knowledge about GM products and improve the performance of the service department.

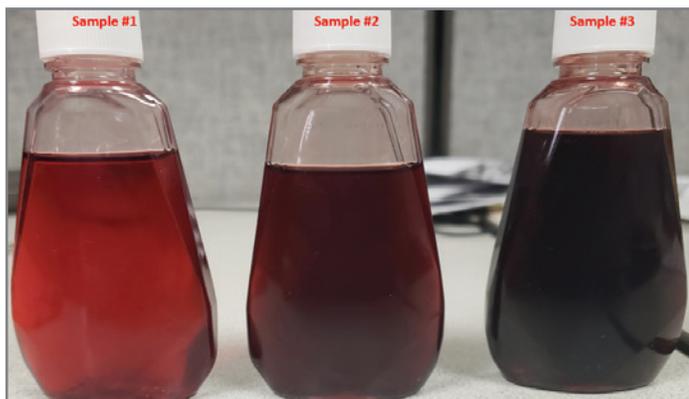
The color of the transmission fluid should be red or brown.

When inspecting the fluid, it's also normal to see a small amount of friction material or metal from the manufacturing process (observed as fine silver streaks) in the fluid. Excessive amounts of particles should be noted on the repair order and may require transmission replacement.

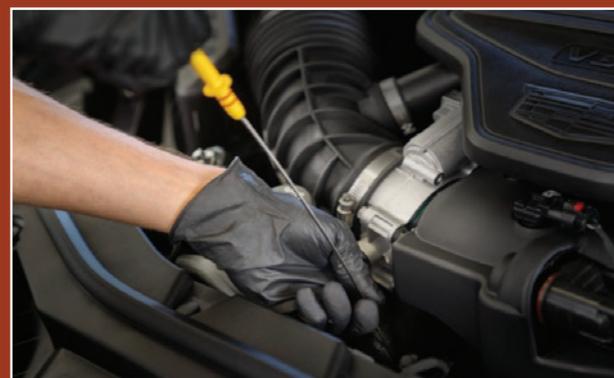
In some cases, the vibration may be caused by the engine being overfilled with oil. Inspect the engine oil level and check to determine if the oil was recently changed.

Check the engine oil level.

Using the PicoScope, a vibration caused by a crankcase overfilled with engine oil will typically display Engine 1 (E1) as the dominant vibration.

If the engine oil level is confirmed to be overfull, verify if the crankcase was overfilled with engine oil or if it is contaminated by an outside substance, such as fuel or coolant. If the oil level is overfull as a result of contamination, determine the source of the contamination and repair as needed.

If the engine was overfilled with only engine oil, adjust the oil level and re-evaluate the concern. The engine may have been overfilled during a recent oil change or other maintenance service.

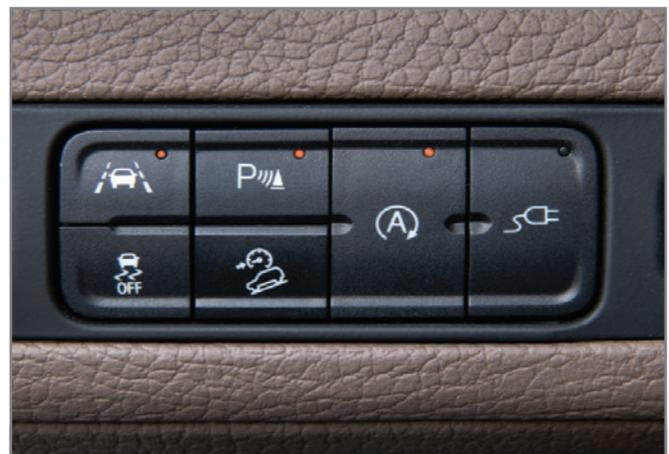
Vehicles with RPO NSS will not have the Auto Stop button

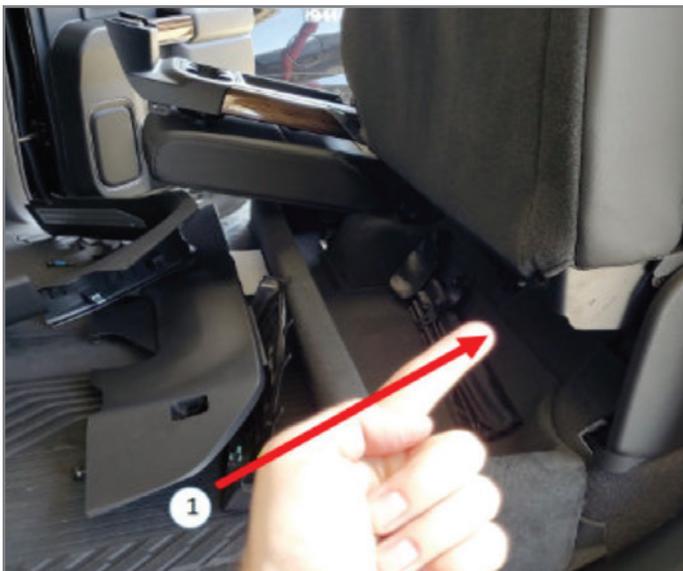
Check for a pinched body harness under the left rear seat.

There are two known areas that can short out LIN Bus circuits 6133 and/or 4115 for the front/rear heated seats. If this occurs, the BCM may stay awake and draw down the battery. Keep in mind that even if a truck is not equipped with rear heated seats, these circuits are still in the harness.

Inspect for a pinched body harness under the left rear seat where the seatback is attached to the back of cab.

If any issues are found, follow the Wiring and Connector Repair instructions in the appropriate Service Information to correct the condition.

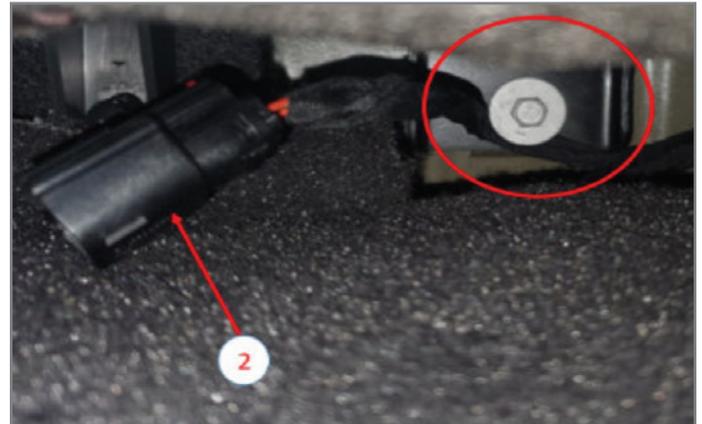
Connector X370 is shown on a truck that was not equipped with rear heated seats. In this example, LIN Bus circuit 6133 was shorted to the B+ circuit in the harness.

Connector X370 on a truck not equipped with rear heated seats.

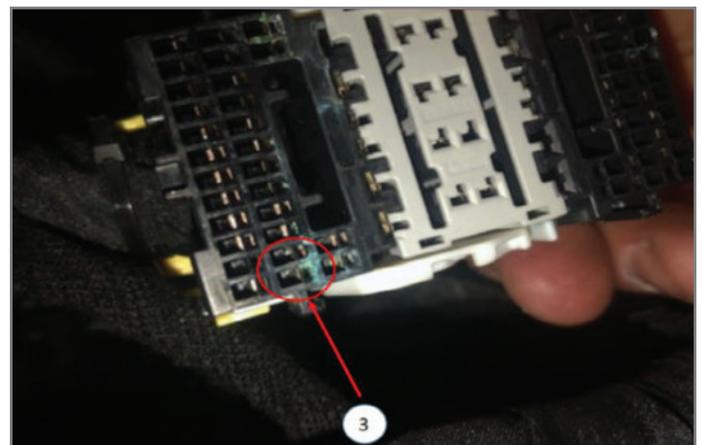
In addition, inspect connector X225 for terminal issues/corrosion. As shown, the LIN Bus circuit 4115 was corroded and shorting to other terminals in the connector.

Corroded LIN Bus circuit 4115

If corrosion is found at connector X225, inspect for a water leak. Water may be entering at the A-pillar grommet for the door pass-through connector if the grommet is not fully seated.

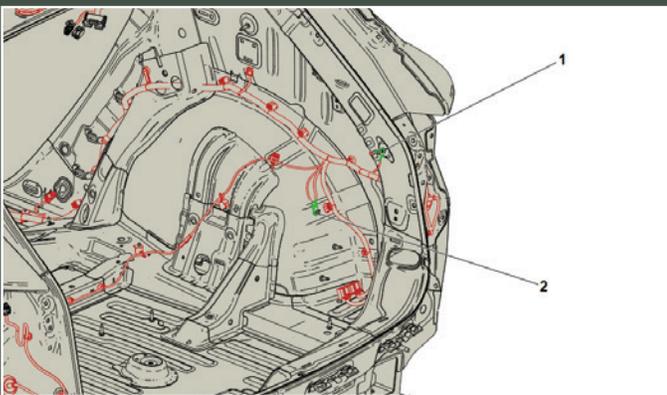
If these conditions are present, they may be the result of terminals that are loose or not attached at G401.

Inspect G401, which is located under the trim panel on the right side of the rear compartment, to the rear of the right wheel well. G401 is located slightly below and forward of G405.

G401 (#2) is located on the right side of the rear compartment, slightly below and forward of G405 (#1).

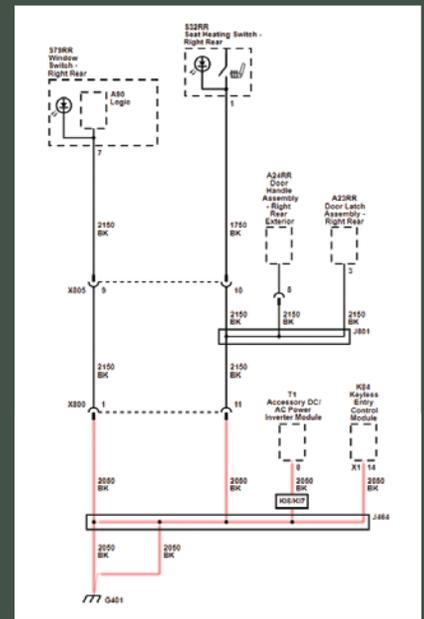
Ensure that there are two wires attached to G401.

Ensure that there are two wires attached to G401 and that the nut is properly installed.

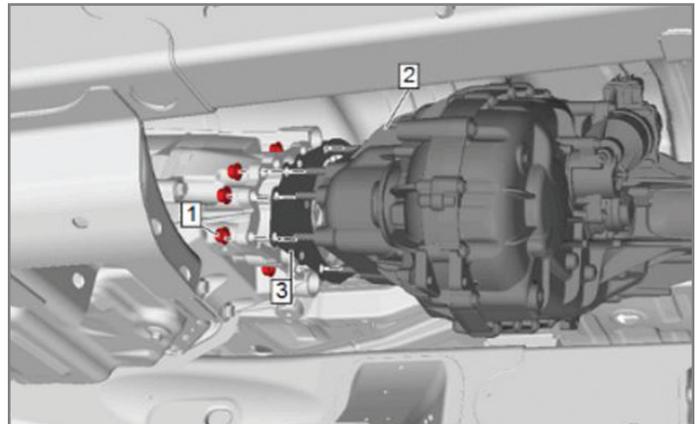
The NVH condition may be the result of a misalignment between the transmission output shaft and the transfer case input. The misalignment could cause the transfer case shift collar to slip out of engagement.

Check for a misalignment of the transmission and transfer case.

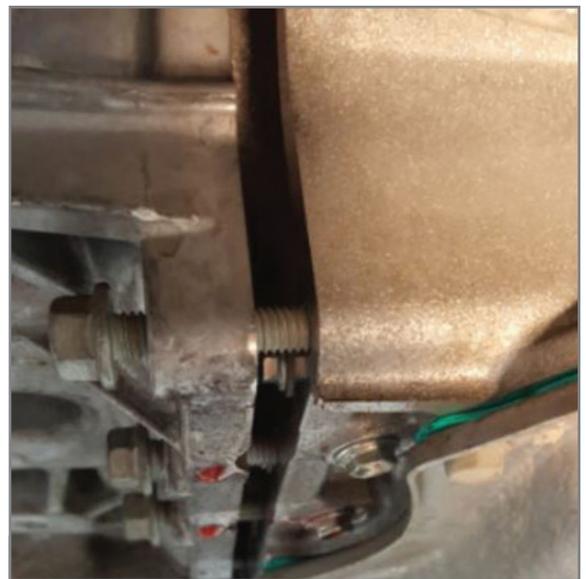
Slide the transfer case rearward so there is a minimum gap and then forward.

With the bolts loosened, slide the transfer case rearward so there is a minimum gap of 1/2 inch (13 mm), but not more than 1 inch (25 mm). Next, slide the transfer case forward until it is contacting the transmission again.

Tighten the transfer case bolts in sequence following the appropriate Service Information.

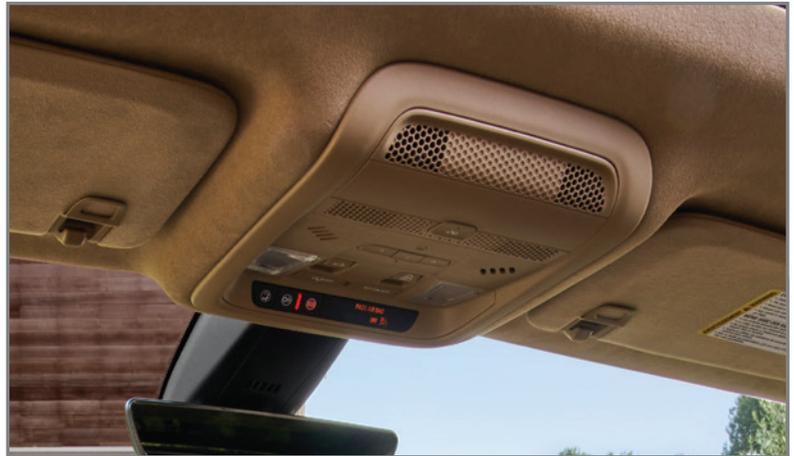
A Service Theft Deterrent message may be displayed on the Driver Information Center (DIC) on some 2018-2021 XT5 and 2020-2021 XT6 models equipped with RPO UTU (Vehicle Inclination Sensor) and RPO UTV (Vehicle Interior Movement Sensor). The DIC message may be the result of a poor connection of the Theft Deterrent Sensor in the overhead console or a self-test in the inclination sensor that may fail due to a mismatch of data.

The Theft Deterrent Sensor is located in the overhead console.

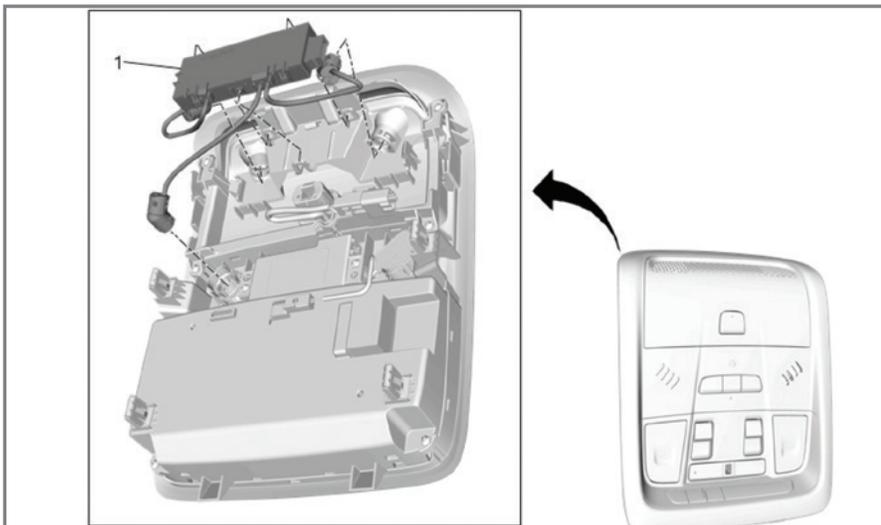
Check the connection of the three Theft Deterrent Sensor leads.

Lower the overhead console and verify the proper connection of the three Theft Deterrent Sensor leads.

After checking the connections, reprogram the Body Control Module with the latest available calibrations. Be sure the VIN selected in the drop-down menu is the same as the vehicle connected before beginning programming.

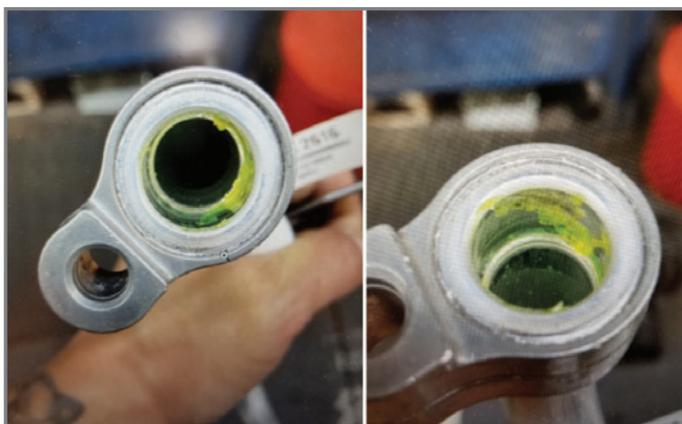
Possible A/C refrigerant contamination may be causing the air conditioning to take longer than usual to cool the vehicle on some 2020-2021 Equinox and 2021 Blazer models. Check the latest version of #PIT5834 for the VIN breakpoints of the affected models.

Look for contamination of the compressor solenoid, inlet and outlet lines from the condenser and at the TXV.

If contamination is found, take pictures of the solenoid, TXV and each of the fittings, open a Technical Assistance Center (TAC) case and attach them to the case. Pictures at all these points are required for review.

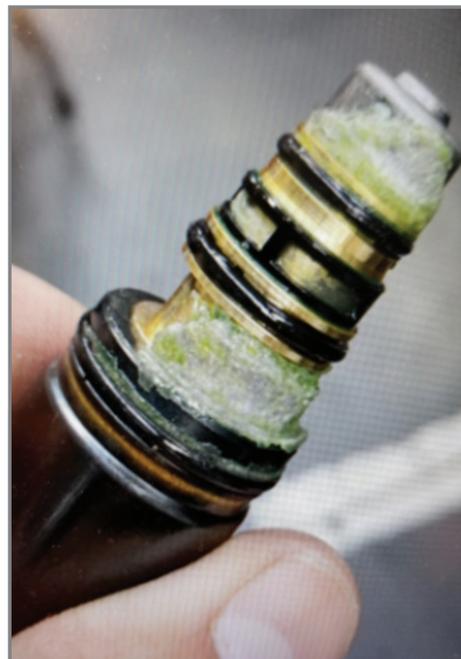
Attach pictures of the contamination to the TAC case.
