TECH LINK

# Exhaust Control Valve Actuator Replacement

Several exhaust-related DTCs may be set in the Engine Control Module on some 2020-2021 CT4 and CT5 models equipped with the 2.7L engine (RPO L3B) or 3.0L engine (RPO LGY). These DTCs may include P31D4 (Exhaust Flow Control Valve - Position Signal Exceeds Upper Limit — Bank 1), P31DB (Exhaust Flow Control Valve Stuck Open — Bank 1), P31E2 (Exhaust Flow Control Valve - Position Signal Exceeds Upper Limit Bank 2), and/or P31E8 (Exhaust Flow Control Valve Stuck Open Bank 2).

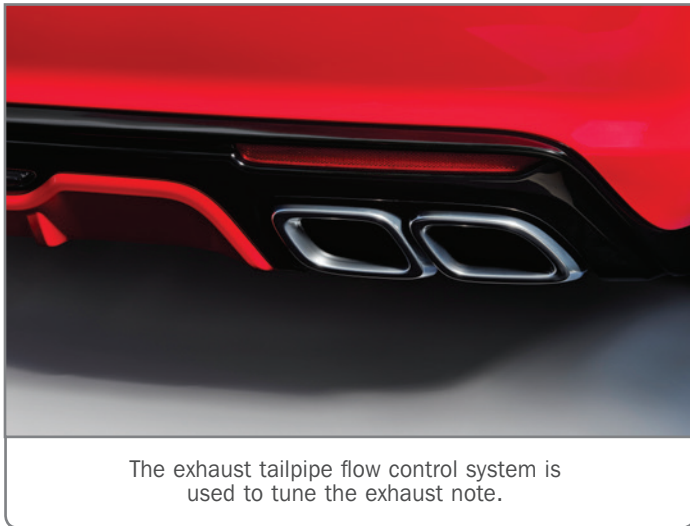
The exhaust tailpipe flow control system is used to tune the exhaust note.

If these DTCs are set, it may be due to older firmware or failure of the fail-safe spring within the exhaust control valve actuator. It will be necessary to replace both exhaust control valve actuators.

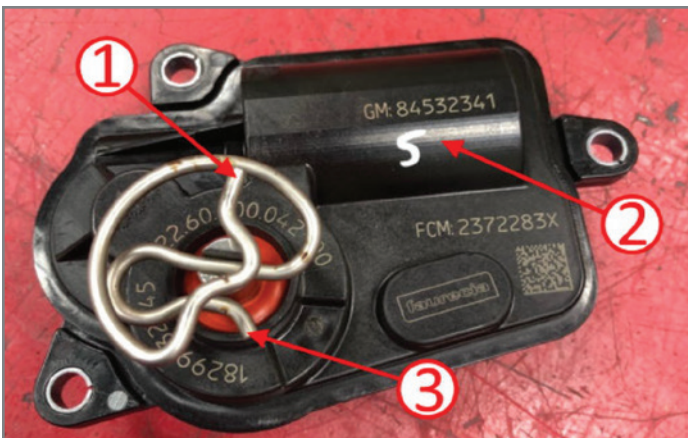
The linkage, or spring, (#1) must be fully seated. The short tab (#3) should point away from the actuator motor (#2).

Prior to installing the exhaust control valve actuators, make sure the exhaust control valve actuator linkage is correctly installed on the actuator. Verify that the actuator is not connected or powered. Next, attach the linkage (or spring). It should be centered and fully seated. The short tab should be pointed away from the actuator motor.

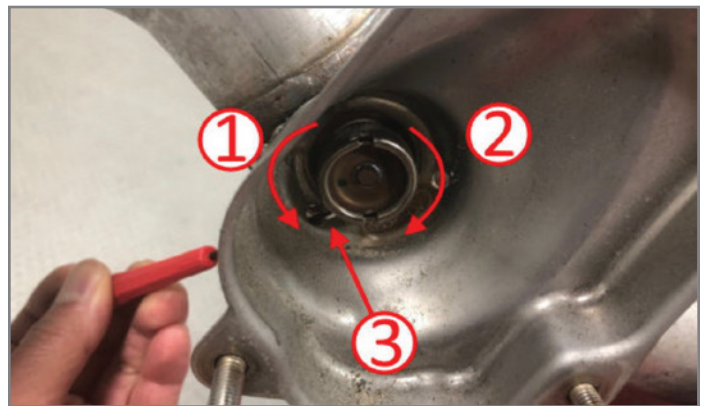
Turn the valve bearing on the exhaust side to its closed position (#1 or #2). Use a flat-head screwdriver or pick tool to hold the valve closed (#3).

To install the exhaust control valve actuator, first manually turn the valve bearing on the exhaust side to its closed position. Note the turning direction – turn the right-side valve bearing clockwise and turn the left-side valve bearing counterclockwise. With the valve bearing in its closed position, place a small flat-head screwdriver or pick tool through the access hole to hold the valve fully closed.

Next, install the unpowered actuator as square as possible to the installation bolts. Once the actuator is installed and held in place, remove the screwdriver or pick.

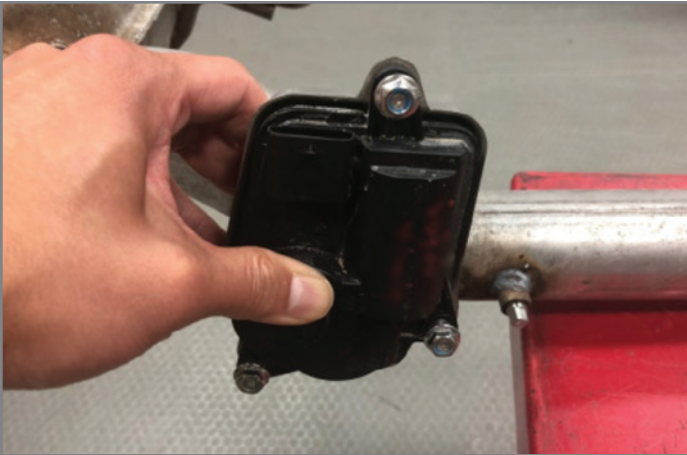
Compress the actuator against the valve body while installing the three nuts.

Compress the actuator against the valve body while installing the three nuts. Tighten the fasteners to specification. The electrical connector can now be connected to the exhaust control valve actuator.

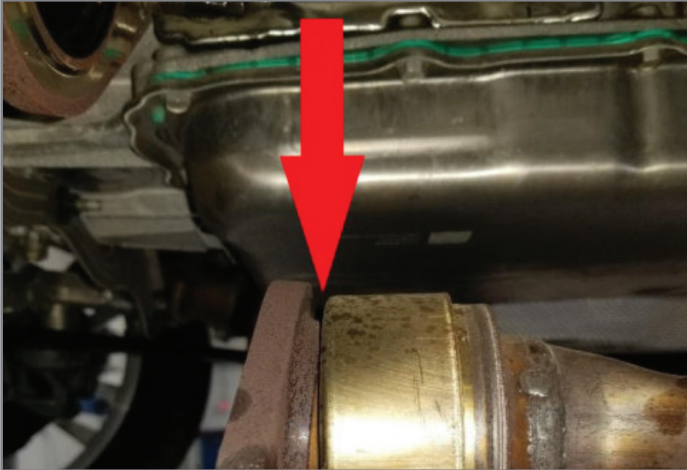
Intermediate exhaust pipe

Some 2016-2021 Camaro models equipped with the 3.6L V6 engine (RPO LGX) may have a squeak sound coming from the exhaust system while driving over bumps. The sound may be generated by a misaligned intermediate exhaust pipe flange rubbing the cup on the flex joint. If this sound is heard, inspect the exhaust system and realign the flange.

To align the flange, first remove the intermediate exhaust pipe of the side where the sound is heard.

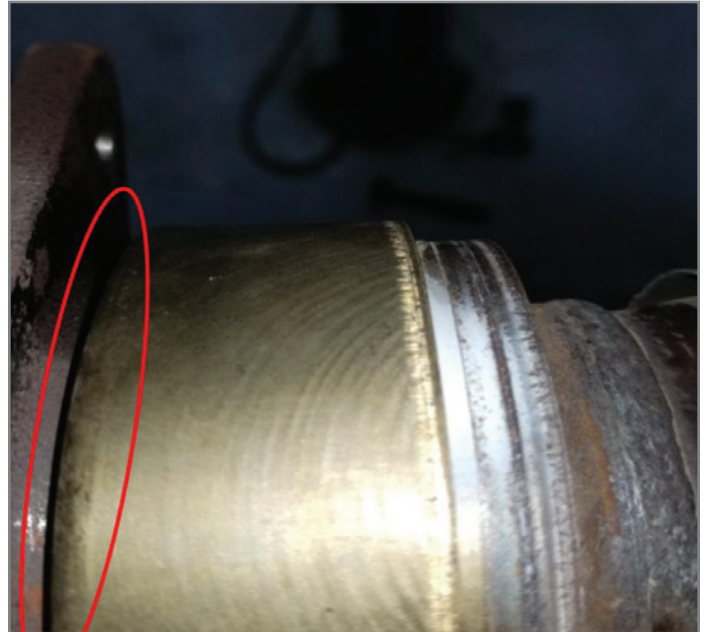
Reposition the flange to attain the proper clearance.

Wedge a suitable tool between the flex coupling cup and the flange to gain clearance between the flange and the flex coupler cup of approximately 1/8 inch (0.5 cm). Reposition the flange to attain the proper clearance.

Reassemble the intermediate pipe to the exhaust system and verify the sound is no longer present.

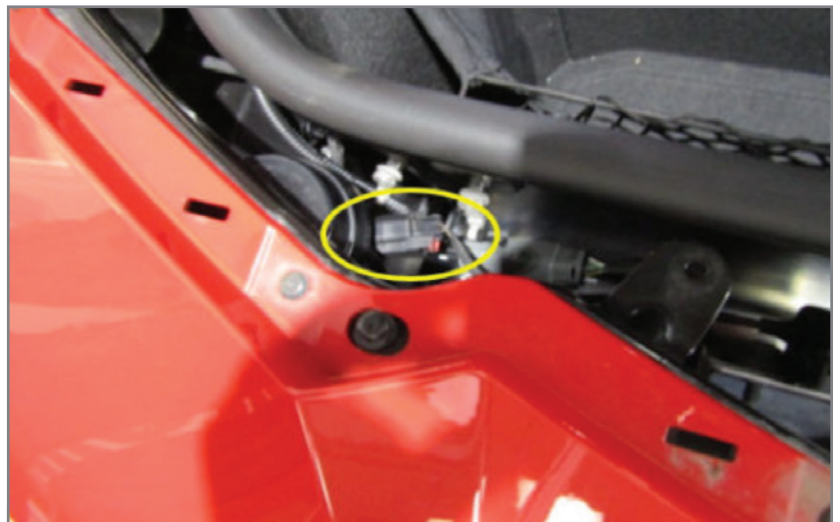
Connector X103

These conditions may be caused by possible water intrusion and terminal corrosion in connector X103, water intrusion in the hood latch actuator or failure of the auxiliary hood latch release switch. Check each of these components to determine the repair needed.

Remove the front compartment front panel to inspect connector X103. If corrosion is found in the connector, replace the connector as necessary.

When reinstalling the front compartment front panel, be sure that the X103 connector is positioned below the right horn connector.

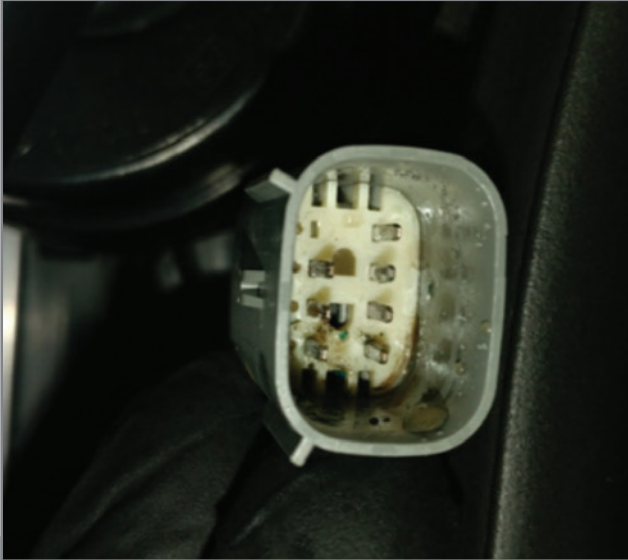
Corrosion in X103

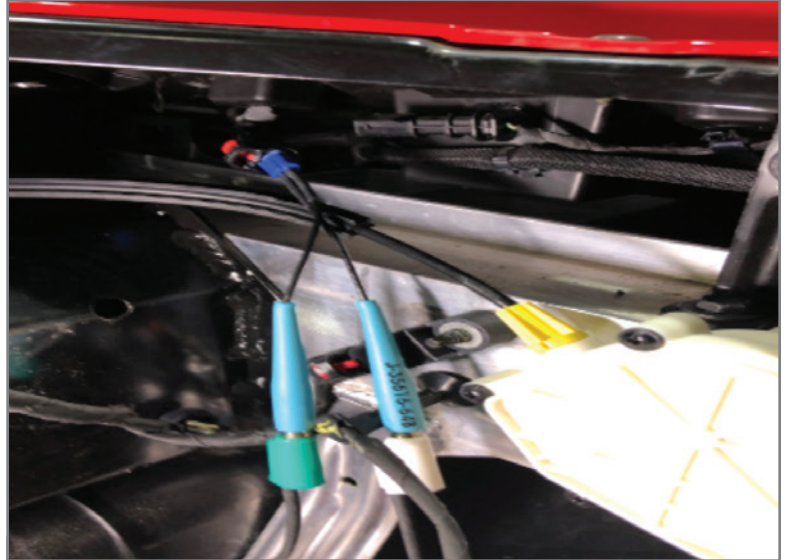
If there is not any corrosion in connector X103, access the hood switch connector X102, remove the left horn and test the auxiliary hood latch release switch with an ohmmeter. The switch should be open when it's not pressed, and resistance should be no more than 0.2 ohm when the switch is pressed. If the switch is not operating correct, replace the switch.

Test the resistance at the auxiliary hood latch release switch.

If the auxiliary hood latch release switch is not faulty, reinstall the left horn and then replace the hood latch actuator.

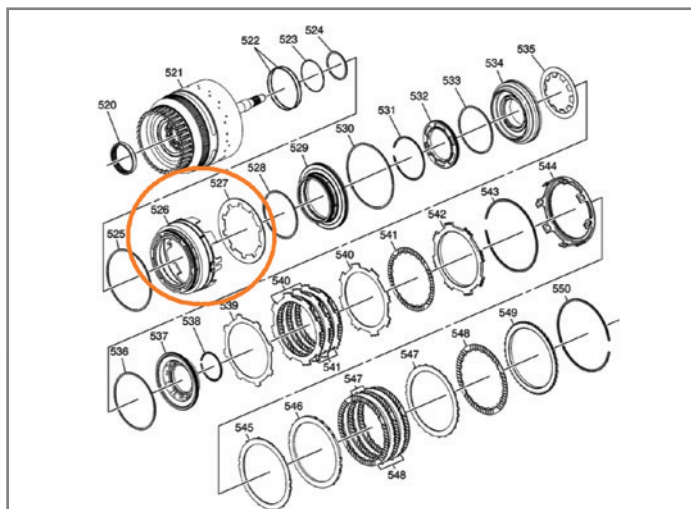
The harsh downshift and upshift conditions may be caused by the 2-3-4-6-8 return spring, which may have degraded over time. If these conditions are found, replace the 2-3-4-6-8 piston and the 2-3-4-6-8 return spring.

2-3-4-6-8 piston (526) and 2-3-4-6-8 return spring (527)

In addition to replacing the return spring and piston, reseal the 2-3-4-6-8 and 4-5-6-7-8 reverse clutch assembly.

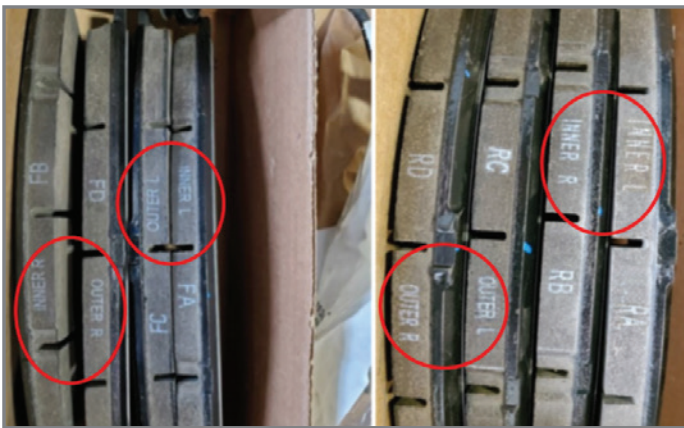
Some 2020-2021 Silverado 2500HD/3500HD and Sierra 2500HD/3500HD models may have a brake squeal condition caused by the low scorch friction material used on the original brake pads.

Each brake pad has an Inner or Outer label.

Replace the front and rear brake pads with the new pads if brake noise occurs. Current parts in inventory are the updated design.

**TIP:** If the pads are replaced and the squeal sound continues, check the orientation of the pads. Each brake pad has an Inner or Outer label to indicate where it should be installed. If the inboard and outboard designation on the pads indicate the pads are installed in the wrong location, the squeal sound may persist.

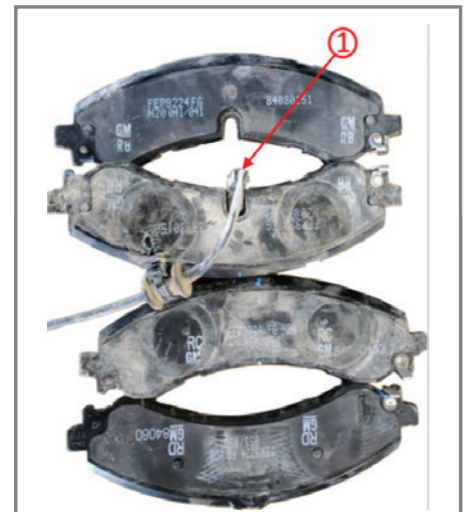
Only the left side of the truck has the wear sensors

During installation, keep in mind that only the left side of the truck has the wear sensors, which are mounted on the inner pad.
