Know Your Shipping Guidelines

When Returning Parts to the Warranty Parts Center

*Engine Misfire Detected without
Drivability Concerns 7*

Wiring Harness Damage 9

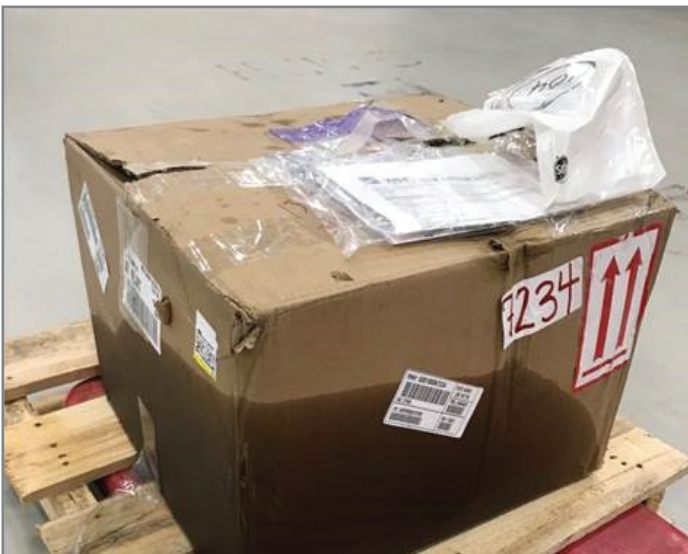
A soaked box shows that the parts were not thoroughly drained and placed in an appropriate packing container.

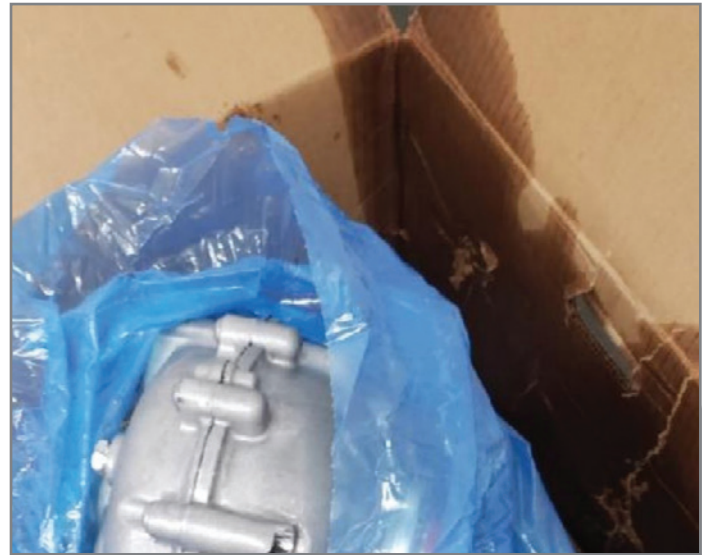
Part was not securely packaged to prevent leakage or contamination.

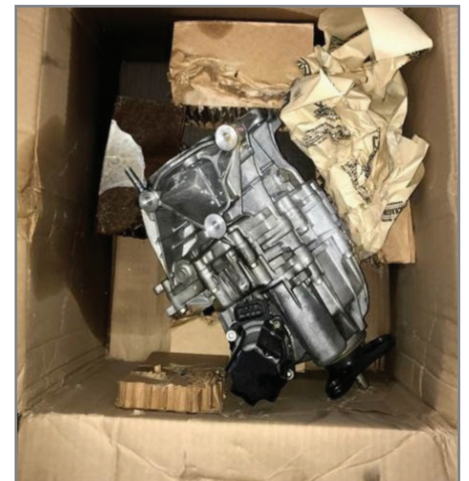
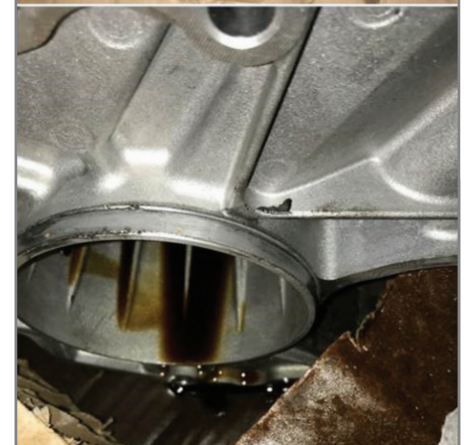
Parts received at the WPC with fluids are not accepted as "Received" and the transaction will be debited.

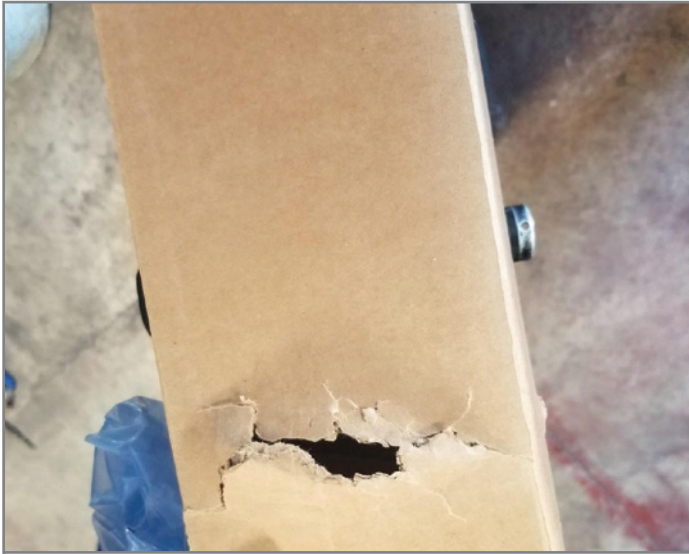
Part was missing when the package arrived at the WPC

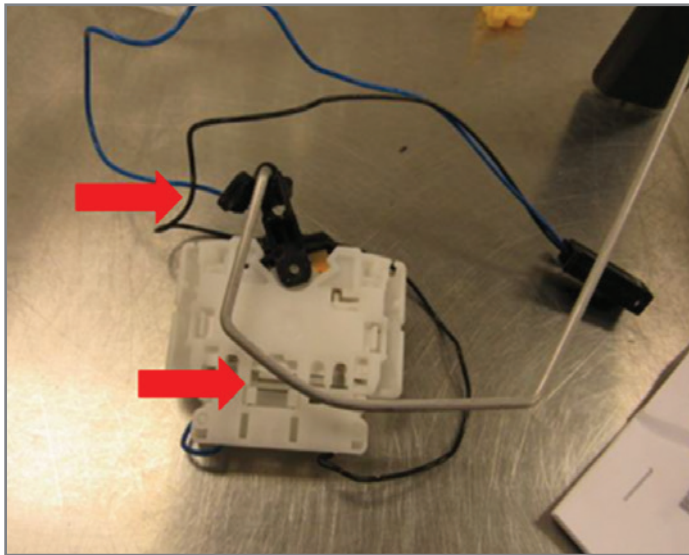
Sensor damaged during shipping.

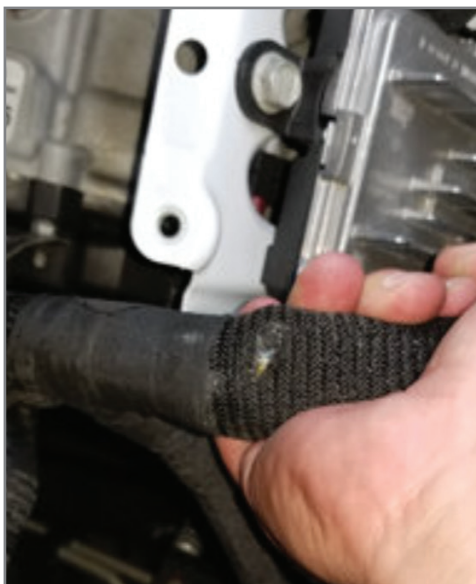
Several Driver Information Center warning messages may display on some 2019-2021 Blazers, including service brake, service steering, reduced power and other messages. The Check Engine MIL also may be illuminated along with any of the following DTCs: P0232, P023F, P0641, P0697, P2535, P129D, P12A6, P12A8, P2635, P3051, P3052, P3055, P3056, P305B, P035C, P035E, U0074, U0077, U0121, U0131, U0151, U0415, U0420, U18A2, U2502, and/or U2616.

These conditions may be caused by the wiring harness rubbing on the battery tray support bracket that secures the Transmission Control

Wiring harness damage from rubbing on the battery tray support bracket for the TCM.

Module (TCM). Several circuits may be damaged in the harness, leading to codes and symptoms that will vary and may be intermittent, depending on the affected circuits.

If these conditions are found, inspect the wiring harness below the battery tray to determine if the routing of the harness is causing it to rub on the bracket for the TCM. Repair any damaged circuits and tape the harness.

Once repairs are completed, reroute or secure the harness to prevent further damage. It may be necessary to install a piece of heater hose or other conduit over the harness to prevent any chafing in the future.

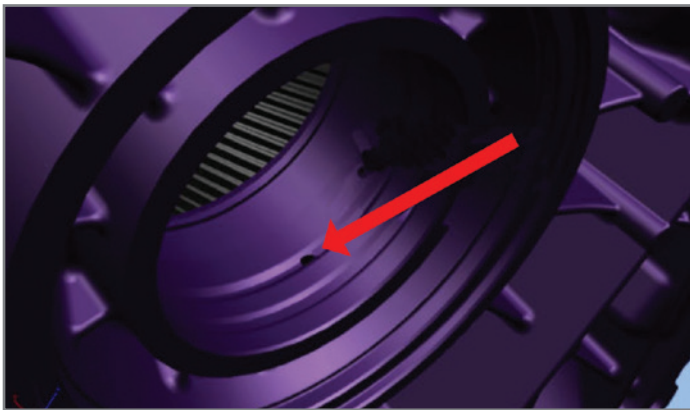
There is a gap around the outer portion of the seal that needs to be centered over a weep hole in the transfer case. The weep hole is drilled in the center of a groove machined into the case. The DT-50648-A Seal Installer will not work for these applications.

The weep hole is drilled in the center of a groove machined into the case.

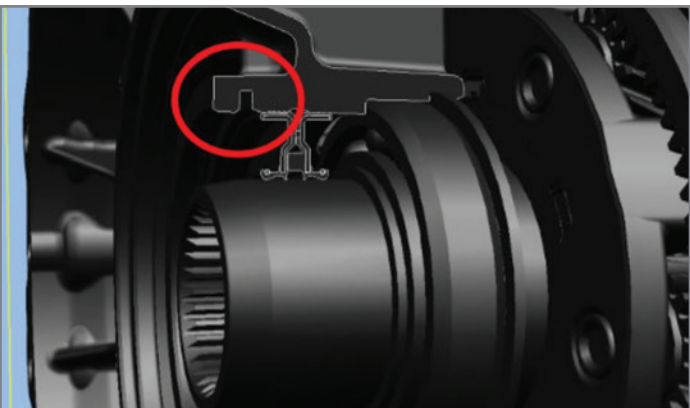
A defined machined groove in the case indicates it is a first design case.

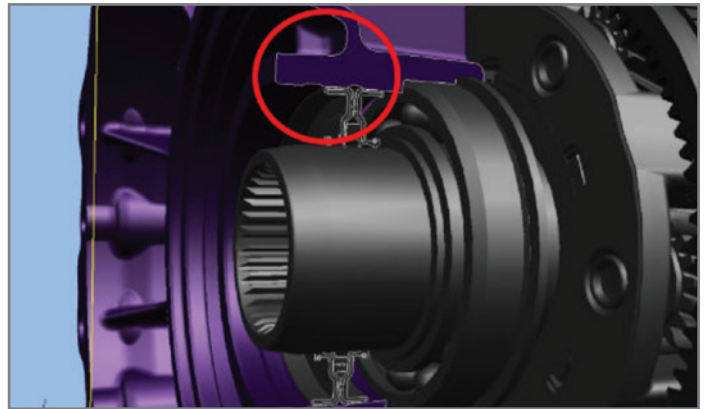
A case without a defined machined groove is a second design case.

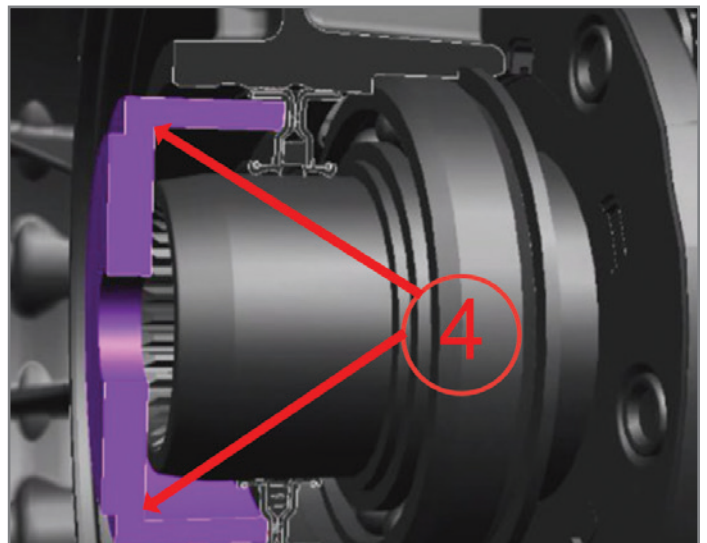
Use the J-45228 tool to drive the seal to the correct depth.

While a service tool strategy is being developed, use the J-45228 Pinion Bearing Cup Replacer to drive the seal in the case. However, there is no stop at the correct depth when using the J-45228 tool. The seal must be driven in slowly during installation and checked for the correct depth. Be careful not to drive the seal in too deep or it will be necessary to replace the seal again.

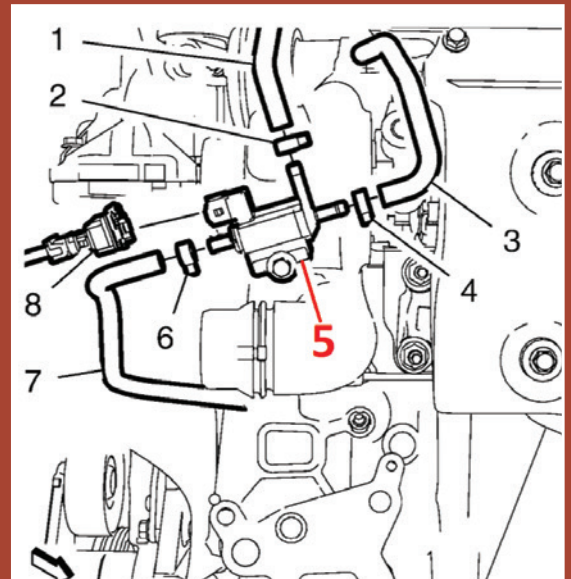
Turbocharger wastegate regulator solenoid valve (#5)

Some 2016-2019 Cruze models equipped with the 1.4L engine (RPO LE2) may have DTC P0234 (Engine Overboost) and P0299 (Engine Underboost) set while driving in colder weather. Due to low ambient temperatures, oil/moisture condensation may freeze in the turbocharger wastegate regulator solenoid valve (TCV).

If these DTCs are set, remove the turbocharger wastegate regulator solenoid valve and drain any condensation by turning the valve upside down. Blow clean shop air, regulated to 15-20 psi, through all three ports (1, 2 and 3) for five seconds each. Repeat this procedure twice.
