## Trailer App

## Functionality and Diagnostic Tips

# Trailer App Functionality and Diagnostic Tips

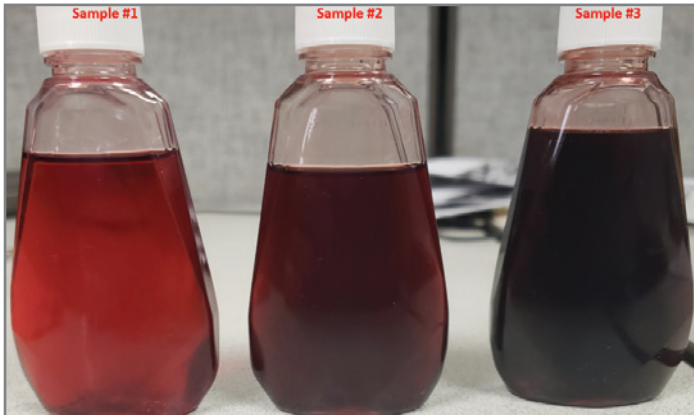
Also check the condition of the fluid. It should be red or brown and transparent enough so that objects or writing can be seen through it.

The fluid should not have an odor of burnt fluid. Dark fluid or a burnt odor would indicate clutch damage has occurred internally in the transmission.

In addition, inspect the fluid for excessive metal particles or debris. A small amount of friction material or metal from the manufacturing process – observed as fine silver streaks – are normal conditions.

Check the condition of the fluid. It should be transparent enough to see through.

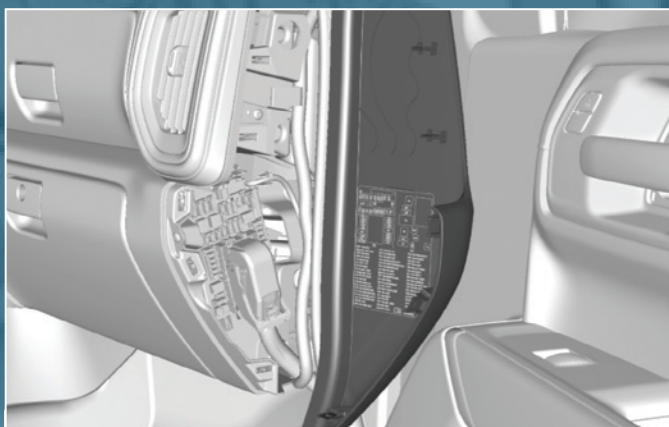
X51R instrument panel fuse block

If these conditions are found, check for the presence of fuses F51DR and/or F52DR in the X51R instrument panel fuse block, located behind the side trim panel on the right side of the instrument panel. These fuses should not be installed on vehicles equipped with Auto Stop/Start. These fuses will create an additional load for the T19 Power Supply Transformer, which will pull down the outlet voltage, causing the Auto Stop/Start system to not function.

Verify that the correct fuses are installed in the F51DR, F52DR, F56DR and the F57DR locations of the X51R instrument panel fuse block.

- If the vehicle is equipped with Auto Stop/Start, there should not be any fuses in the F51DR and F52DR locations on the front of the fuse block.
- If the vehicle is equipped with Auto Stop/Start, verify fuses are present in the F56DR and F57DR locations on the back of the fuse block.
- If all four fuse locations are correct, but the concern is still present, follow the diagnostic procedures in the appropriate Service Information.

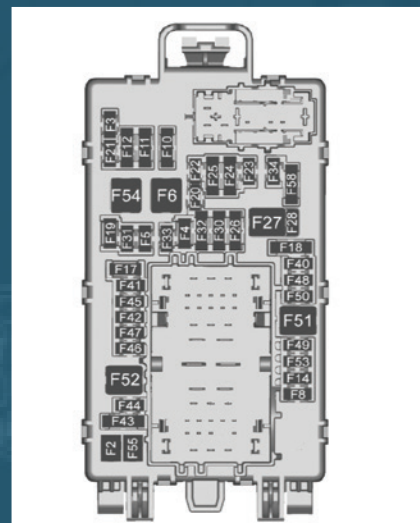
There should not be any fuses in the F51DR and F52DR locations (with Auto Stop/Start)

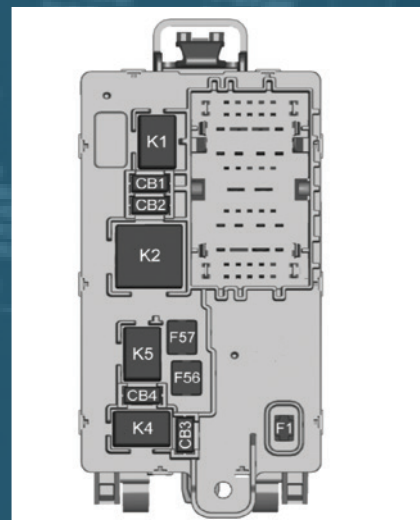
Verify fuses are present in the F56DR and F57DR locations (with Auto Stop/Start).

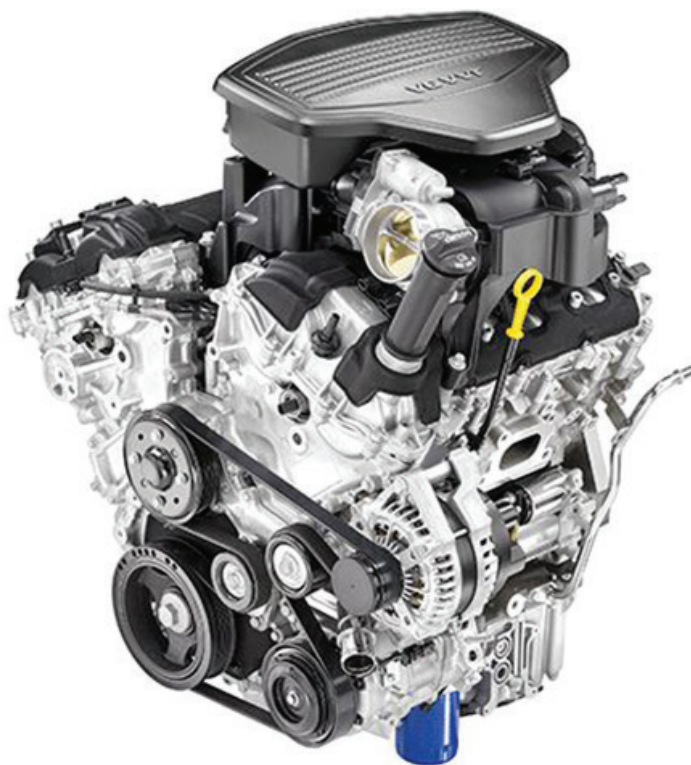
Some new 2020-2021 XT5, XT6, Blazer, Camaro and Acadia models equipped with the 3.6L V6 engine (RPO LGX) may have an oil leak at the engine oil filter. Drops of oil may be noticed on the ground underneath the front of new vehicles before the first oil change.

Before removing the oil filter, take a photo of the location of the oil leak. Use a pointer, colored tape or another type of stick-on marker to indicate the area of the oil leak.

The leaking oil filter will be requested back by Engineering for review and testing. Please properly drain the filter and return it to the parts department.
