The Blackwings Take Flight

<i>The Blackwings Take Flight</i>	1
<i>VT40 CVT Transmission Slipping Condition</i>	6
<i>Fuse Block or Junction Block Terminal Retention</i>	8
<i>Inoperative Steering Wheel Thumbwheel Select Control Reset</i>	9
<i>New Inserts Address Rear Leaf Spring Sounds</i>	10
<i>9th Gear Operation on 9-Speed Transmissions</i>	11

TECH LINK

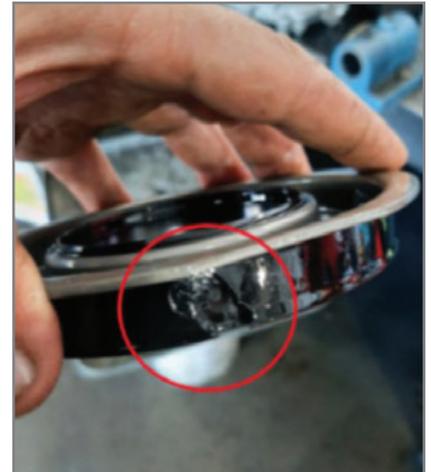
These intermittent conditions may be caused by the clutch regulator valve sticking in the valve body, damage to the forward clutch piston, and/or wear in the primary pulley bearing bore causing damage to the case.

If there is a loss of drive, slipping, the fluid has a burnt odor, or any of the other listed indicators are present, disassemble the transmission and inspect the edges of the forward clutch piston for damage.

Damage along the side of the forward clutch piston

If the forward clutch piston is damaged, replace it along with the forward clutch fiber plates and the forward clutch steel plates as needed.

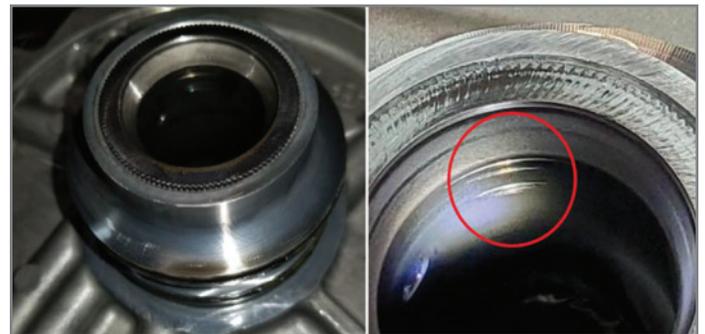
If the forward clutch piston is not damaged, inspect the pump for signs of internal wear. Wear may be found internal to the primary pulley bearing bore.

Any signs of wear may indicate that the primary pulley bearing has spun in the bore and is allowing the turbine shaft to become off center. If this occurs, there may be a pressure leak and the transmission may need to be replaced.

Inspect the pump for signs of internal wear.

TIP: The primary pulley bearing is installed on the inside of the case on the primary pulley, which cannot be accessed for inspection. Inspection of the pump for DTC P2714 and no concern found with the Forward Clutch Piston is critical to proper diagnosis.

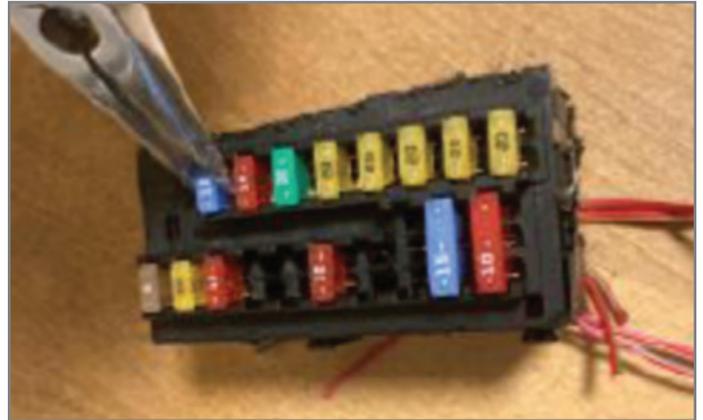
Some 2020-2021 Corvettes may experience several electrical concerns related to terminal retention issues at the instrument panel wiring harness fuse block (located at the passenger's side of the instrument panel) or the body wiring harness junction block (located at the rear compartment closeout panel between the seats). The locking feature of the electrical center may not retain the terminal, resulting in the electrical concerns.

After verifying the condition at either the instrument panel wiring harness fuse block or body wiring harness junction block, remove the block and identify the correct fuse that requires rework. Remove it from the block.

Remove the fuse from the block.

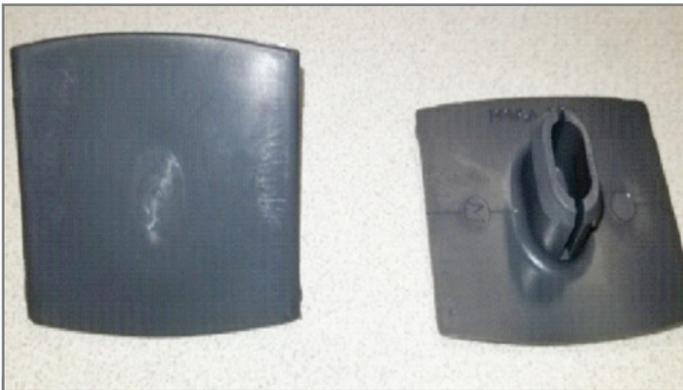
A squeak or clunk sound from the rear leaf springs may be heard on some 2015-2021 Silverado 2500HD/3500HD and Sierra 2500HD/3500HD models. The sound may be caused by the spring insert interacting with the leaf spring. Keep in mind that some noise is a normal characteristic of leaf spring suspensions when travelling over rough roads or bumps.

To help reduce excessive leaf spring noise, a new insert with a graining pattern is available. Replace the rear leaf spring inserts using a plastic trim tool or plastic wedge in between the leaf springs.

New inserts with a graining pattern
