# Inadvertent Airbag Deployments

*Preventing Inadvertent Airbag Deployments . . . . . 2*

GM TechLink is published for all GM retail technicians and service consultants to provide timely information to help increase knowledge about GM products and improve the performance of the service department.

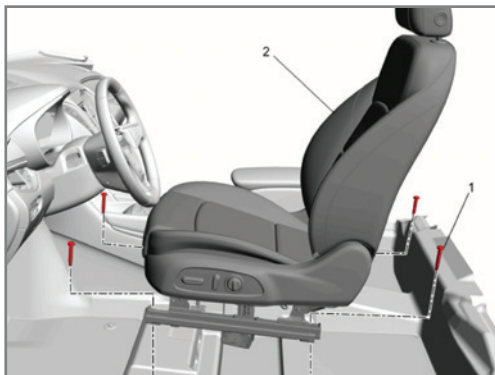
Diagnosing front seat movement conditions on 2016-2022 Malibu and 2019-2022 XT4 models requires verifying the operation of the seat adjuster track. If there are issues with fore/aft movement, binding or other conditions, check for proper operation of the motor bridge as well as the flex shaft of the H-frame assembly. There should not be any excessive noise or any fore/aft travel restrictions when adjusting the seat position.

Front seat adjuster track

If diagnosis leads to the need to replace the front seat adjuster track, the H-frame assembly has recently been released as a service part. Do not replace the complete seat cushion frame assembly for a seat track movement condition.

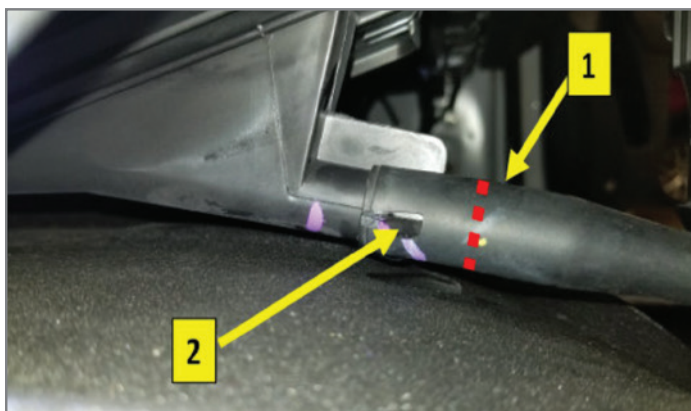
These conditions may be caused by possible water intrusion to the Body Control Module (BCM) from the HVAC drain hose leaking at the connection to the HVAC module.

If water is found at the notch in the hose (#2), add a tie strap to the drain hose, below the locking nib (#1) near the top of the hose connection.

If there is a leak at the drain hose connection to the HVAC module, water will be seen at the notch in the hose or just above it.

To prevent any current or potential leaking, add a tie strap to the drain hose, below the locking nib near the top of the hose connection.

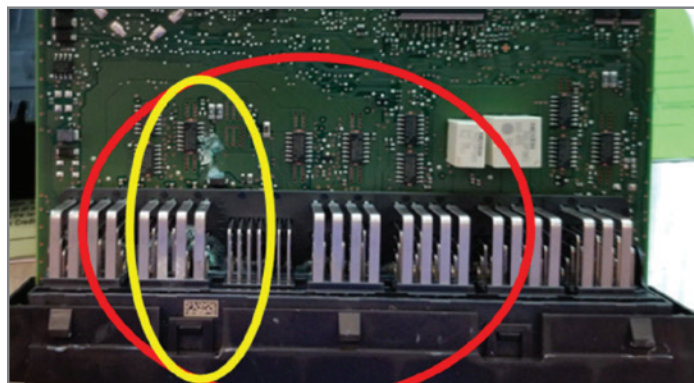
Water leakage will require an internal BCM inspection.

Look for corrosion and damage to the BCM (red circled area). Any internal corrosion (yellow circled area) will require replacement of the BCM.

Any signs of water leakage on the BCM will require disconnecting the BCM and opening the case for an internal inspection.

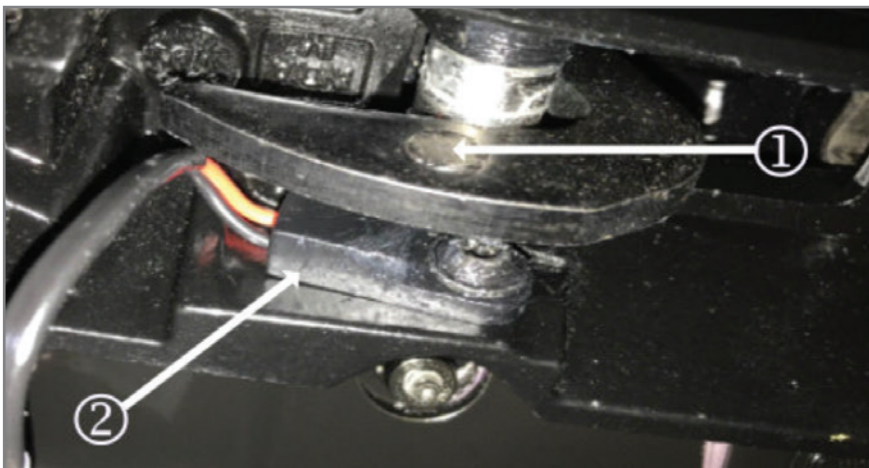
The convertible top may not lower intermittently on some 2020-2021 Corvettes. DTC B19E4 (Hard Top Locked Closed Signal) SYM64 also may be stored in history. SYM64 indicates that the folding top control module detects the signal circuit is invalid for greater than 1 second.

The hall effect sensor (#2) looks for the top to be fully latched. The hook of the latch striker may not be extending far enough to reach the magnet (#1).

The hall effect sensor looks for the convertible top to be fully latched at the header. The hook of the latch striker may not be extending far enough to reach the magnet. The front latch striker should be adjusted so that it latches completely.

To correct the intermittent convertible top operation, align the hall effect sensor in the right-side front latch striker.
