Program Radio Updates

TECH LINK

GM TechLink is published for all GM retail technicians and service consultants to provide timely information to help increase knowledge about GM products and improve the performance of the service department.

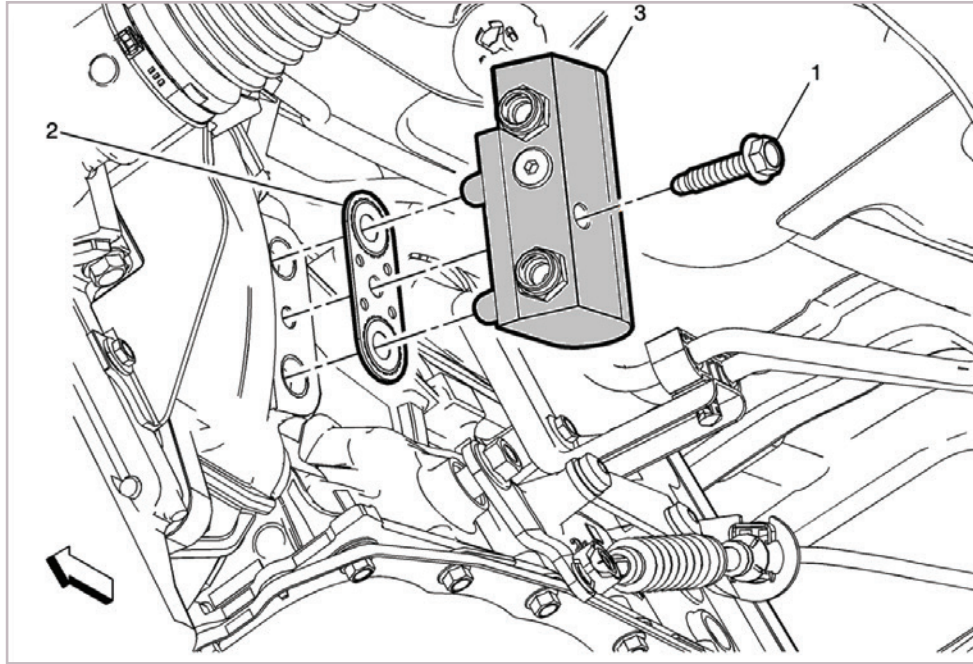
When performing transmission repairs on 2014-2019 Silverado and Sierra models and 2015-2020 Tahoe, Suburban and Yukon models equipped with the 6L80 6-speed automatic transmission (RPO MYC) for harsh shift, delayed shift, shudder, noise or vibration conditions, also replace the Thermal Bypass Valve (TBV).

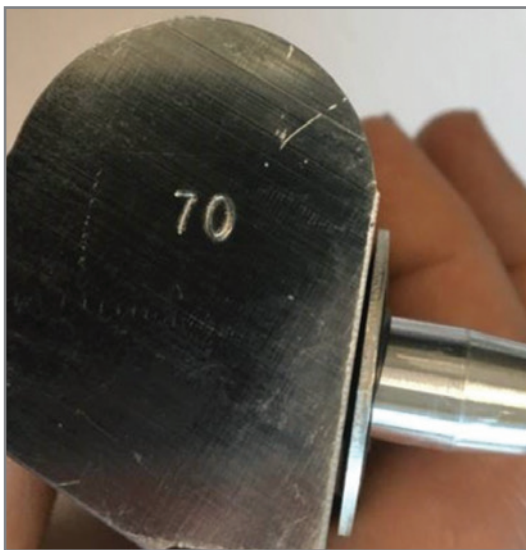
A new TBV is available that has a cooler operating temperature. The previous TBV had a full-open temperature of 194°F

New TBV with "70" stamp

(90°C). The new TBV has a full-open temperature of 158°F (70°C).

The new TBV can be identified by the "70" stamped into the bottom of the valve. The "70" stamp is visible on the valve when it is installed on the transmission.

The TBV should be replaced with the new valve only once for any transmission repairs, including Customer Concern Not Duplicated (CCND). The TBV should not be replaced again unless it is determined through normal diagnosis that the TBV has failed.

TIP: If vehicle is equipped with a new TBV, the transmission fluid level should be checked only after the transmission fluid temperature (TFT) has reached or exceeded an operating temperature of 158°F (70°C). Reaching or exceeding an operating temperature of 158°F (70°C) opens the bypass valve and allows the cooler to fill up with fluid, which will result in a more accurate fluid level check.

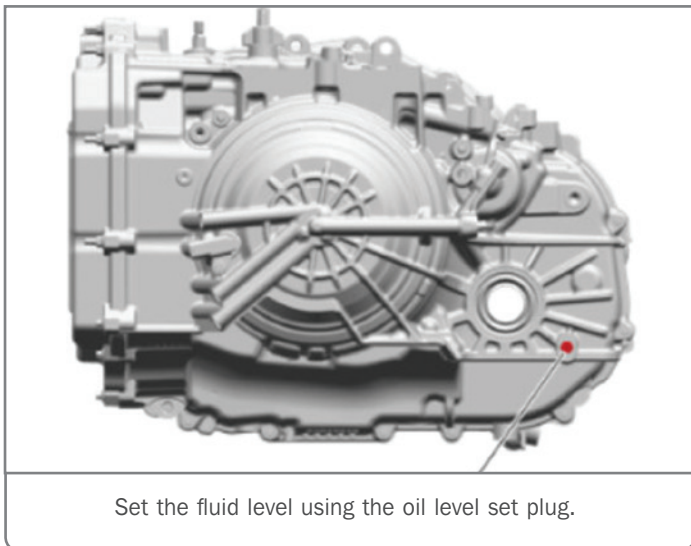
To check the transmission fluid level, the transmission fluid temperature (TFT) must be 185–203°F (85–95°C). Setting the fluid level with a TFT outside this temperature will result in either an under- or over-filled transmission. An under-filled transmission will cause premature component wear or damage. An over-filled transmission will cause fluid to discharge out the vent tube, fluid foaming, or pump cavitation.

If the fluid level is correct, check the condition of the fluid. The color of the fluid should be red or brown. It also should be transparent to the point where objects or writing can be seen through it. Refer to Bulletin #20-NA-136 for examples of acceptable fluid.

When inspecting the fluid, it's also normal to see a small amount of friction material or metal from the manufacturing process (observed as fine sliver streaks) in the fluid. Excessive amounts of particles should be noted on the repair order and would require an internal transmission inspection.

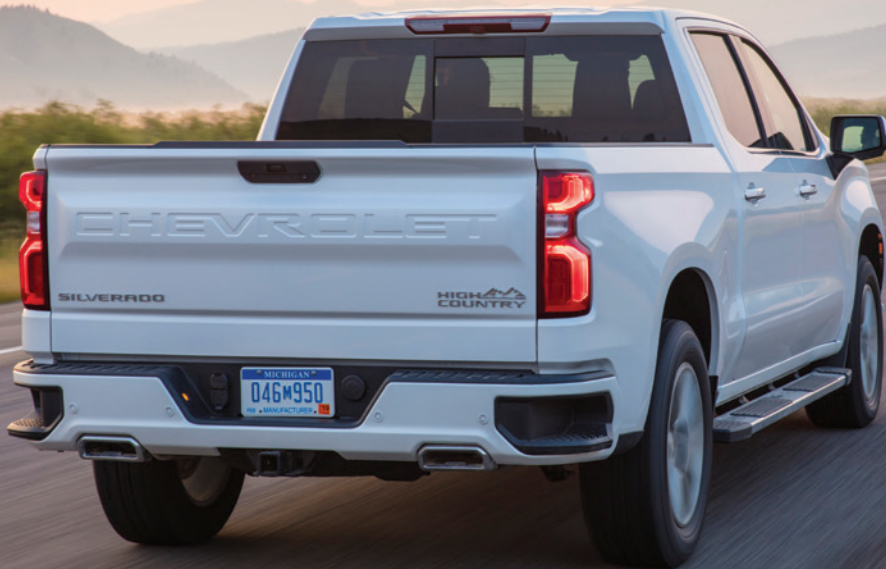
A shudder may occur when coasting between 15—13 mph (24—21 km/h)

Some 2021 Silverado 1500 and Sierra 1500 trucks equipped with the 5.3L V8 (RPO L84) and 10L80 10-speed automatic transmission (RPO MQB), excluding models with RPO YK9, may have a shudder condition when coasting to a stop between 15—13 mph (24—21 km/h). The shudder may feel similar to driving over rumble strips on the pavement when the vehicle is coming to a stop.

During diagnosis, the shudder condition will be easily duplicated every time the vehicle coasts at the affected speeds. The shudder may be due to the reduction in the number of cylinders firing during deceleration, which may lead to structure-borne noise, vibration and harshness (NVH) on some vehicles when coasting to a stop between 15—13 mph (24—21 km/h).

If the shudder condition at the affected speeds is confirmed, reprogram the Engine Control Module (ECM) with the latest calibration available. Do not replace any parts for this condition.

It will also be necessary to perform the Crankshaft Position Variation Learn procedure covered in the appropriate Service Information once the ECM has been updated. The crankshaft position sensor variation is used to calculate reference period errors caused by slight tolerance variations in the crankshaft and crankshaft position sensor, which allows the ECM to accurately compensate for reference period variations and detect misfire events over a wider range of engine speed and load. If the

Crankshaft Position Variation Learn procedure is not completed, the ECM calibration will not provide the desired results.

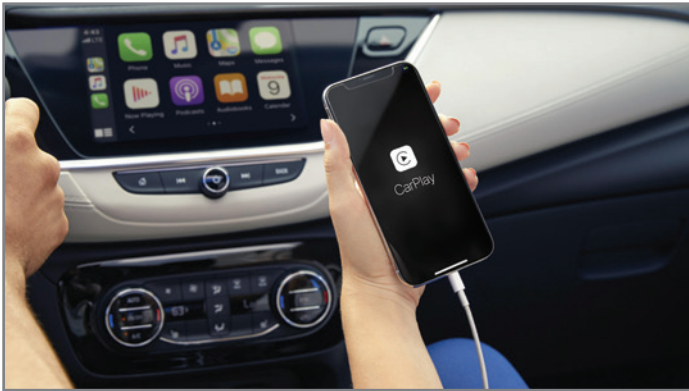
Connectivity issues may be difficult to reproduce and diagnose.

Mobile devices require being rebooted– powered off and then on again, especially after software updates – on a regular basis. When a device is not rebooted often, it could lead to device connectivity issues with the infotainment system, such as concerns with access to phone contacts, phone connections, wireless and wired projection for Apple CarPlay or Android Auto, and other issues.

However, in some instances, device connectivity issues may be resolved by rebooting the device. Performing the reboot procedure may help avoid spending additional time diagnosing a device that doesn't always connect with the vehicle.

If the customer concern cannot be reproduced, attempt to reset the device as well as the infotainment system:

1. Unpair or delete the device by removing the device from all infotainment system connections (Bluetooth, Wi-Fi and projection). Also remove or “forget” the vehicle from all settings on the device.
2. Restart the device.
3. Cycle off the vehicle ignition long enough for the radio sleep cycle to occur.
4. Reset the radio by selecting Erase Infotainment Data under the Settings > System tab. The Erase Infotainment Data option is under the Reset Options menu.
5. Pair and connect the device to the vehicle again.
