## SiriusXM with 360L Connectivity

# Transmission Neutral Service Mode

# Poor Performance During High Ambient Temperatures

# Turbocharger

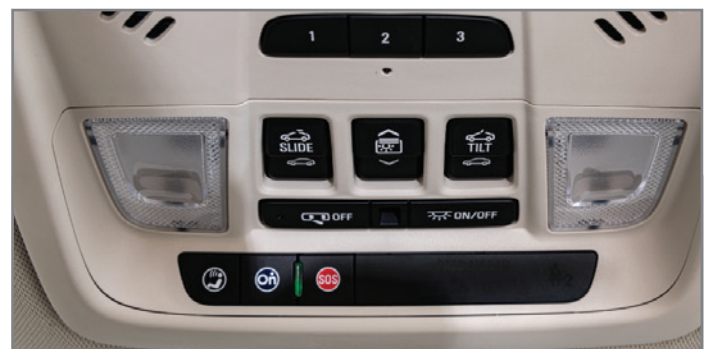
Another reason why the "Connection unavailable" message may be displayed is because of the vehicle's OnStar connection status. Internet connectivity will not exist if customers decline the OnStar Terms and Conditions (T&Cs). If a customer declines the Terms

and Conditions, a connection cannot be made with the vehicle in order to comply with the customer's wishes as well as state and federal privacy regulations. However, declining the Terms and Conditions will cause the loss of connectivity and prevent SiriusXM with 360L from operating properly.

To approve the OnStar Terms and Conditions, customers should press the OnStar button twice to initiate a call with an OnStar advisor to approve the OnStar Terms and Conditions for their vehicle. Approving the Terms and Conditions does not require or result in any subscription, but it does allow for connectivity to the SiriusXM servers and prevents the "Connection unavailable" message from being displayed.

Contact OnStar to approve the Terms and Conditions.

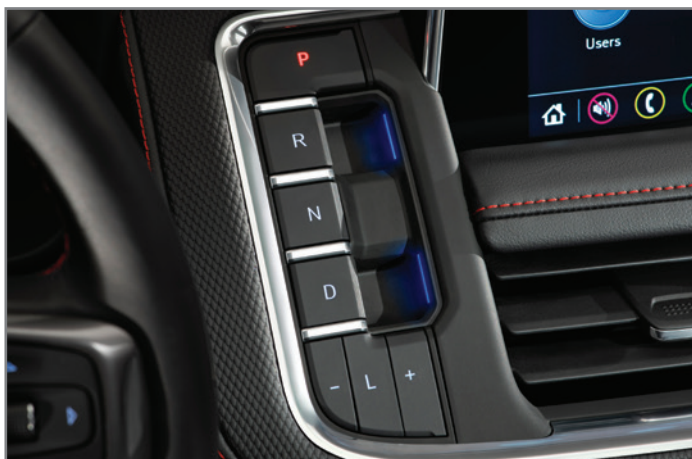
Electronic Transmission Range Select (ETRS) system requires hydraulic pressure to disengage the park mechanism.

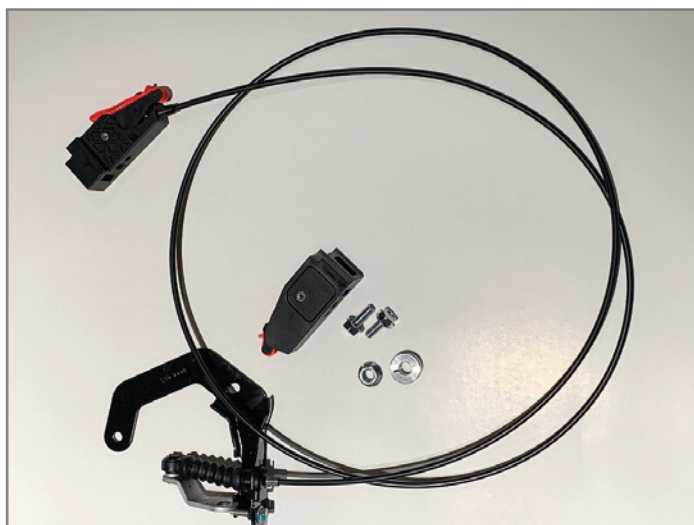
In cases where there is an ETRS system fault or a no start condition and the vehicle needs to be moved, the DT-52910 Manual Park Release tool can be installed to temporarily shift the vehicle into Neutral when the engine is not running. The manual park release tool is now available through the GM Special Service Tools website at [gmtoolsandequipment.com](http://gmtoolsandequipment.com).

To install the tool, refer to Document ID 5620825. The transmission will be placed in N(Neutral) when the manual park release is pulled. Ensure the vehicle is on level ground, the parking brake applied, and the wheels are blocked prior to installing the manual park release tool.

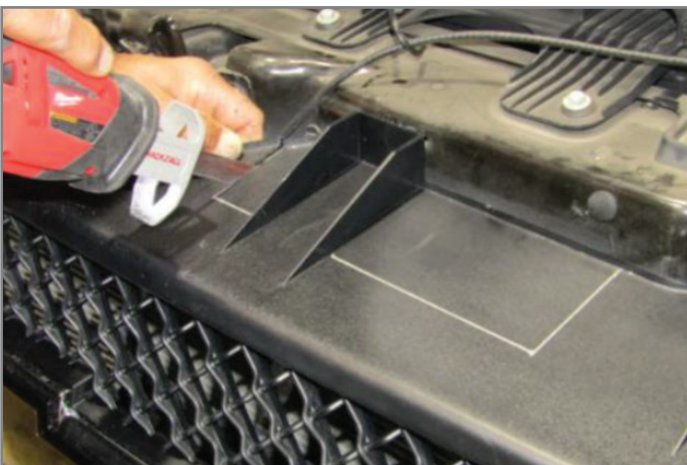
Some 2016-2020 Express and Savana models equipped with the 6.0L V8 engine (RPO L96, LC8) may have a lack of power or poor performance when driving up grades or after the vehicle has been idling for long periods of time in high ambient temperatures (90°F, 32°C, or above). At lower temperatures, these conditions may be less noticeable or eliminated. The poor performance may be more noticeable when the vehicle is outfitted with heavy work equipment, such as work boxes or ambulance bodies, and is driven in stop-and-go traffic.

At high ambient temperatures of 90°F (32°C) or above, the intake airflow to the engine may be reduced. The GDS2 scan tool data may show an increase in total knock retard and the ignition timing may be backed out, which may occur while the vehicle is under a load or driving in a situation where more throttle input is required, including going up a grade. The Engine Control Module (ECM) is adjusting to protect the engine from damaging spark knock, which is normal under these conditions.

The new engine air inlet duct requires removal of part of the grille material.

Installing the new engine air inlet duct requires removal of part of the grille material on the right side of the grille.

The new engine air inlet duct should be sealed with RTV engine sealant around the complete perimeter of the upper opening at the interface to the intake duct. Three push retainers are used to secure the duct to the vehicle.

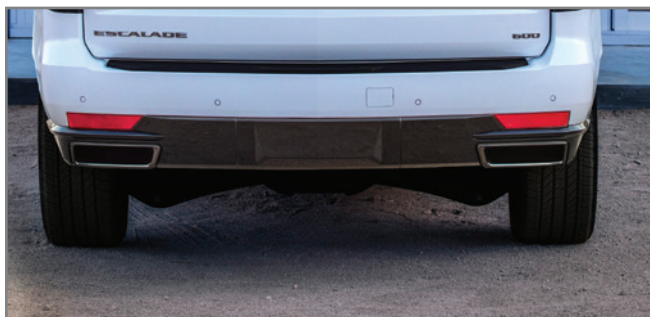
Some 2021 Tahoe, Suburban, Yukon and Escalade models equipped with the Reverse Automatic Braking system (RPO UVZ) may have a Service Driver Assist message displayed on the Driver Information Center (DIC) along with DTC U3000 49 (Control Module Internal Malfunction). These conditions may be caused by an issue with the Short Range Radar (SRR) due to highly reflective environments. Some temporary faults that trigger DTC U3000 49 may be detected while the radar is actively radiating.

Reverse Automatic Braking uses one or two Short Range Radar Sensors and the ultrasonic Parking Assist Sensors to identify objects behind the vehicle.

If DTC U3000 49 is set, reprogram the Short Range Radar with the latest calibrations and verify the condition is no longer present. Refer to Short Range Radar Sensor in the appropriate Service Information.

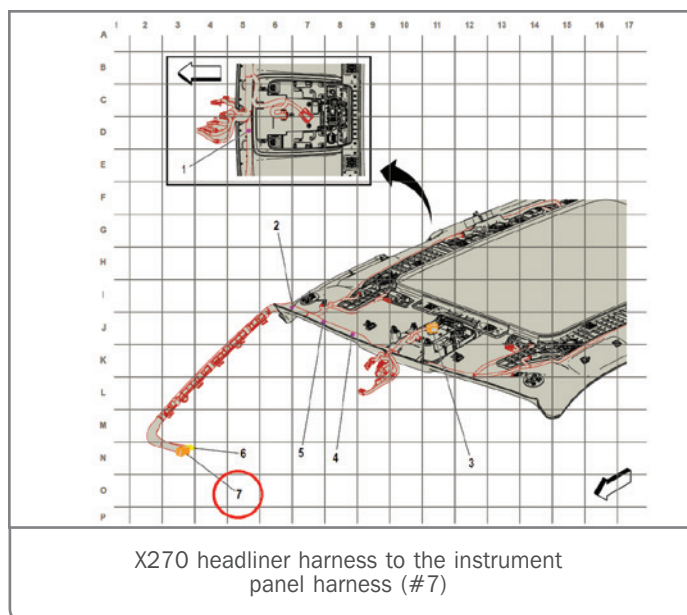
X270 headliner harness to the instrument panel harness (#7)

If the condition is still present after reprogramming, there may be an issue with the X270 headliner harness to the instrument panel harness.

Check for any loose terminals in the X270 harness. Repair as necessary.

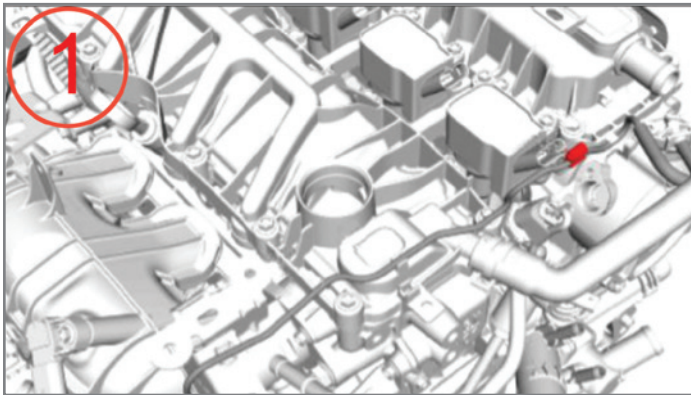
Turbocharger wastegate solenoid vacuum supply hose connection

Some 2019-2022 Encore GX and Trailblazer models equipped with the 1.2L engine (RPO LIH) may have an illuminated Check Engine MIL with DTC P0299 (Engine Underboost) set. These conditions may be caused by possible turbocharger wastegate linkage wear.

Begin diagnosis by connecting the EN-27738-A Vacuum Pump to the turbocharger wastegate solenoid vacuum supply hose. With the engine idling, the tool should read  $-50\text{ kPa}$  ( $-0.5\text{ bar}$ ,  $15\text{ in Hg}$ ).

If the desired pressure/vacuum cannot be achieved or does not hold steady, test and replace the vacuum pump assembly and related hoses as needed.

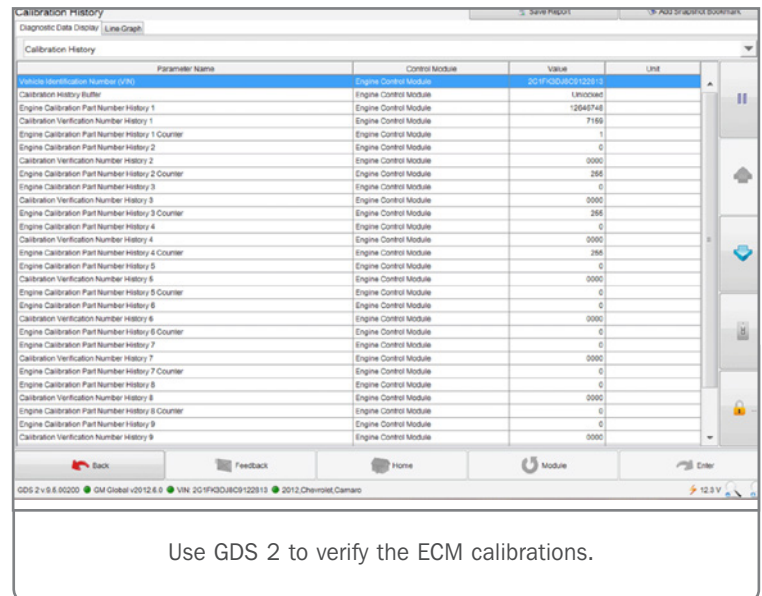
These fleet vehicles, which may be equipped with RPO VZ8, may have an aftermarket Engine Control Module (ECM) calibration installed that limits the speed and total power output as well as reduces vehicle idle speed. The reduced idle speed can create a vibration at idle.

If the vehicle is no longer owned by the original fleet customer, the aftermarket calibrations may still be installed in the ECM. Verify the current ECM calibrations are not the original factory calibrations following the calibration verification process using the Tech 2 or GDS 2 that are covered in Bulletin #09-06-04-026T.

Use GDS 2 to verify the ECM calibrations.
