# Global Wiring Harness

## REPAIR STRATEGY AND PARTS INFORMATION UPDATE

# Global Wiring Harness Repair Strategy and Parts Information Update

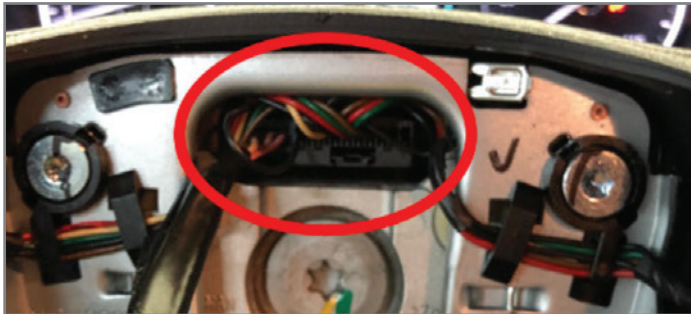
Some 2019-2020 Encore and Trax models may have several features operating improperly, including an unwanted windshield wiper swipe upon starting the vehicle, the front wipers may not park and the steering wheel controls may be inoperative at times. DTCs P155A SYM00 (Cruise Control Switch State Undetermined) and B1529 SYM03 (Control Module Voltage Reference Output 5 Circuit Low Voltage) may be set.

Check the condition of the wiring under the steering wheel inflator module.

If these conditions are found, check the condition of the wiring under the steering wheel inflator module. There may be a short in the steering wheel harness. If repairs are needed, refer to Wire to Wire Repair in the appropriate Service Information for more information about proper wire repair procedures.

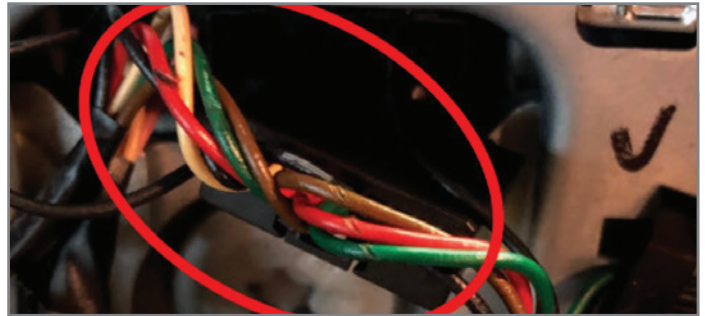
Look for a short in the steering wheel harness.

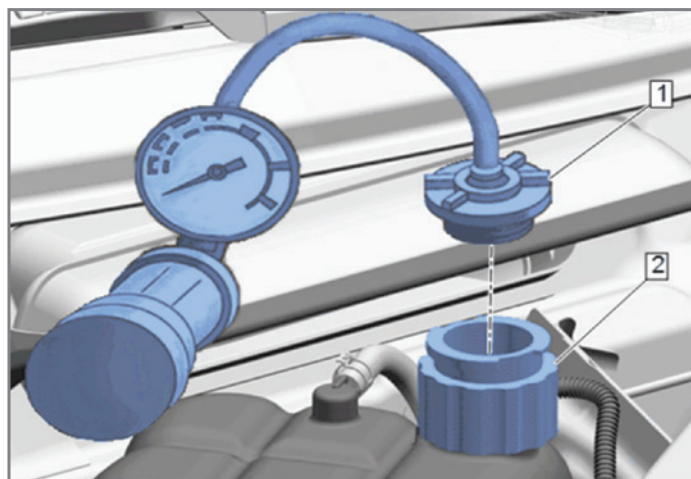
An illuminated Check Engine MIL and DTC P3075 (Engine Coolant Flow Too Low) may be set in the Engine Control Module (ECM) on some 2019-2022 XT4, Blazer, Silverado 1500, Sierra 1500; 2019-2021 Malibu; 2020-2022 Encore GX, CT4, CT5, XT5, XT6, and Acadia; and 2021-2022 Trailblazer models equipped with the 1.3L engine (RPO L3T), 2.0L engine (LSY) or 2.7L engine (RPO L3B). These conditions may be caused by low coolant or air trapped in the engine cooling system.

If these conditions are found, do not replace the coolant pump. Begin diagnosis by pressure testing the cooling system using the EN-24460-A Cooling System Pressure Tester to check for any coolant leaks. Repair any leaks to the cooling system following the procedures in the appropriate Service Information.

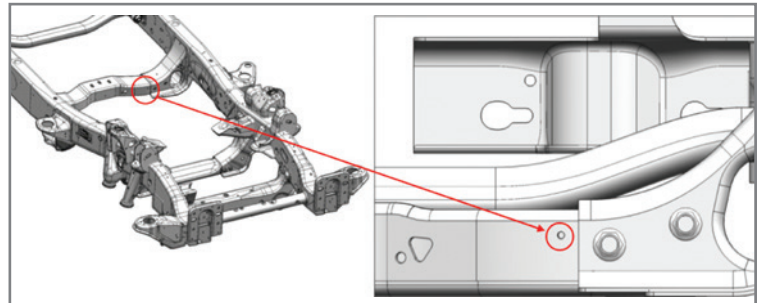
Some 2020-2022 Silverado 2500/3500 and Sierra 2500/3500 trucks equipped with the 6.6L Duramax diesel engine (RPO L5P) may have a coolant leak under the vehicle. The Check Engine MIL may be illuminated along with DTC P2C48 (Low Temperature Loop Coolant Pump Performance) set in the Engine Control Module. These conditions may be the result of contact between the auxiliary diesel fuel cooler coolant hose and the front driveshaft at the crossmember. This type of contact typically occurs when driving through deeper water or snow.

Drill a hole in the transmission crossmember for a retainer.

Repair any coolant leaks found and, to prevent future contact, re-route the coolant hose away from the front driveshaft. Drill a 6.5 mm-sized hole near the middle of the transmission crossmember.

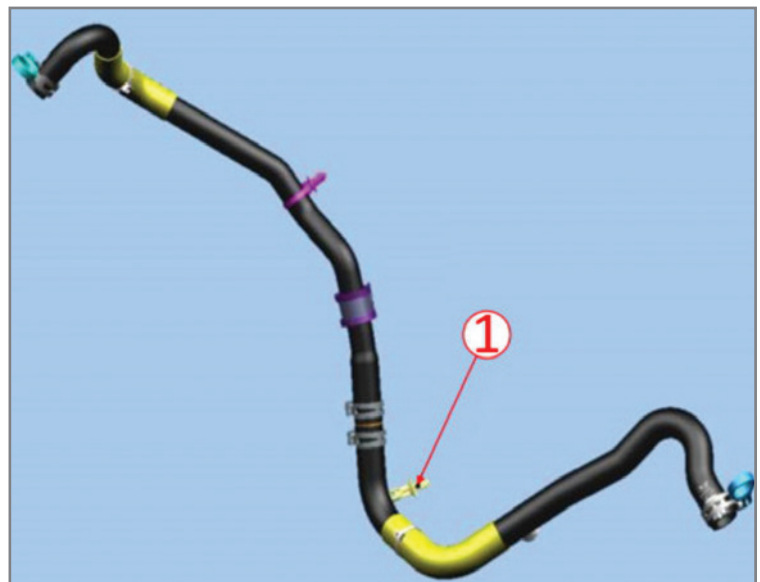
Install the retainer into the hole in the crossmember.

Add a retainer or equivalent onto the coolant hose and install the retainer into the hole in the crossmember.
