Disabling the Chevrolet Multi-Flex Tailgate & GMC MultiPro Tailgate Function

TECH LINK

GM TechLink is published for all GM retail technicians and service consultants to provide timely information to help increase knowledge about GM products and improve the performance of the service department.

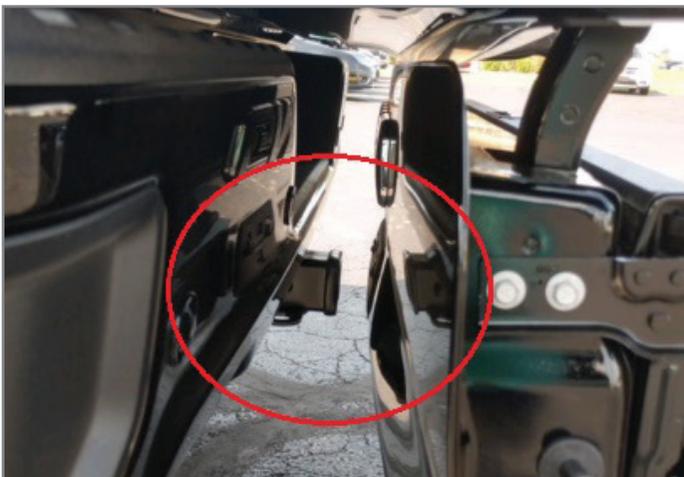
Do not lower the inner gate with the primary gate open (easy access or step positions) if a hitch ball or trailer is attached. This

Clearance between hitch receiver and lowered inner gate.

may damage the tailgate due to the amount of clearance between the hitch receiver and the lowered inner gate. The inner gate is equipped with an enable/disable feature to prevent it from being opened when a hitch or other equipment is installed that could damage the inner gate when lowered.

To disable the inner gate from opening, press and hold the upper button on the tailgate for 3 seconds. The key fob must be within 3 feet (1 meter) of the rear bumper.

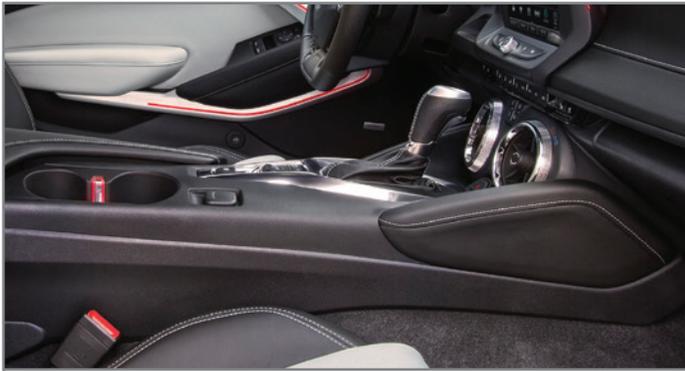
Automatic transmission

Some 2016-2020 Camaro models equipped with the 8-speed automatic transmission (RPO M5T, M5U) or 10-speed automatic transmission (RPO MF6, MGL, MI1, MI2, MI4) may have a Shift to Park message displayed on the Driver Information Center (DIC).

The Shift to Park message may be caused by the park switch being unable to pull the signal circuit low, telling the Body Control Module (BCM) that it is electronically in Park. If this condition is found, install a jumper harness and replace the transmission control assembly.

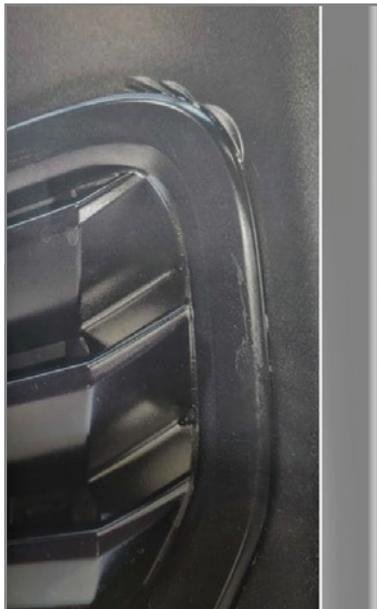
A wrinkle or bubble may be seen in the stripe decal or hood wrap around the outer edges of the hood air scoop on some 2019-2022 Camaro models.

The wrinkle or bubble may be caused by the edges on the bottom of the hood air scoop pressing deep into the stripe or hood wrap, causing air pockets to form over time.

Wrinkle around the hood scoop

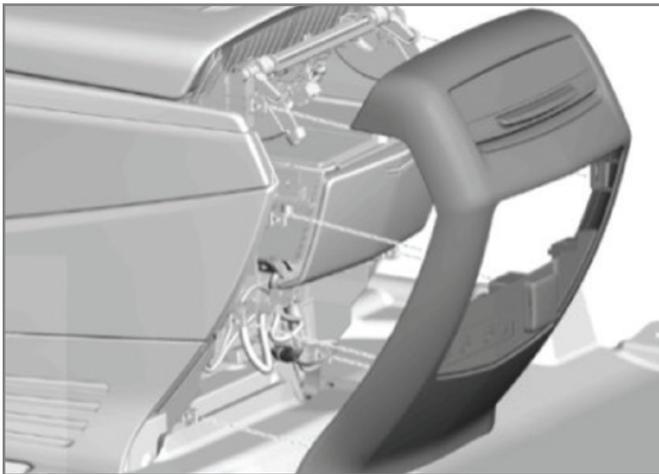
The air conditioning may blow warm air on some 2021-2022 Tahoe, Suburban, Yukon and Escalade models. The Check Engine MIL may be illuminated and DTCs B1AA3 (Run/Crank Relay Coil Control), U3018 (Control Module Input Power Circuit 1/2 Correlation) and U3505 (Control Module Input Power 2 Circuit Low Voltage) may be set.

These conditions may be the result of circuit 4786 in the front floor console compartment lamp shorting out, opening the BCM 2 fuse F4DR. If the cause is not found after following the Service Information diagnostics for any DTCs set, access the front floor console lid hinge area to inspect the wiring for the console compartment lamp.

Access the front floor console lid hinge area to inspect the wiring.

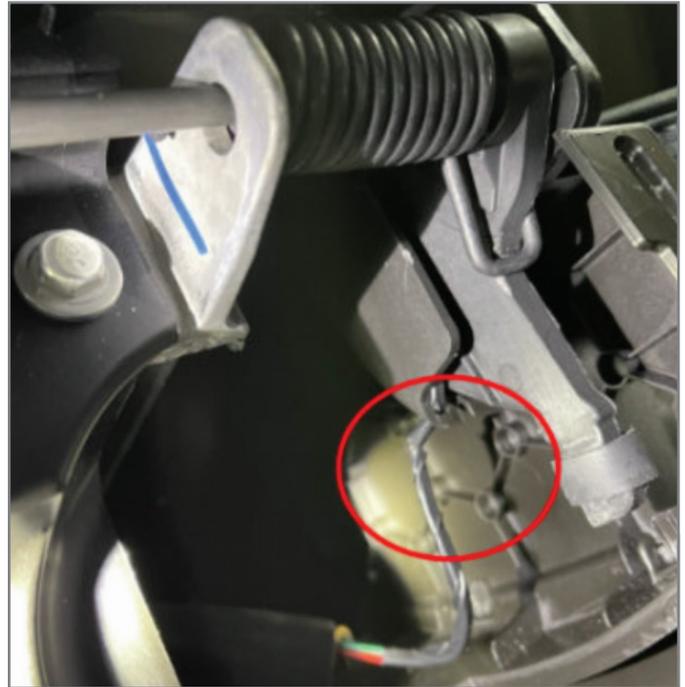
Check if the two circuits to the compartment lamp are shorted together.

In some cases, the two circuits to the compartment lamp will be broken and shorted together. Repair any damaged circuits following the wiring repairs in the appropriate Service Information.
