GM TECHNICAL ASSISTANCE CENTER (TAC)

February Newsletter
February 01, 2022

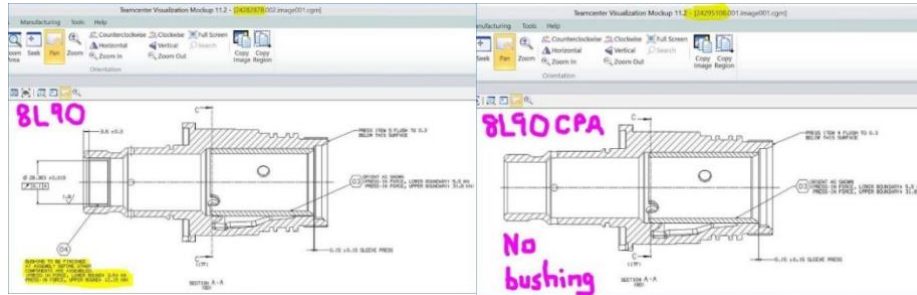
9) Front Turbine Shaft Bushing All models with an 8L90 Transmission

Not all 8L90 transmissions have a front turbine shaft bushing in the front stator support.

The following information refers to CPA (Centrifugal Pendulum Absorber) torque converters. CPA-type torque converters are not used in the 8L45 transmission. If the transmission does not use a CPA torque converter, the front turbine shaft bushing is used, as shown below
