Brake Rotor Conditions

Corvette Brake Rotor Conditions

TECH LINK

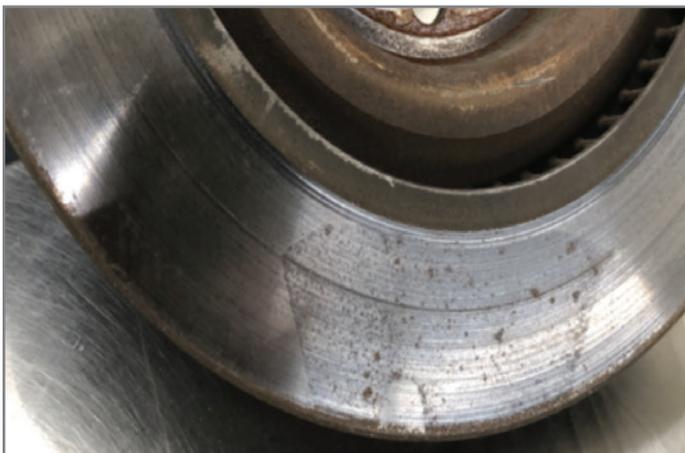
Typically, the brake rotor conditions are caused by corrosion pad spotting and surface grooving on the rotor surface. Burnishing the brakes can help to restore optimal brake performance and reduce brake noise.

Corrosion pad spotting

BRAKE BURNISHING PROCEDURE FOR CORROSION CLEANUP

Refer to Bulletin #22-NA-026 and the Owner's Manual for the complete brake burnishing procedure. The procedure includes applying the brakes 10 times starting at 60 mph (100 km/h) to 30 mph (50 k/h) while decelerating at 0.4g, which is a medium brake application. The Friction Circle (or Friction Bubble), found under the Performance menu on the instrument cluster, can be used to monitor the g-force. Use the Driver Information Center (DIC) steering wheel controls to view the menus on the instrument cluster. Between brake applications, the vehicle should be driven for at least 0.3 miles (0.5 km).

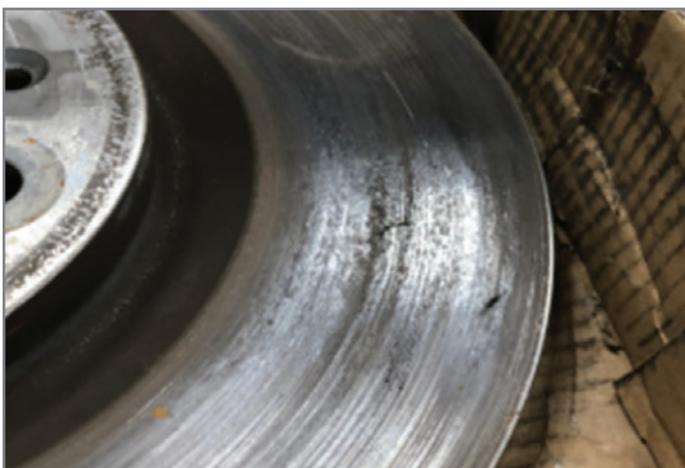
Rotor surface grooving

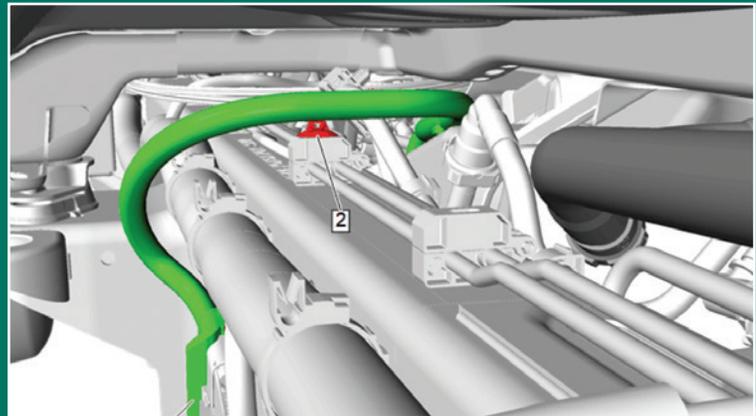
After replacing the wiring harness on the Diesel Exhaust Fluid (DEF) tank on some 2020-2022 Silverado 2500HD/3500HD and Sierra 2500HD/3500HD trucks equipped with the 6.6L Duramax diesel engine (RPO L5P), several DTCs may set. DTCs P20B9 (Reductant Heater 1 Control Circuit) and P20C1 (Reductant Heater 3 Control Circuit) may be caused by a wiring change to the service DEF tanks.

If these conditions are found, examine the 16-pin wiring harness connector to verify which wiring harness is installed on the vehicle prior to ordering any parts. On the first-design DEF tank harness, pin location 12 will be empty. The second-design DEF tank harness, pin location 12 has a wire in the connector.

DEF tank wiring harness

For complete wiring pinout charts for the first-design harness and second-design harness, refer to #PIP5838.

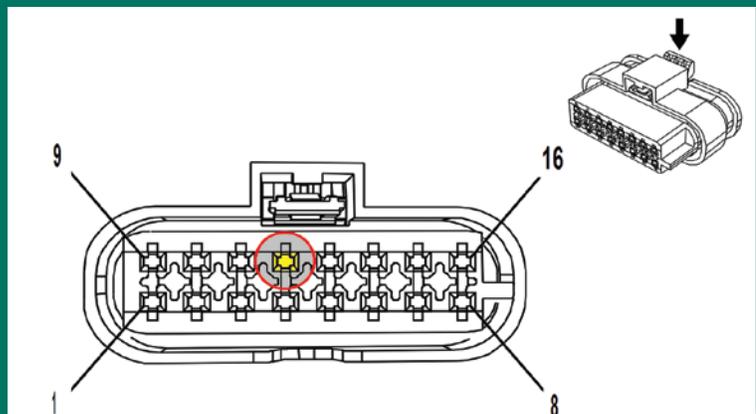
Check for a wire in pin 12

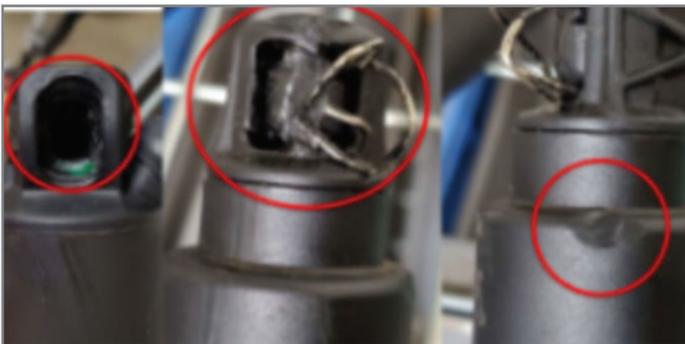
The power liftgate actuators from some 2018-2022 Acadia, XT5 and 2020-2022 XT6 models that have been returned to the Warranty Parts Center show damage due to improper removal.

Not following the proper procedure to remove a power liftgate actuator, such as prying the actuator off the ball socket, may damage the actuator.

Damaged power liftgate actuators

To properly remove the actuator, with the liftgate fully open, push the actuator ball socket onto the ball toward the liftgate edge.

Make sure that the spring clip is snapped into the closed position; otherwise, push the spring in by hand.

Insert a flat pocket screwdriver behind the clip. The clip does not need to be removed. Pull the ball socket off the ball completely to remove the actuator.

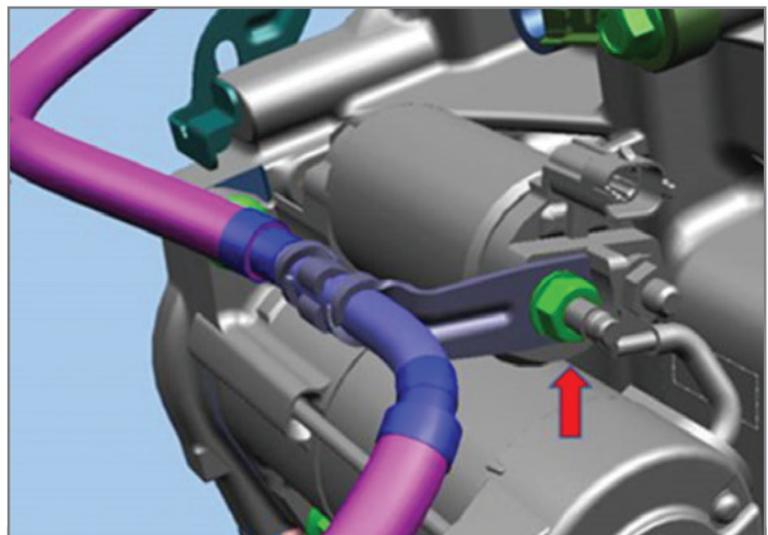
Some 2021-2022 Equinox and Terrain models equipped with the 1.5L engine (RPO LYX) may have an intermittent no crank condition, but the vehicle powers up normally.

If the intermittent power up, no crank condition is found, verify the BCM Power Mode Data shows Crank, the ECM Electrical Data shows an active Crank Request and Crank Relay command. If the data is correct, check for power at the B+ terminal at the starter. If there is power present, inspect the B+ stud on the starter for oxidation.

Replace the nut and clean the B+ stud terminals if oxidation is evident and then re-check starter function for proper operation. If the no crank condition is no longer present, repairs are complete. If not, continue with starter diagnosis following the appropriate Service Information.

Replace the nut and clean the B+ stud terminals if oxidation is evident.

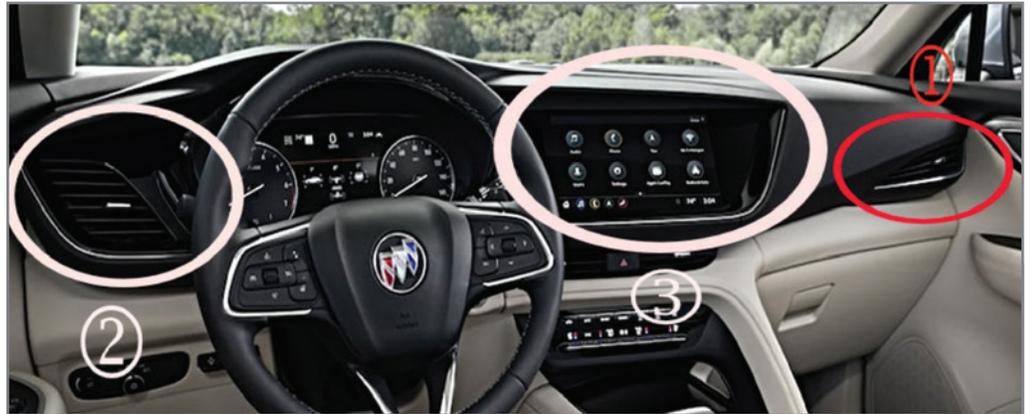
However, the far right chrome strip under the HVAC vent near the front-passenger door does not illuminate like the left and center sections of the instrument panel. This is the intended design of the instrument panel lighting and is a normal operating characteristic of the vehicle. Do not replace any parts or attempt any repairs to the far right chrome strip.

Chrome strip under far right vent (1) does not illuminate like the far left (2) and center (3) sections of the instrument panel.

Customers should be notified of this normal lighting operating characteristic and that it does not impact the designed performance of the vehicle.
