Possible Condensation in Crankcase Pressure Sensor Assembly

Service 4WD Message with DTC C119E

TECH LINK

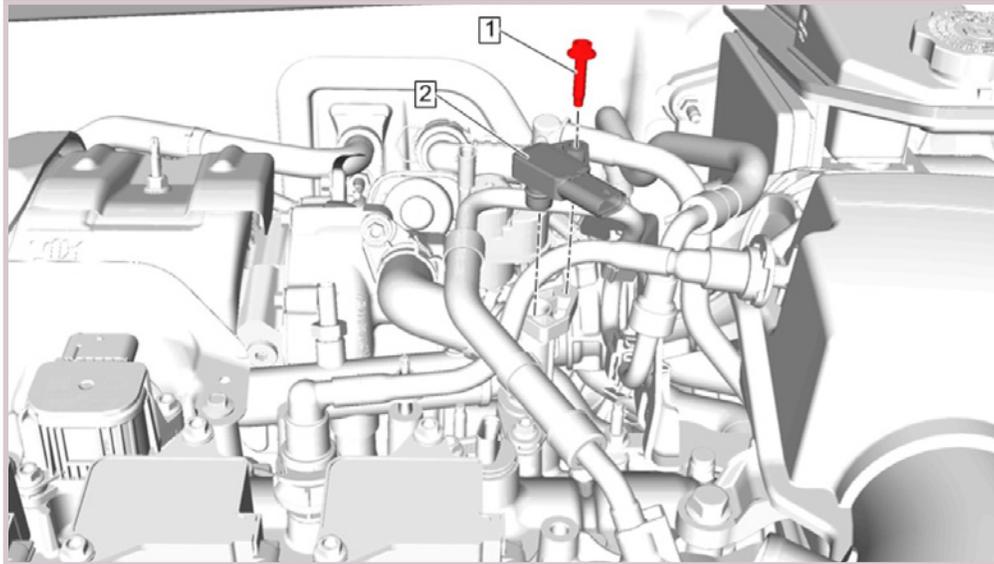
There may be possible moisture or condensation freezing in the crankcase pressure sensor assembly on some 2019 CT6; 2019-2022 XT4; 2020-2022 CT4, CT5, XT5, XT6, Blazer, Acadia; and 2021-2022 Envision models equipped with the 2.0L engine (RPO LSY). As a result, DTC P04FB (Crankcase Ventilation Hose Connection Pressure Sensor Performance) may be set.

If a root cause cannot be determined, check the PCV/crankcase pressure sensor assembly. Remove the PCV/crankcase pressure sensor and hose assembly and inspect it for any frozen moisture or condensation.

If frozen moisture is present, allow the crankcase pressure sensor and hose assembly to thaw out and the moisture to drain. Next, using a combination of light compressed air and a shop towel, remove any residual condensation/moisture. Once completed, clear any remaining DTCs using GDS and evaluate the condition.

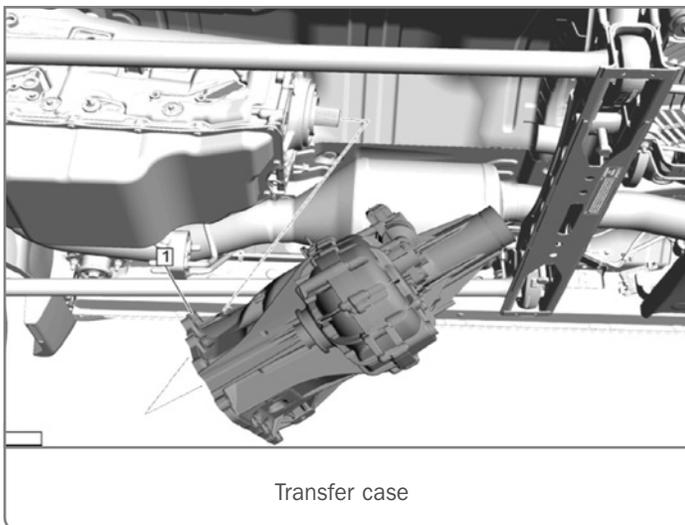
Some four-wheel drive 2020-2022 Silverado 2500HD/3500HD and Sierra 2500HD/3500HD trucks equipped with the 10-speed automatic transmission (RPO MGM, MGU) and transfer case MP 3023/2024 (RPO NQH) may have a Service 4WD message displayed on the Driver Information Center (DIC). DTC C119E symptom 5A (Range Actuator System Performance) also be may be set in the Transfer Case Control Module (TCCM).

If the transfer case clutch high value is above 5 degrees, follow the diagnostic information in the appropriate Service Information.

If the transfer case clutch high value is below 5 degrees, remove the transfer case in order to replace a clutch shim. Refer to Transfer Case Assembly Replacement (with MGM, MGU Automatic Transmission) in the appropriate Service Information.

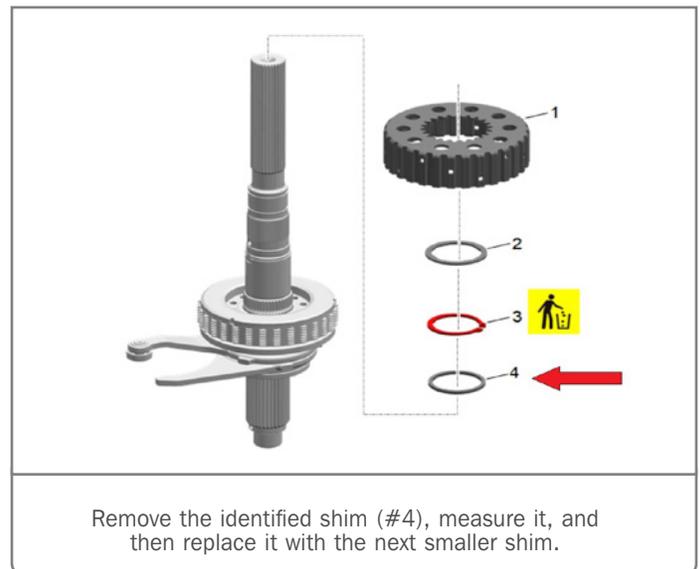
After removing the four-wheel-drive clutch housing (#1), front output shaft driven sprocket spacer (#2) and two/four-wheel-drive clutch retaining ring (#3), remove the four-wheel drive clutch shim (#4, identified below), measure it, and then replace it with the

next smaller shim. For example, a removed shim that is 4.8 mm should be replaced with a 4.6 mm shim. Do not use the tool listed in the service document in Service Information to measure the clutch pack shim for this repair.

After installing the smaller shim, reassemble and reinstall the transfer case. Perform the Transfer Case Range Actuator Learn procedure and then verify the high clutch value. Under the Engineering Data 3 list, the high clutch value should increase by 10–12*.
