AERO SHUTTER DIAGNOSTIC TIPS

The aero shutters on some 2019-2021 Silverado 1500, Tahoe, Suburban, Sierra 1500, Yukon, Escalade; 2020-2021 Silverado 2500HD/3500HD and Sierra 2500HD/3500HD models may have several conditions that could potentially cause improper shutter operation. Several DTCs may be set, depending on the specific conditions.

TECH LINK

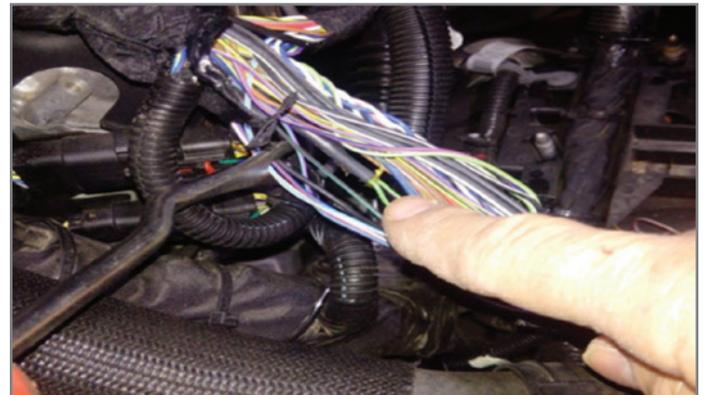
Movement of the J170 splice on light-duty trucks may cause an intermittent communication issue.

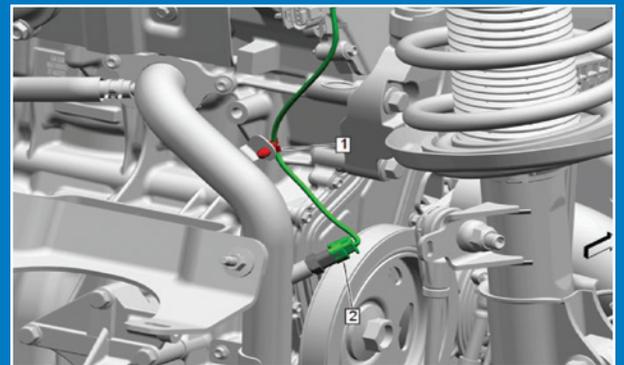
If the root cause of the overheating or running hot condition cannot be isolated after completing the published engine overheating diagnostics, replace the Engine Coolant Temperature (ECT) sensor #1, identified in the engine overheating diagnostic chart. The ECT sensor #1 may be reading noticeably cooler than the other ECT readings, which could affect the position of the Coolant Control Valve (CCV) and limit the amount of coolant entering the radiator. As a result, the engine may be running hot.

Be sure to use the latest part listed in the Electronic Parts Catalog. Refer to the Engine Coolant Temperature (ECT) #1 – Coolant Pump Outlet Pipe procedure in the appropriate Service Information. After repairs, validate that the engine is operating in the proper temperature range.

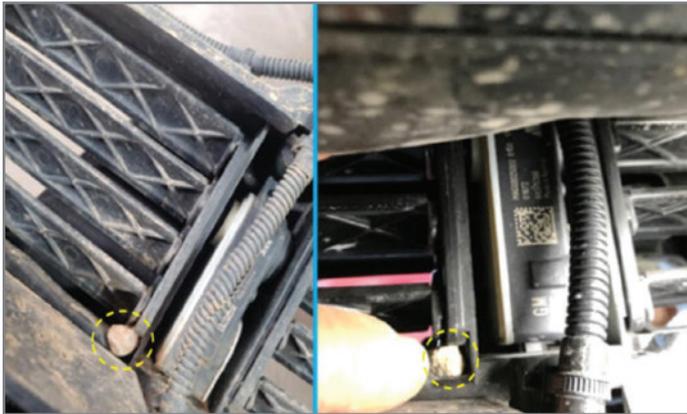
If DTCs P059F and P05AE are set, check for any debris in the upper and lower shutters, a louver/vane that is disengaged from the linkage, or a shutter that is binding. Try to remove any debris by hand or using compressed air before removing the front fascia of the vehicle or the shutter.

Look for debris that may be binding the shutters.

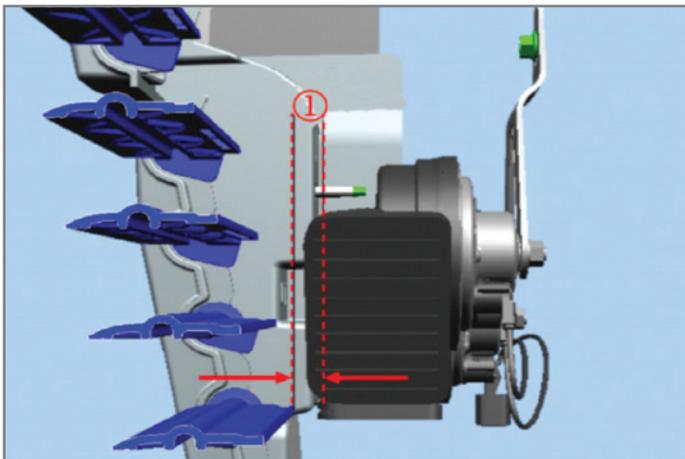
On SUVs as well as light-duty trucks, the upper shutter also may be binding on the horn or bracket (upper passenger's side). There should be at least 0.40 inches (10 mm) of clearance between the shutter louver/vane and horn.

Check for the proper clearance (#1) between the shutter vane and horn.

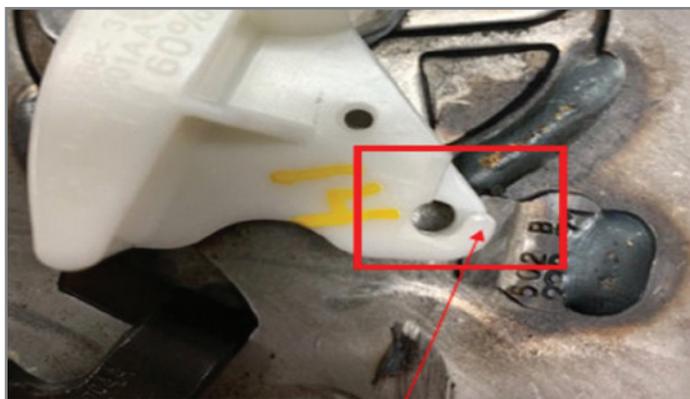
Outboard white release lever

After removing the rear seat adjustment and recline handles and outer finish cover, inspect the outboard white release lever for damage or missing material.

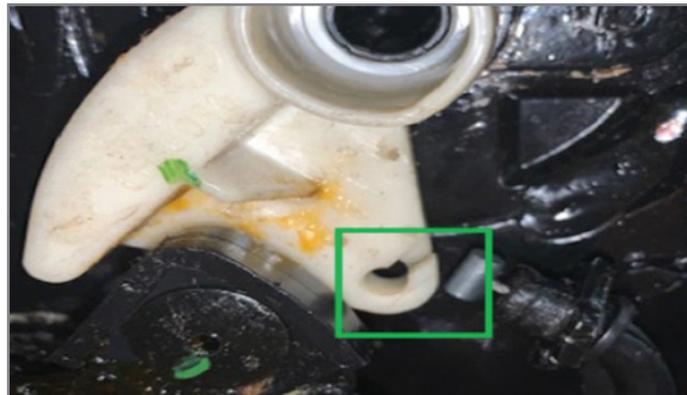
Also verify that the seat cable is disconnected from the release lever.

Cable disconnected from the release lever.

If these conditions are found, install a reinforcement retainer following the steps in the Service Bulletin

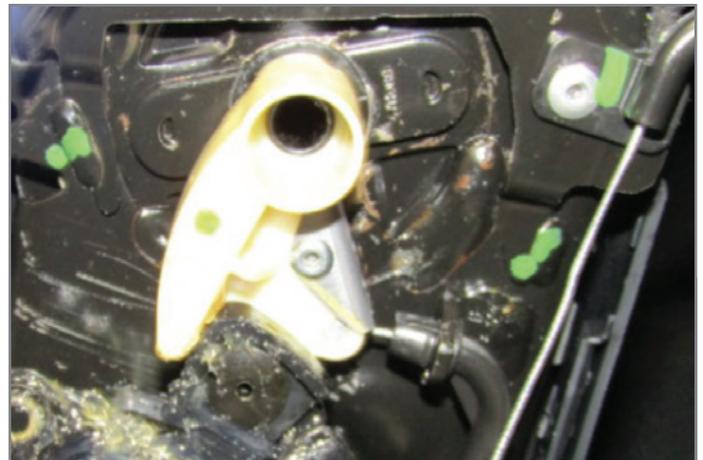
The retainer should not contact the cable strand.

Once the retainer is installed, verify the edge of the retainer is not contacting the metal cable strand and that the seat folds freely.

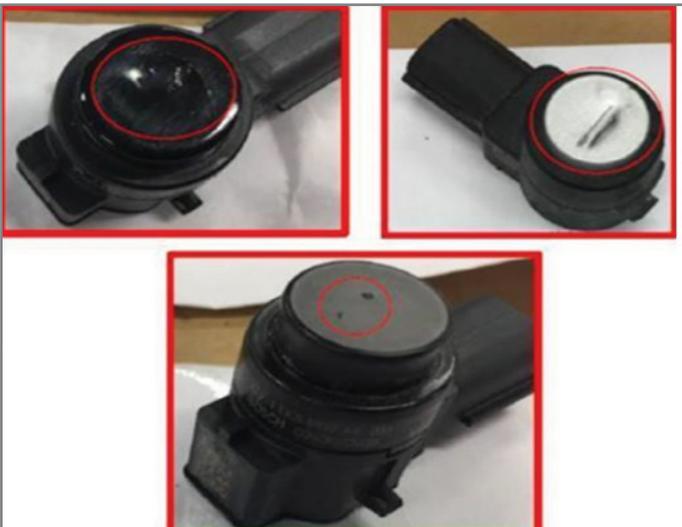
Check for a sensor with visible stone chip and membrane damage.

Stone chip and membrane damage

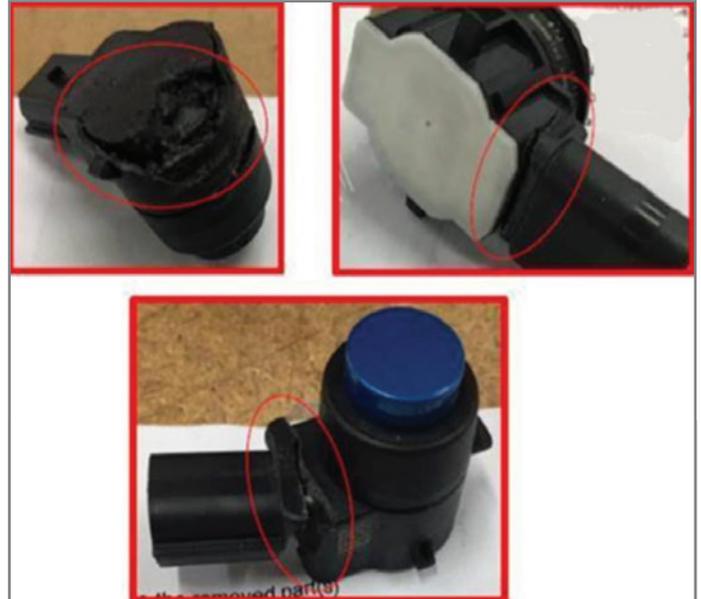
Inspect the sensor for damage to the connector.

Connector damage

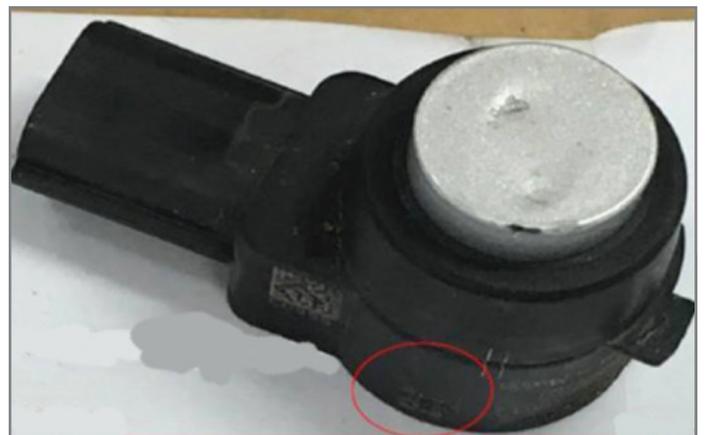
The retaining tabs should not show any damage from impacts or improper removal.

Broken retaining tabs

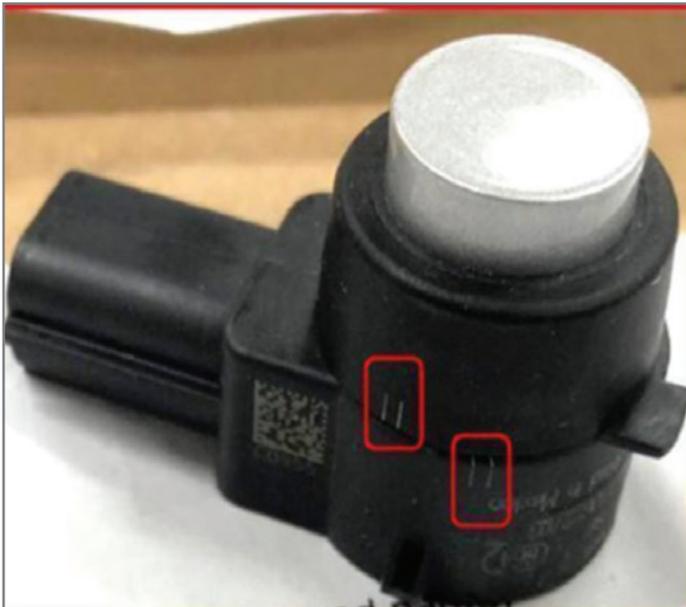
A twisted sensor without the marks aligned is typically caused during sensor removal or installation.

Twisted sensor

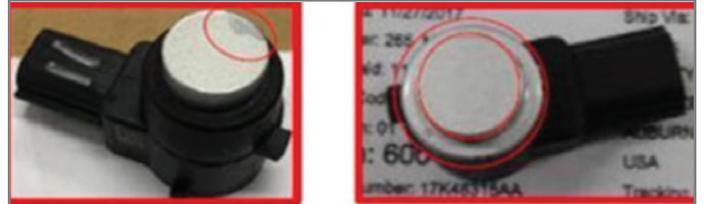
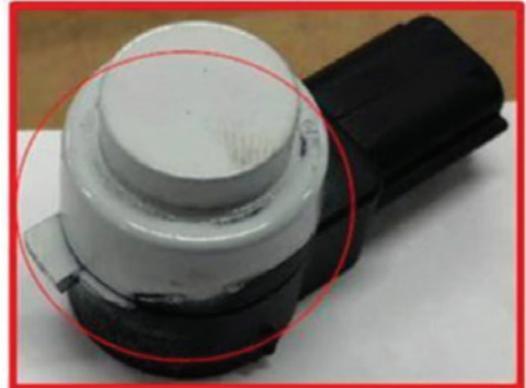
Verify the sensor is painted correctly without any overspray, grinding or re-painting. Follow the appropriate Service Information for the correct painting procedure. Do not refinish previously painted sensors. Excess paint build-up will cause the sensor to be inoperative.

Incorrectly painted sensors

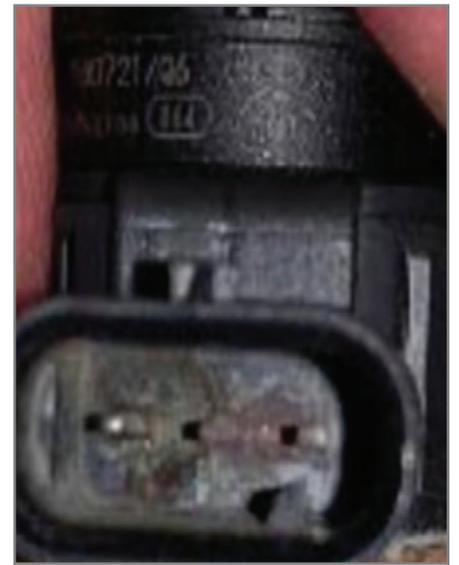
Check for any damage by the outside environment, including a corroded connector.

Corroded connector

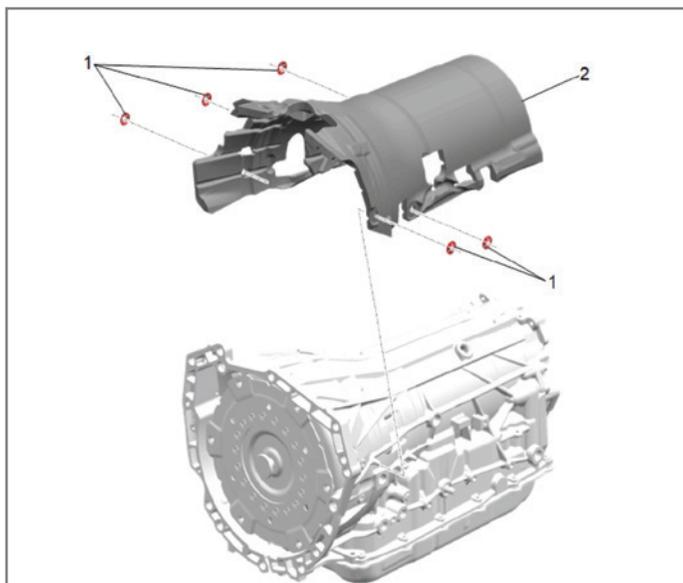
The remanufactured transmissions do not include the transmission housing acoustic sound insulator cover as part of the service transmission assembly. The sound insulator must be transferred from the original transmission to the remanufactured service transmission. Remanufactured transmissions shipped to the dealership without the sound insulator are not built incorrectly.

Remanufactured transmissions do not include the transmission housing acoustic sound insulator cover.
