GM TECHNICAL ASSISTANCE CENTER (TAC)

Dealer Tips and New Information Newsletter

April 4, 2022

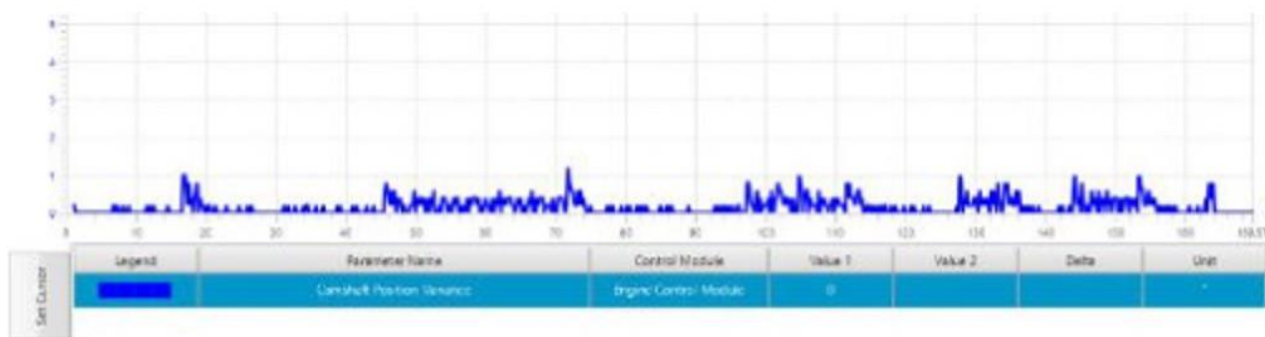
Below are line graph examples from GDS2: one showing normal operation of the camshaft actuator system and one that is considered suspect and not operating properly.

Normal operation (variance under 4 degrees)

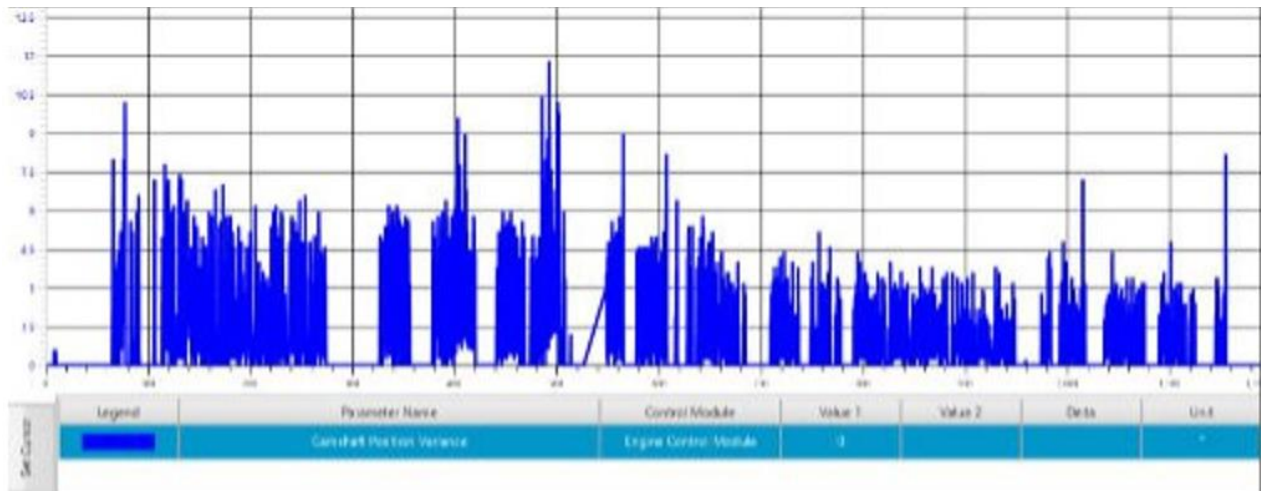
Involved Region or Country	North America, Europe, Uzbekistan, Middle East, Iraq, Israel, Palestine, Argentina (Mercosur), Brazil (Mercosur), Bolivia (West), Chile (West), Colombia (West), Ecuador (West), Paraguay (West), Peru (West), Uruguay (West), Venezuela (West), Japan, Cadillac Korea (South Korea), GM Korea Company, China - SGM, Taiwan , Thailand (ASEAN), Singapore, Philippines , Australia/New Zealand, Egypt, Other Africa, South Africa
Condition	Some customers may comment that they feel a Shudder or Surge type feeling when driving at a steady speed. <ul style="list-style-type: none"> Some customers may mistake it for a transmission related concern.
Cause	This condition may be caused by the camshaft actuator magnet sticking.
Correction	<p>If the concern has been determined to be engine related and not being caused by the transmission the following diagnosis may be helpful:</p> <ul style="list-style-type: none"> While duplicating the Shudder or Surge concern monitor the data parameter "Camshaft Position Variance" in GDS2. Although target variance is 0 degrees, it is not uncommon to observe variance of up to 3-4 degrees on a properly functioning system. Any variance exceeding 3-4 degrees could potentially cause a noticeable Shudder or Surge concern. If after diagnosis you confirm that the concern has been isolated to the camshaft actuator system, it is recommended to replace the camshaft actuator magnet and re-evaluate. Refer to Camshaft Position Actuator Magnet Replacement. <p>If the Shudder/Surge is still present after camshaft actuator magnet replacement and camshaft actuator variance is over 4 degrees, refer to GM Service Information for further diagnosis.</p>

Suspect fault in camshaft actuator system (variance over 4 degrees)

Causal Part	Description	Part Number	Qty
X	MAGNET, CM/SHF POSN ACTR	12675031	1

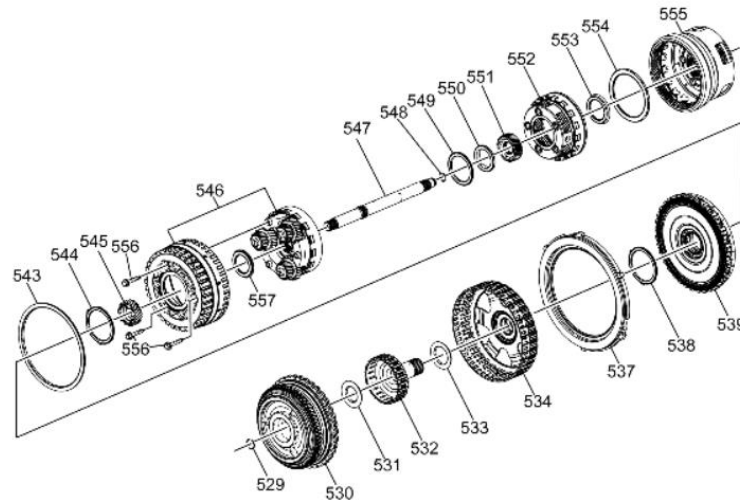
The parts catalog for item #550 shown below from document #4368697 shows P/N 24260431, but should be and will be changed to 24268852.

There is very low inventory as of right now on this part number. See the diagram below.
