GM TECHNICAL ASSISTANCE CENTER (TAC)

Dealer Tips and New Information Newsletter

May 10, 2022

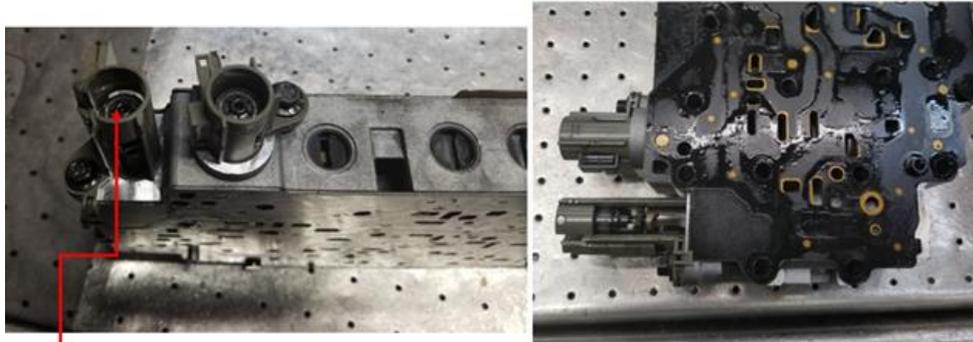
If a vehicle with a 9Txx transmission with ETRS is setting DTC P187E, the following images may help with the diagnosis.

Here are the magnets that are attached to the valves in their natural state.
If these magnets are all the way out to the end of the switch, the valve is stuck.

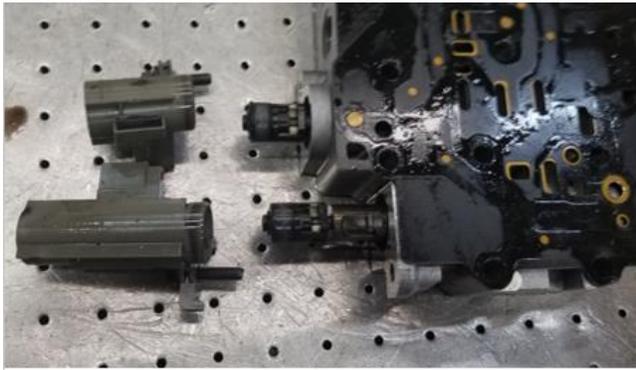
Top picture is when the switch is removed.
The bottom picture is when the magnets are removed from the valve.

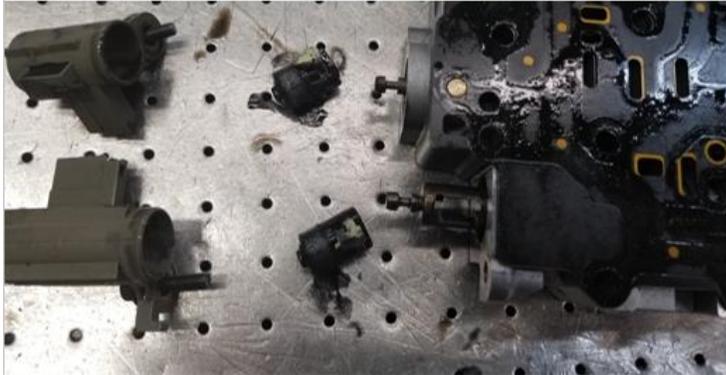
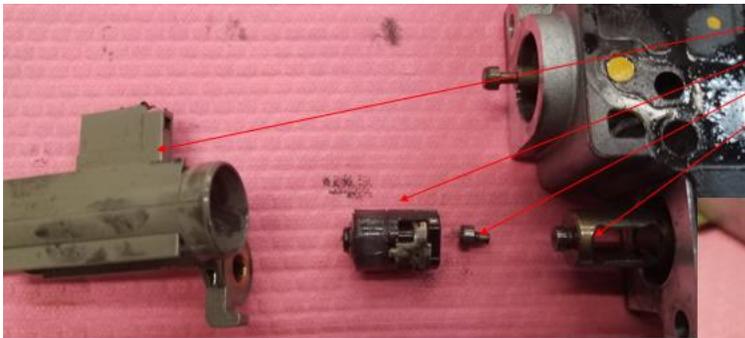
Switch
Magnet
Knob broken off valve
Valve

So the magnet hangs on the knob on the end of the valve. As you can see when the knob breaks off the valve that is when the magnet falls off. The magnet nor the valve are serviceable so when it breaks off the only repair is to replace the valve body.
