GM TECHNICAL ASSISTANCE CENTER (TAC)

Dealer Tips and New Information Newsletter

May 10, 2022

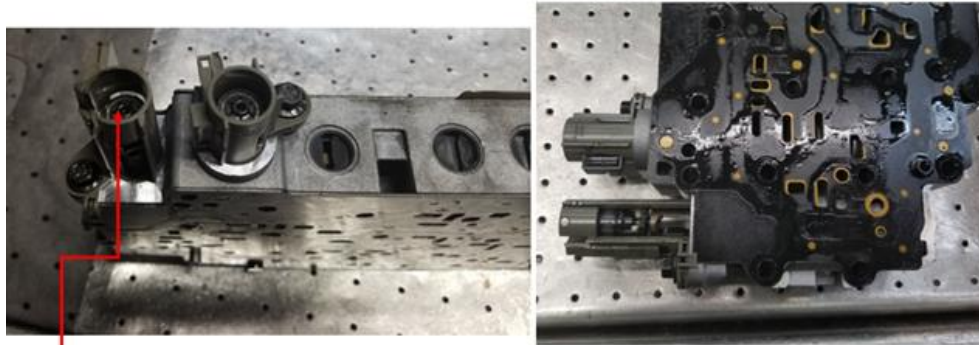
1) 9Txx Transmission with ETRS Setting DTC P187E

If a vehicle with a 9Txx transmission with ETRS is setting DTC P187E, the following images may help with the diagnosis.

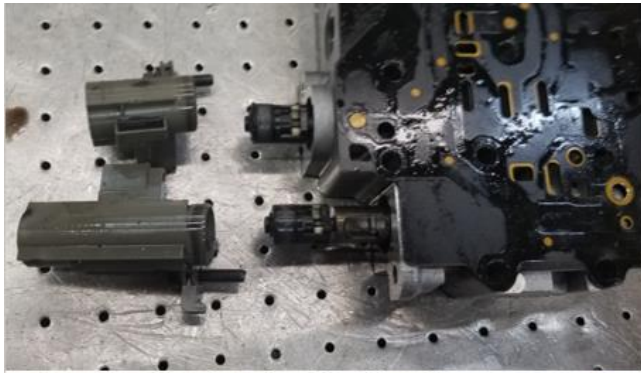
Here are the magnets that are attached to the valves in their natural state.
If these magnets are all the way out to the end of the switch, the valve is stuck.

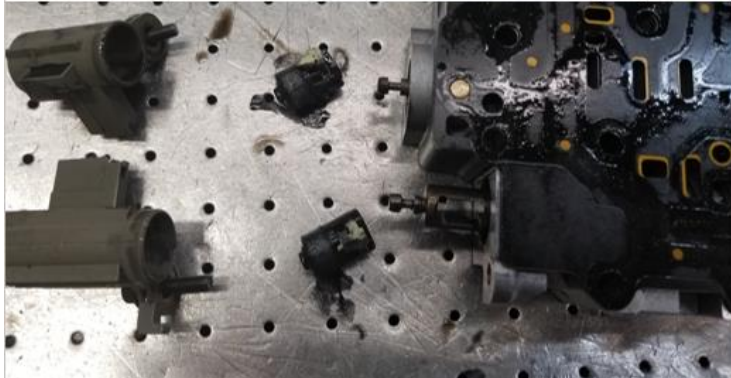
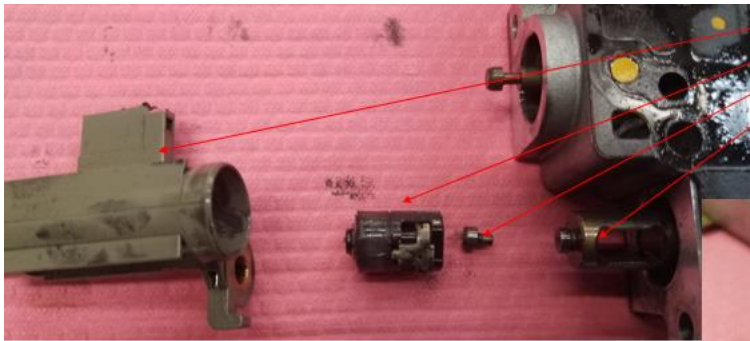
Top picture is when the switch is removed.
The bottom picture is when the magnets are removed from the valve.

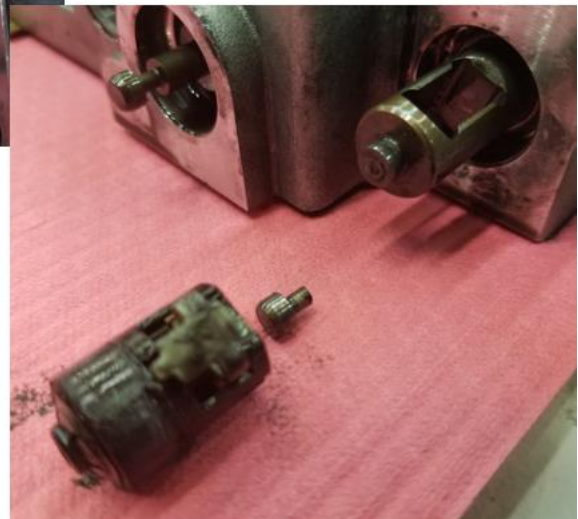
Switch
Magnet
Knob broken off valve
Valve

So the magnet hangs on the knob on the end of the valve. As you can see when the knob breaks off the valve that is when the magnet falls off. The magnet nor the valve are serviceable so when it breaks off the only repair is to replace the valve body.
