# DCBS Becomes Essential Equipment

## MIDTRONICS GR8 TO BE DISCONTINUED IN 2024

## TECH LINK

GM TechLink is published for all GM retail technicians and service consultants to provide timely information to help increase knowledge about GM products and improve the performance of the service department.

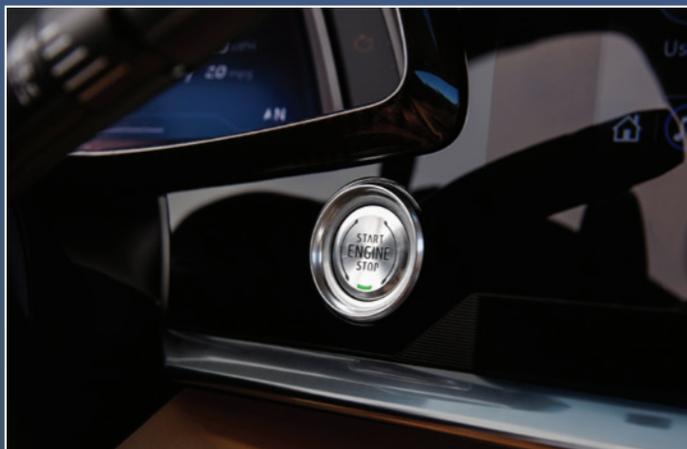
Some 2020-2022 Corvette models may have a Service Transmission message on the Driver Information Center (DIC), an illuminated Check Engine MIL and a squealing sound immediately after starting the engine. DTC P0700 (Transmission Control Module Requested Malfunction Indicator Lamp Illumination) may be stored in the Engine Control Module (ECM) and DTC P0606 (Control Module Processor Performance) or P0607 (Control Module Performance) may be stored in history in the Transmission Control Module (TCM). Other P codes also may be set. This condition will be present on vehicle start up only and not when the vehicle is in motion.

The DIC transmission message and possible squealing sound are default actions of the DTC as the TCM is in a defaulted state and may not be controlling line pressure, resulting in the transmission operating a maximum line pressure.

The DTCs may set on vehicle start up only.

DTC P0700 is an informational DTC. Do not replace the control module if DTC P0700 is set.

If DTC P0606 or P0607 is set as a current DTC in the TCM, without other DTCs set, follow the published diagnostics in the appropriate Service Information. The condition should be resolved by allowing the vehicle to go through a complete sleep cycle (i.e., 15 minutes). Explain to customers that they can complete this process if they experience the condition again before a correction is available.

If DTC P0606 or P0607 is set as a history DTC in the TCM with other P codes (e.g., P07E5 or P07E6), the other codes are a byproduct of the controller state. Do not replace the TCM for P0606/P0607 when other P codes are present or when DTCs P0606/P0607 are in history. If DTCs P0606/P0607 are in history, clear the codes and test drive the vehicle to make sure the DTCs do not return. If the DTCs do not set again, return the vehicle to the customer. Permanent repair information will be released when available.

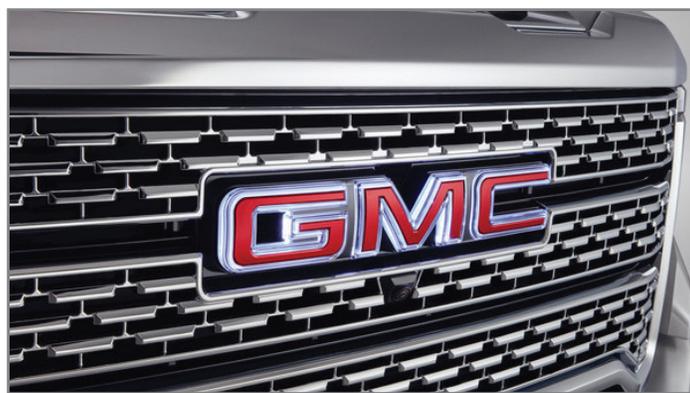
Some 2020-2022 Sierra 1500, Sierra 2500/3500; and 2021-2022 Yukon models may have a driver-side headlamp or turn signal that stays on, flickers or is inoperative. The dealer-installed GM Accessory Illuminated Emblem also may be inoperative. These conditions may be caused by water intrusion from the GM Accessory Illuminated Emblem.

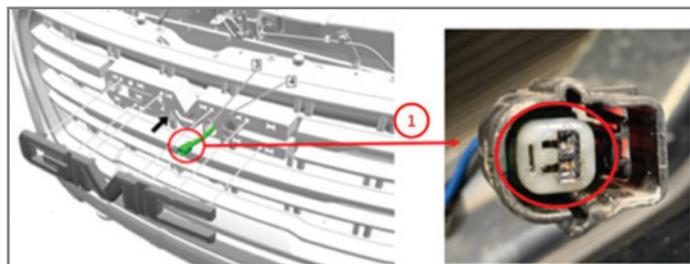
Inspect for water intrusion and corrosion at the GM Accessory Illuminated Emblem connection as well as the driver-side headlamp connector and the inline GM Accessory Illuminated Emblem harness.

If water intrusion or corrosion is found, perform any necessary repairs to the headlamp connector on the body harness and clean the headlamp assembly terminals.

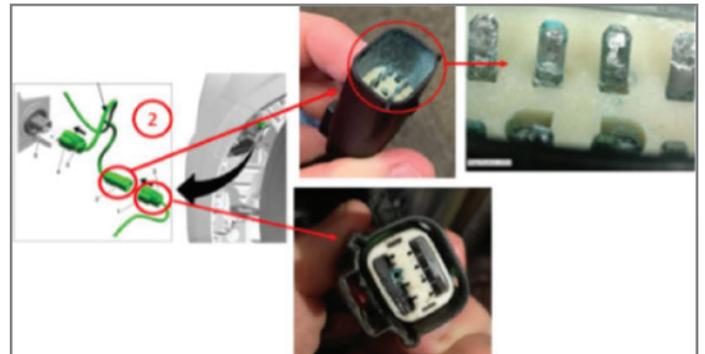
Driver-side headlight connector and the inline GM Accessory Illuminated Emblem harness

**TIP:** The headlamp assembly is not currently known to be a source of the water intrusion.

To prevent further improper operation, bypass the GM Accessory Illuminated Emblem harness by plugging the original headlamp connector from the body harness back into the headlamp

assembly. This will temporarily disable the Illuminated Emblem. Permanent repair information will be released when available.
