GM TECHNICAL ASSISTANCE CENTER (TAC)

Dealer Tips and New Information Newsletter

June 14, 2022

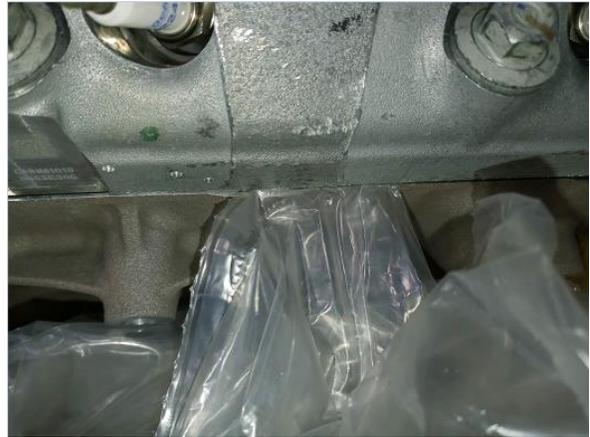
3) Service V8 Engine Pinched Plastic Covering

If you encounter a new replacement V8 engine with part of the plastic covering pinched between the engine and the cylinder head, do not replace the engine.

Remove the affected cylinder head(s), remove the plastic, and replace the head gasket(s) and bolts. The plastic likely was pinched when validated lifters were installed after the engine was already assembled and secured to the crate.

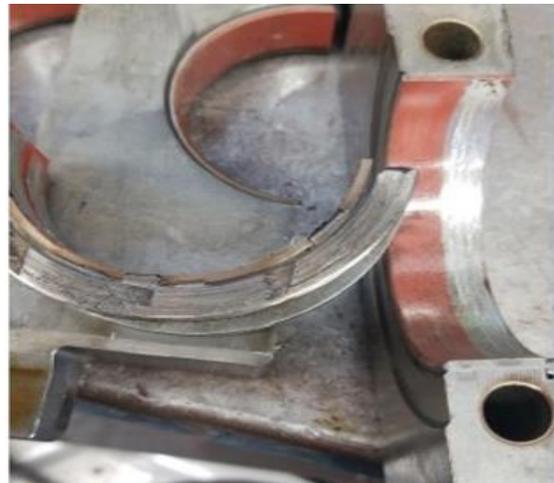
4) New Small Block Bearing Failures have been Identified

Thrust Bearing Failures on 2020 – 2021 model year applications, 6.2L engine RPOs L86/L87/LT2/LT1 and the 6.6L LT8.

These engines were built in the December 2020 to February 2021 time frame. Issues seem to be more prevalent at two specific engine plants, but all plants had an increase in issues between March and April 2021.

The issue can be identified by a thumping, knock, or tap-type noise coming from the lower engine area. Upon inspection, there may be excessive crankshaft endplay along with the #3 main bearing (thrust bearing) being damaged or the side “wing” of the bearing being out of place. Engine replacement is the correct repair for this issue.

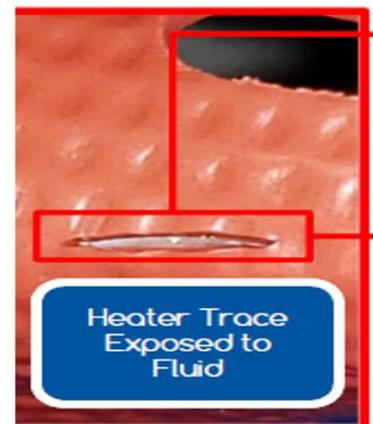
If the vehicle returns, it is likely due to the heater inside the DEF tank having been exposed to DEF fluid. **Bulletin #21-NA-002** illustrates how to test for this condition. If a vehicle fails this test, a new DEF tank will be required to repair the vehicle.

Here is an example of a heater that would set the code if it was in a tank and exposed to DEF. GM now has a different supplier making these heater mats for both production and service.

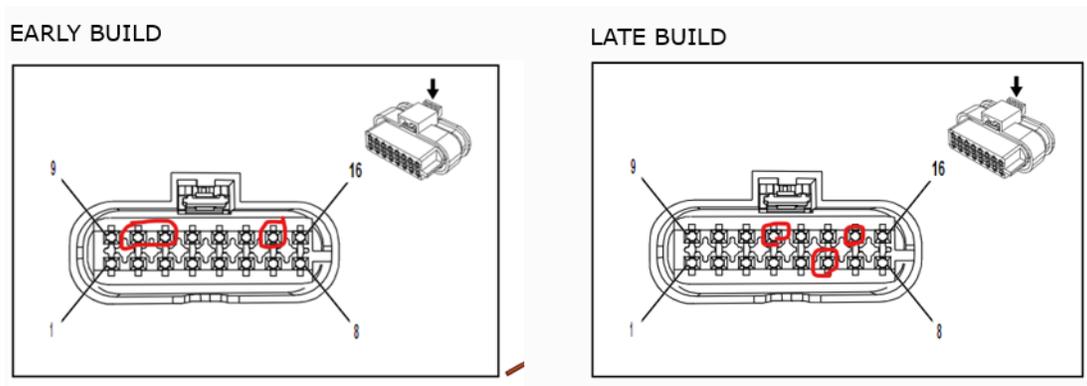
On a vehicle setting DTC P20C1, P21DD, P221C, P10D9, P10F3, P143C, P20B9, and/or P221E, it is likely that the electrical connector is damaged at the DEF pump assembly and the DEF tank harness. This damage is illustrated in **Bulletin #21-NA-006**. GM has taken two actions to mitigate this issue:

- 1) There is an update to the DEF controller that will lower the amperage to the DEF tank heaters. The DEF controller update was released in N212342980. It is also included in the latest calibration for the DEF controller.
- 2) There is a pinout change in the DEF harness connector at the pump module and in the module itself. The pinout change has been in production since the first of the year. Therefore, there is a first- and second-design schematic for model year 2022. Around the same time, this same change was made to all service parts. Any part ordered today and going forward will have this change. The following illustration shows how the pin locations have changed.

When testing or servicing a DEF tank that has already been replaced, it is important to keep the change in pinout in mind. Service Information will not show a schematic for the change in pin location for model year 2020 or 2021, but **#PIP5838** discusses this change. The same change will be coming in the LM2 pickup trucks followed by the LM2 SUVs. Once these changes have occurred, **#PIP5838** will be deleted and a bulletin will be released.

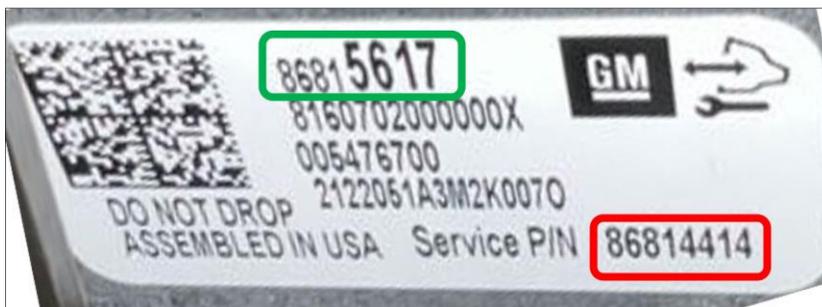
4) **Front Camera Module**

On some 2022 trucks, when ordering a replacement front camera module at rear view, for any reason, the current module may have a mislabeled service part number (86814414 is for HUMMER EV only). Order the new module in the EPC by the VIN being working on, not the listed service part number on the module.
