*Reducing Wi-Fi Interference
in the Service Department. 2*

*Common Customer
Trailer-Side Faults When
Using the Trailing App 8*

*Intermittent Click Sound at
the Front of the Vehicle. 10*

TECH LINK

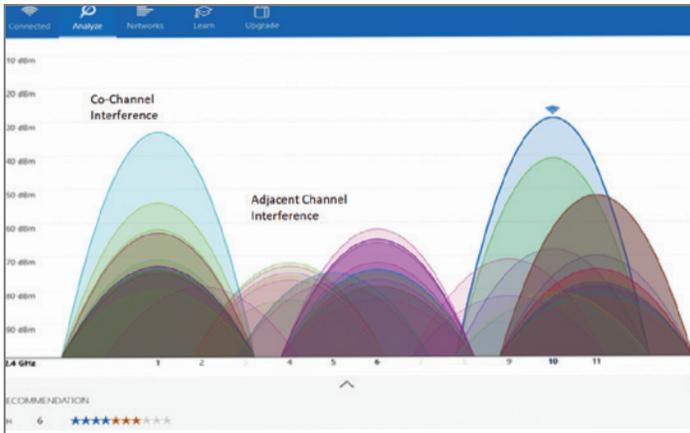
Example of a very crowded Wi-Fi environment that will cause slow responses and even failure to connect to devices.

- Avoid using too many wireless devices at the same time within proximity of each other.
- If possible, configure your MDI 2 to use Wireless Access Point Mode via the MDI Manager.
- In ideal environments, Wireless Access Points sharing the same channel should be spaced apart far enough that their area of effect does not reach one another. Failing to maintain adequate spacing when using the same channel will cause signal interference.

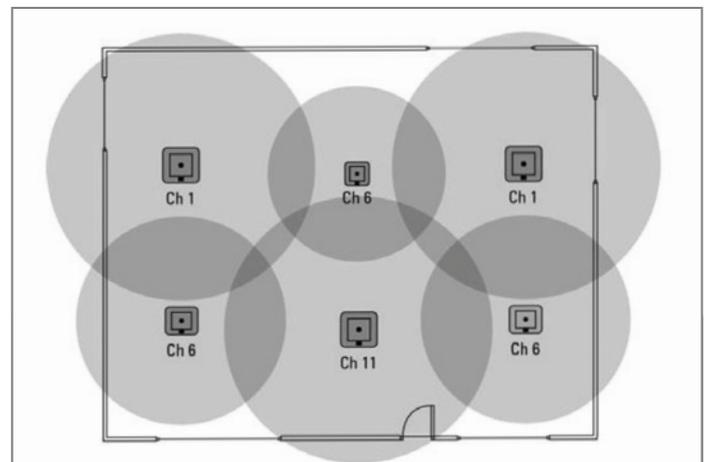
Wireless Access Points sharing the same channel should be spaced apart.

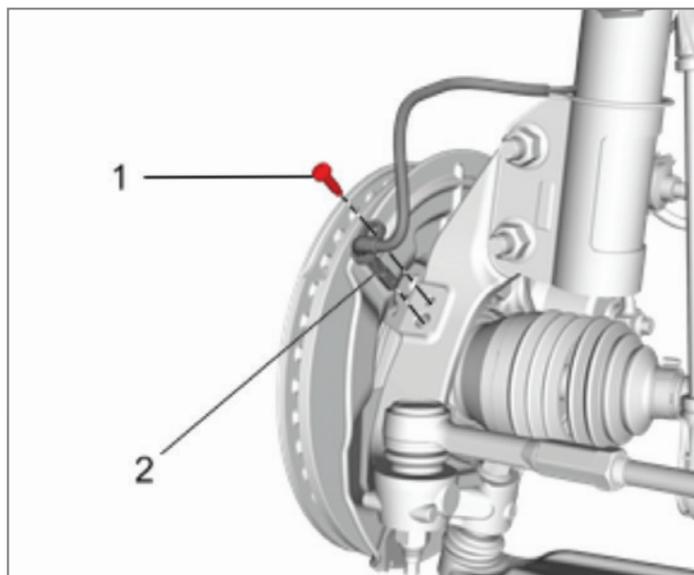
Some 2017-2019 Bolt EVs may have an intermittent click sound at the front of the vehicle and the ABS, traction control and/or StabiliTrack warning lamps may illuminate on the instrument cluster. DTC P215B (Vehicle Speed – Output Shaft Speed Not Plausible) may be set along with wheel speed sensor DTCs C0035–C0051. These conditions may be caused by the fracturing of the front-wheel drive shaft anti-click washer, which also may result in possible damage to the ABS wheel speed sensor (WSS).

Also inspect the wheel speed sensor for any damage that may have been caused by contact with the oversized washer and replace the sensor if needed. If the wheel speed sensor is not damaged, reinstall the lower control arm to the steering knuckle.

Replace the wheel speed sensor (#2) if damaged.

After verifying these conditions, replace the anti-click washer on the affected half shaft and then inspect the wheel speed sensor. If DTC P215B is set, the wheel speed sensor should be replaced.

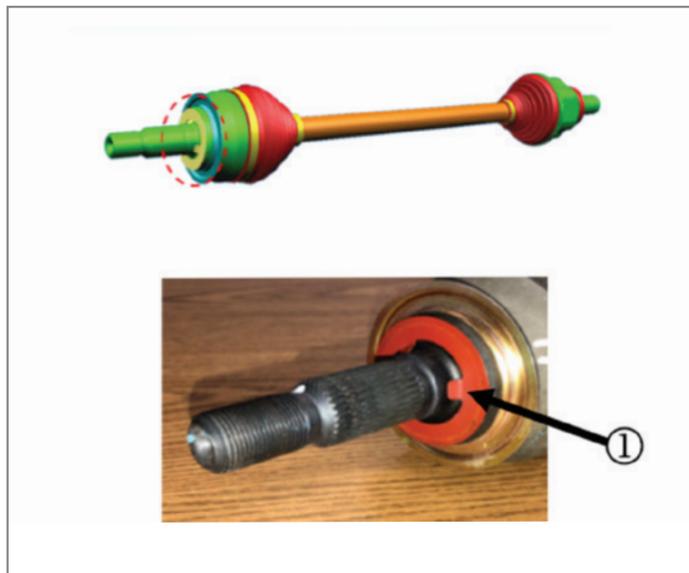
Front-wheel drive shaft anti-click washer (#1)

To check the anti-click washer on each front-wheel drive shaft, separate the lower control arm from the steering knuckle and remove the anti-click washer from the outboard joint of the half shaft.

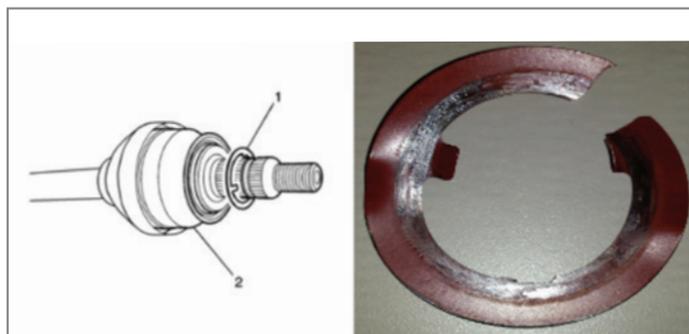
Remove the anti-click washer from the outboard joint of the half shaft.

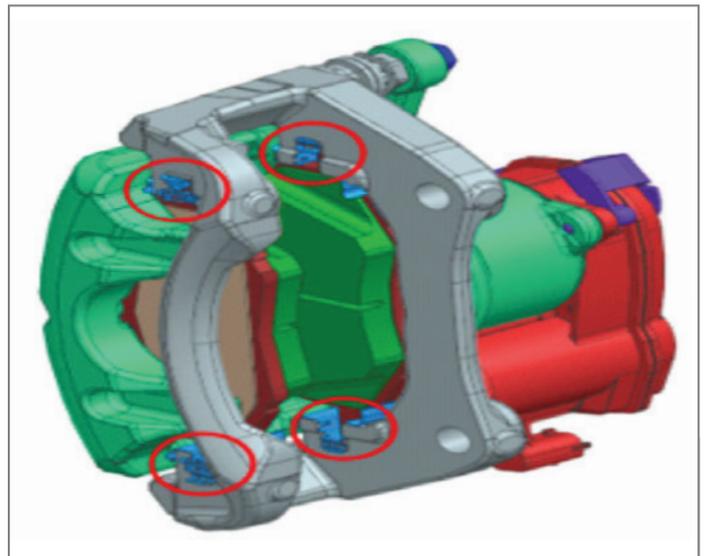
Some 2020-2022 Encore GX and 2021-2022 Trailblazer models may have a squealing sound originating from the front of the vehicle during light brake pedal application. The sound may occur at low speeds when the brakes are first applied or lightly applied, such as when exiting a parking lot or during first use after sitting overnight.

There are four pad abutments per caliper.

For 2020-2021 Encore GX and 2021 Trailblazer models built before March 20, 2020, apply grease on the caliper pad spring abutments and anti-rattle clips as well as replace the front brake pads and front disc pad wear sensors. Only Encore GX models are equipped with brake wear sensors.

For 2021-2022 Encore GX and Trailblazer models built between March 20, 2020 and February 14, 2022, remove the original front disc brake pads, apply grease on the caliper pad spring abutments and anti-rattle clips, and reinstall the pads.

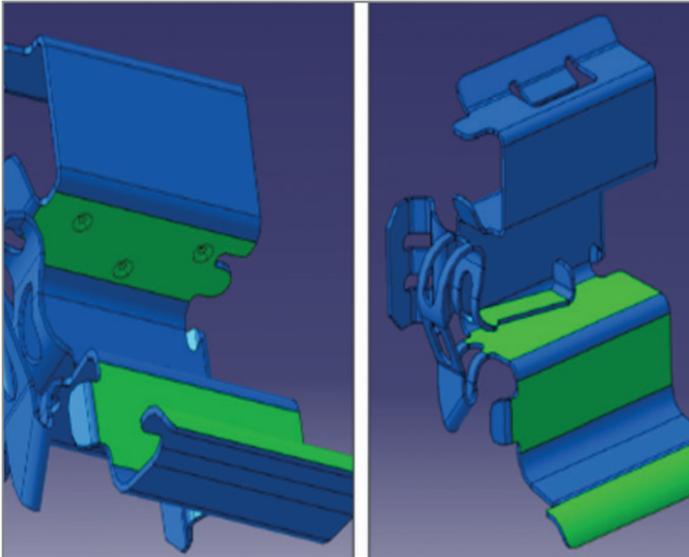
Green areas indicate the locations where grease should be applied.

Be sure to clean the pad spring abutment area on the caliper and anti-rattle clip before applying Molykote M-77 Grease. Apply

approximately 1.1 g of grease per caliper.

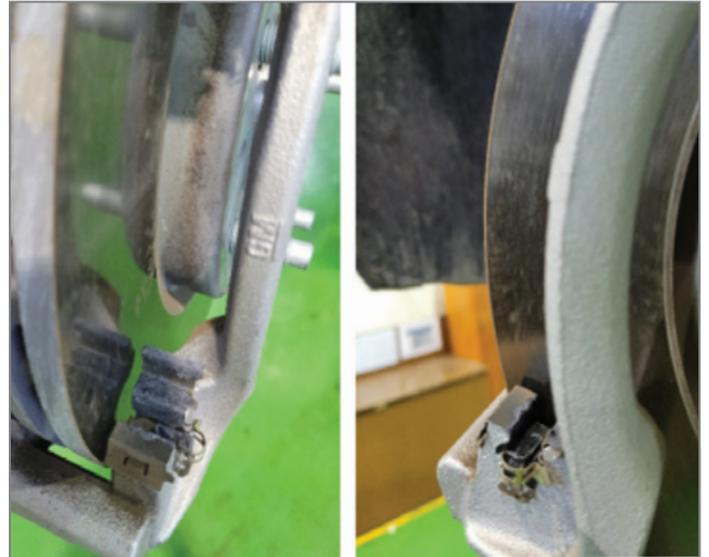
Apply grease to the pad spring abutment area on the caliper and anti-rattle clip.
