GM TECHNICAL ASSISTANCE CENTER (TAC)

Dealer Tips and New Information Newsletter

July 18, 2022

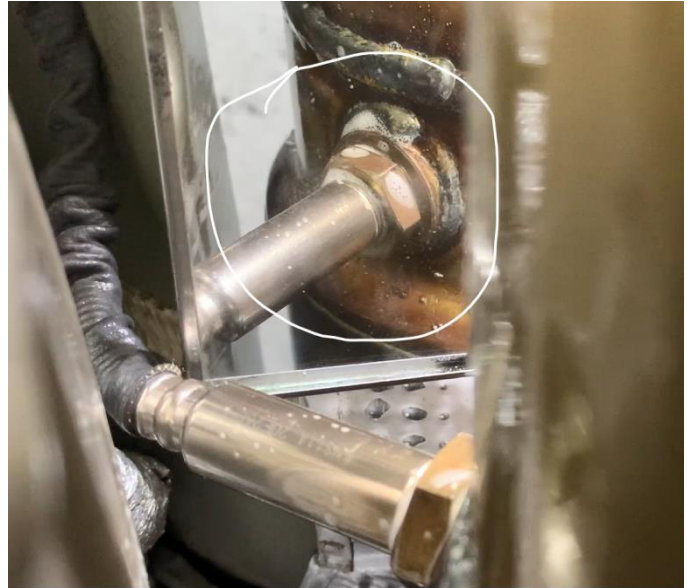
Recent TAC and Field Service Engineering cases for exhaust leaks have shown no leaks found after smoking the exhaust. For small leaks, it is imperative to use soapy water around all connections and sensors because a small leak will not always show smoke. Please make sure to review an induction system leak indication ratio as well as check the system using soapy water.

Shown is a picture of NOX 3 leaking that was only found using soapy water.

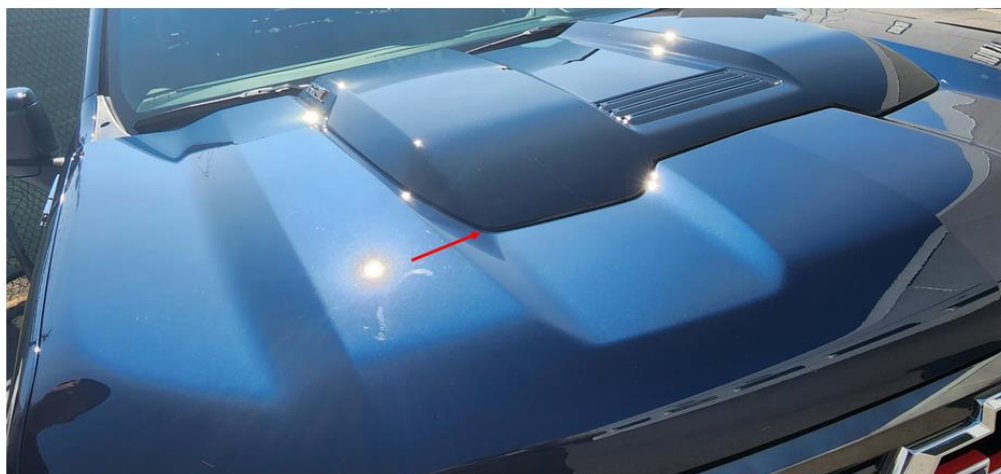
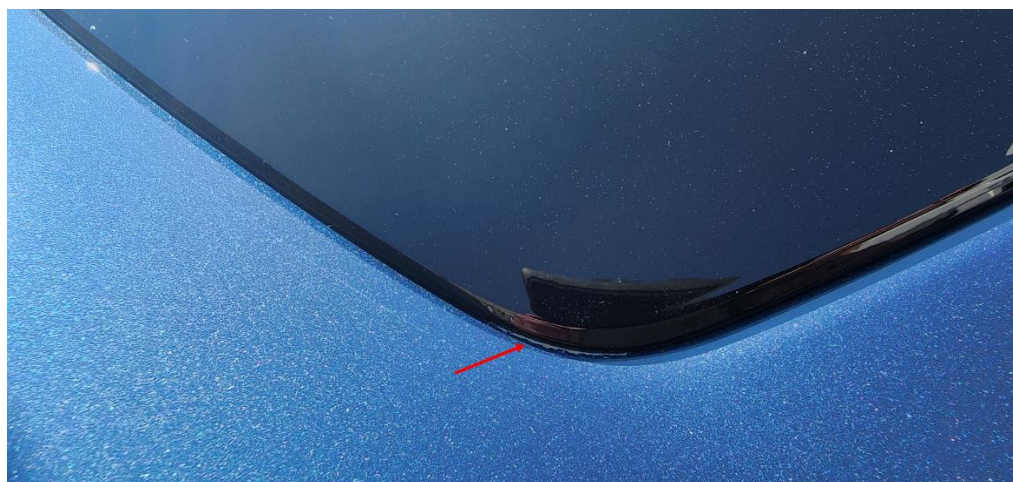
1) Hood Paint Damage at the Edges of the Hood Center Molding

Brand:	Model:	Model Years:	VIN:		Engine:	Transmissions:
			from	to		
Chevrolet	Silverado 1500 New(RPO J22, VIN Digit 5 = A or D)	2022	All	All	All	All
Involved Region or Country	North America					
Additional Options (RPO)						
Condition	Some customers may notice the hood paint is damaged or chipped where the edge of the center hood molding contacts the hood, as shown below.					
Cause	Insufficient clearance between the center hood molding and hood.

A PI is available for this issue on 2022 Silverado 1500 New (RPO J22, VIN Digit 5 = A or D). Engineering is investigating. Additional repair information will be released when available.

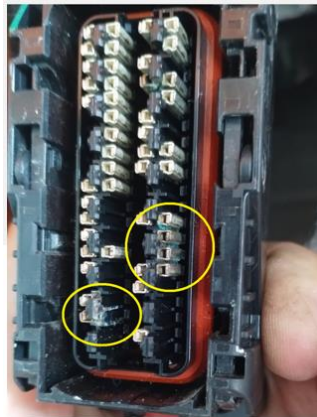
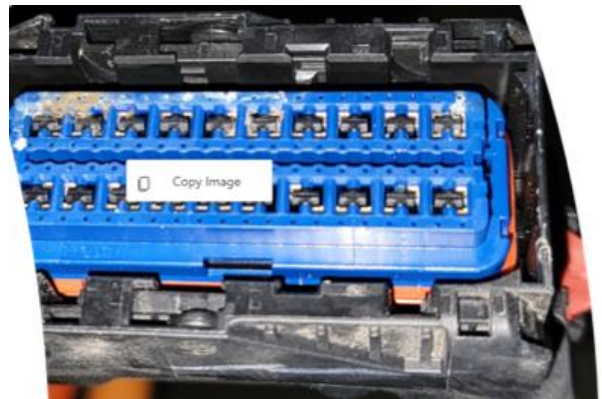
3) Hummer EV

There have been several concerns with water getting into the BECM1. So far, the most common DTC is P0D58, but this could affect any circuit going to the BECM1. It's necessary to remove the terminal cover to inspect the terminals.
