Camshaft Sliding Lobe Pack Binding..... 5

Cooling Fan Speed Too Low Condition..... 6

Residue on Liftgate Strut is not a Fluid Leak..... 6

TECH LINK

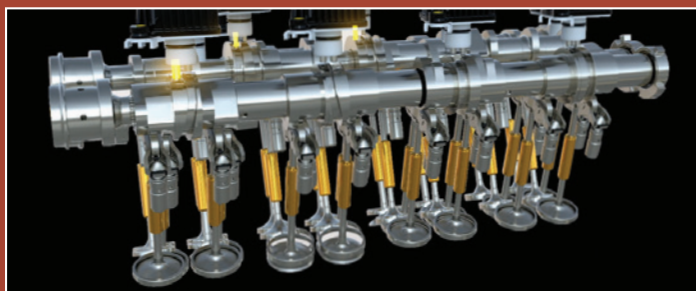
Some low-mileage 2022 Silverado, Sierra and CT4-V models equipped with the 2.7L turbocharged engine (RPO L3B) may have DTC P30BF (Intake Camshaft Profile Sleeve Position Sensor Performance) set in the Engine Control Module and an illuminated Check Engine MIL. The affected engines usually have less than 5,000 miles.

If these conditions are found, the cylinder 1 / 2 sliding lobe pack may be binding on the intake camshaft of the Sliding Cam Valve Lift system.

Follow the diagnostics in the appropriate Service Information for DTC P30BF. If the diagnostics are inconclusive, replace the intake camshaft, intake cam actuator and actuator solenoid valve bolt.

Once repairs are completed, clear any DTCs and evaluate engine operation.

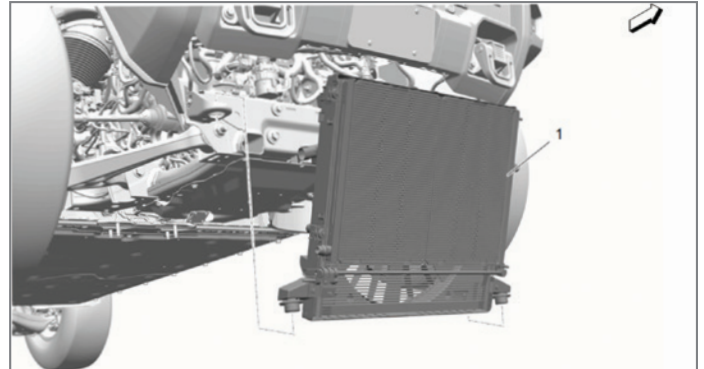
While fording a river with the 2022 HUMMER EV pickup, an excessive amount of water may slow or stop the cooling fan from spinning, which may cause DTC P0494 (Cooling Fan Speed Too Low) to set in the Battery Energy Control Module. A Service High Voltage System message may be displayed on the instrument cluster along with an illuminated Service Vehicle Soon MIL.

These conditions do not require replacement of the cooling fan motor or indicate an issue with the high-voltage battery system. After a key cycle or during the same key cycle, if the cooling fan is commanded on again, the condition will no longer be

The cooling fan is part of an assembly at the front of the vehicle.

To verify fan operation, command the fan on using GDS2. The air conditioning condenser, cooling fan and radiator are an assembly at the front of the vehicle. If the fan operates normally, clear the DTC. Do not replace any parts for this condition.

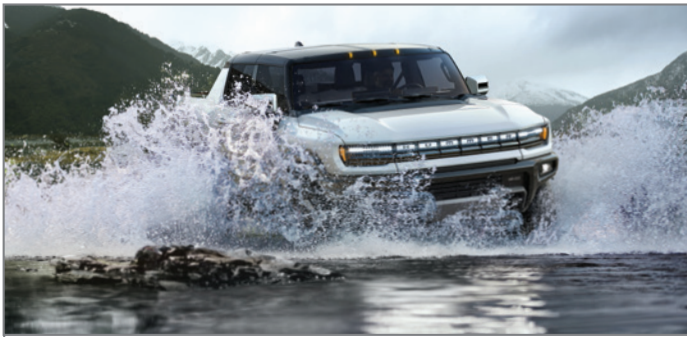
Excessive water may temporarily affect cooling fan operation.

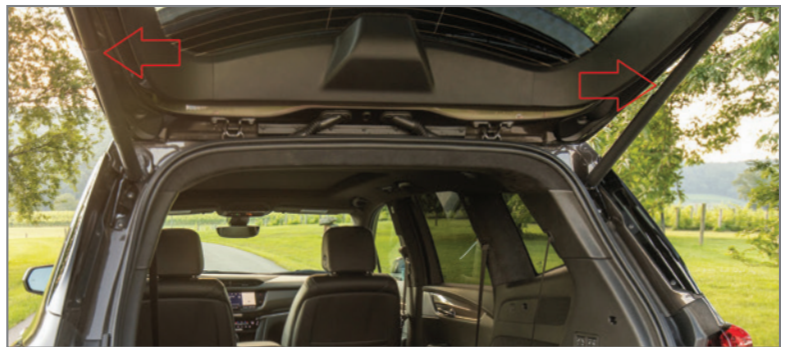
Residue on the rear liftgate strut of some 2018-2020 Enclave, Traverse; 2020-2022 Acadia, XT5 and XT6 models is not a fluid leak that requires strut replacement. The residue is typically extra padded grease from the boot that is used to help reduce noise from movement of the strut during operation.

In some cases, the residue may be mistaken as a leak of hydraulic fluid that would assist with the pressure of the actuator. The rear liftgate struts on these models do not contain any fluid for their mechanical functionality. The residue on the struts does not affect the operation of the parts. Any extra grease seen on the struts has simply worked its way out due to added pressure on the boot.

Any residue on the struts is not a fluid leak.

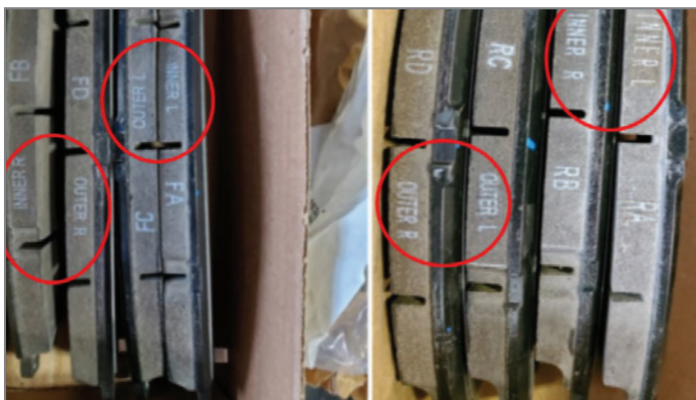
A brake squeal condition may be heard on some 2020-2022 Silverado 2500HD/3500HD and Sierra 2500HD/3500HD models. The brake noise may be caused by the lining shim friction material used on the brake pads.

Each brake pad has an Inner or Outer label.

TIP: If the pads are replaced and the squeal sound is still present, check the orientation of the pads. Each brake pad has an Inner or Outer designation to indicate where it should be installed. If the inboard and outboard pads are installed in the wrong location, it can result in brake noise.

Replace the front and rear brake pads with the new pads if there is a brake noise concern. Current parts in inventory are the updated design.

To increase the effectiveness of the new brake pads, a brake burnish should be performed during the test drive after installation to properly prepare the pads to the rotors. Refer to

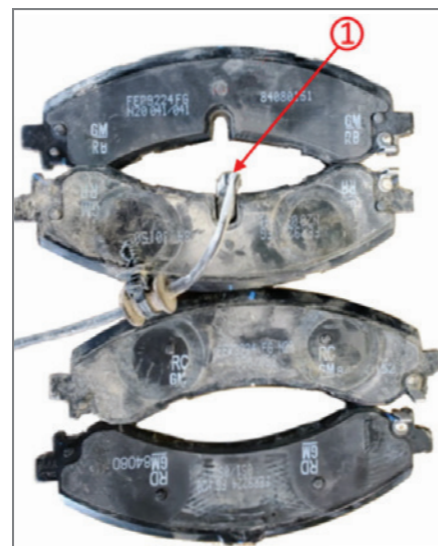
Only the left side of the truck has the wear sensors.

During installation, keep in mind that only the left side of the truck has the wear sensors, which are mounted on the inner pad. Refer to Front and Rear Disc Brake Pads Replacement in the appropriate Service Information.

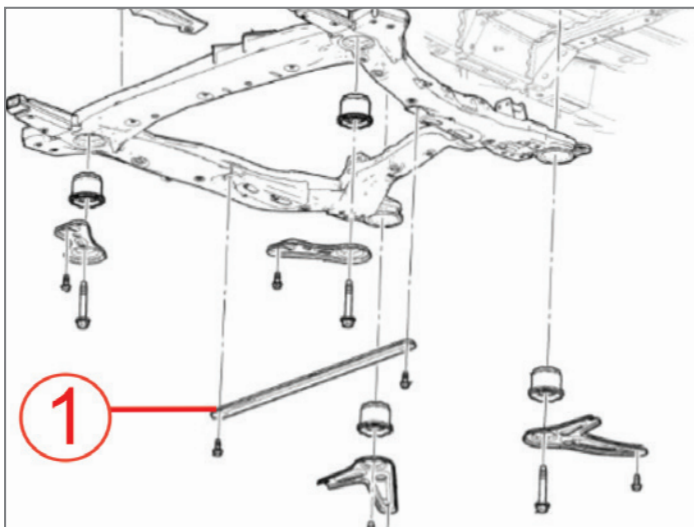
A rattle or clunk sound may be heard at the front of the vehicle on some 2017-2023 Acadia; 2018-2023 Traverse; 2019-2023 Blazer; and 2020-2023 XT5 models. The sound may seem to be coming from a strut, control arm or sway bar. It may be possible to duplicate the concern by driving the vehicle over bumps or making turning maneuvers.

The cradle brace (#1) is a flat bar bolted across the cradle.

The rattle or clunk sound may be the result of a loose, mispositioned or improperly torqued cradle brace. The cradle brace is a flat bar that is bolted across the cradle.

If the rattle or clunk sound is heard, check the position of the cradle brace. To verify the source of the sound, remove the cradle brace and drive the vehicle under conditions that will cause the sound. If the sound is no longer heard while driving with the brace removed, reinstall the brace and torque it to the proper specification.

TIP: Do not simply torque the cradle brace to specification. The cradle brace bolts are torque-to-yield (single use) fasteners. New fasteners must be used when installing the brace. Be sure to remove and reinstall the brace with new torque-to-yield fasteners before torquing the bolts to specification.
