## 2023 Battery Ratings Chart and Battery Maintenance FAQs Update

## TECH LINK

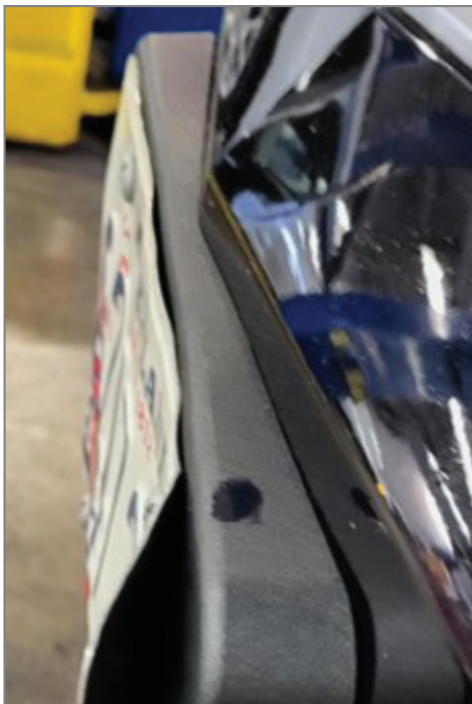
Exterior interference, such as a bent license plate, may affect proper object detection.

A recent example from a dealership was a damaged front license plate with bent corners that was affecting system operation and resulting in a collision warning without anything in front of the vehicle. Exterior conditions or objects, even a small bend in a license plate or a dirty camera or sensor, can affect the Driver Assistance systems.

In this particular case, when the front license plate, not the bracket, was removed, the symptoms were no longer present and the Forward Collision Alert system operated properly.

If a false collision warning is present, perform a visual inspection of the vehicle to check for any conditions that may interfere with correct vehicle or object detection by the system. Refer to the diagnostic aids in the appropriate Service Information for more information.

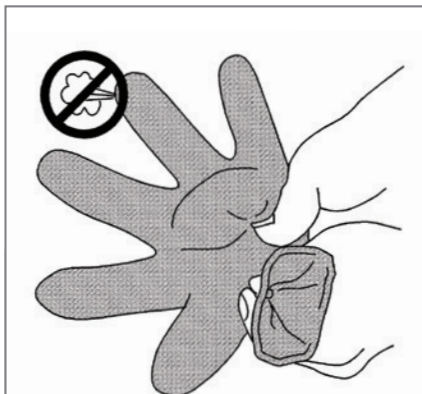
Inspect the gloves for any air leak or wear.

Inspect the insulation gloves by trapping air in the glove and sealing the opening to prevent any air loss. While pressing the glove to increase pressure, check for any pin holes, air leaks, wear or abrasions as well as any swelling that could indicate exposure to chemicals.

If glove damage is observed, do not use the gloves and have them tested and recertified or replace them.

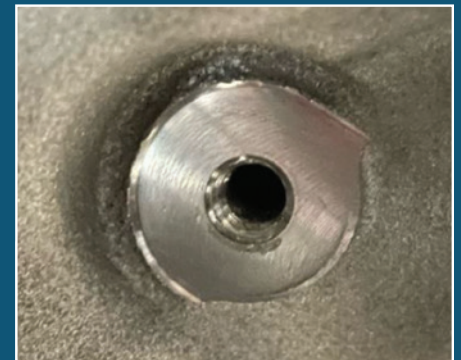
Some 2022 Camaro, Colorado, Acadia, Canyon, XT5 and XT6 models equipped with the 3.6L V6 engine (RPO LGX, LGZ) may have an illuminated Check Engine MIL along with DTC P0331 (Knock Sensor 2 Performance) set in the Engine Control Module at low mileage. These conditions may be caused by metal around the knock sensor boss on the left side of the engine block that allows contact with the plastic covering the knock sensor.

Block flashing around the knock sensor boss

If these conditions are found, in addition to replacing the knock sensor, check for block flashing (excessive block material) around the knock sensor boss that may contact the knock sensor black plastic. If there is block flashing, use a flat or half-round hand file to remove the flashing so it will not contact the sensor plastic. Do not mar the knock sensor mating surface, which may affect the accuracy of the knock sensor readings.

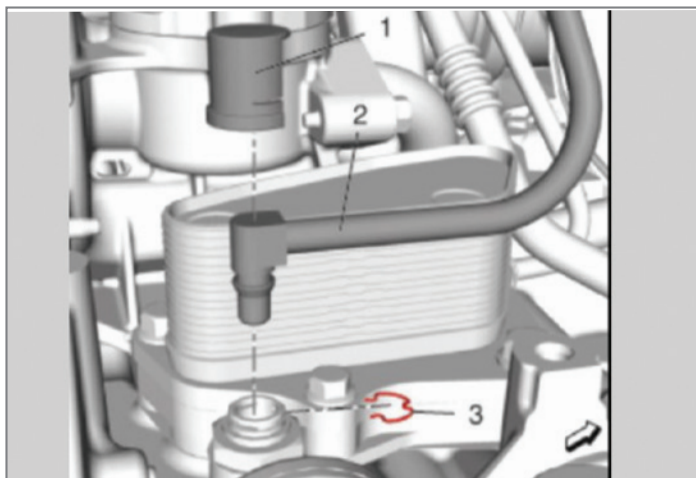
The leak may appear to be related to the lower-crankcase extension to block-sealing surfaces or to block porosity. However, warranty analysis shows that this oil leak may be coming from the turbocharger oil feed pipe fitting at the engine block or from the engine oil cooler gasket.

Block-mounted turbocharger oil feed pipe fitting

Prior to removing the lower crankcase extension or replacing the engine, determine if the turbocharger oil feed pipe fitting or the engine oil cooler gasket is the source of the leak.

If the turbocharger oil feed pipe fitting is removed from the engine block for inspection, the fitting and gasket must be replaced.

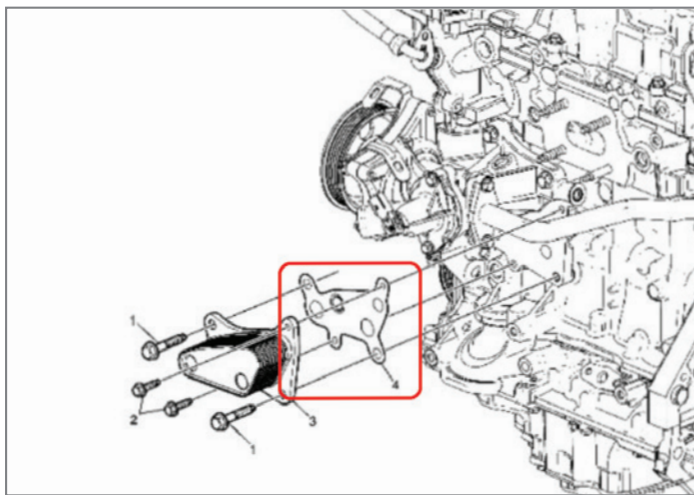
Engine oil cooler gasket (#4)

Check the engine oil cooler gasket and the turbocharger oil feed pipe fitting in the block just below the engine oil cooler. If the engine oil cooler is removed for inspection, the gasket must be replaced.

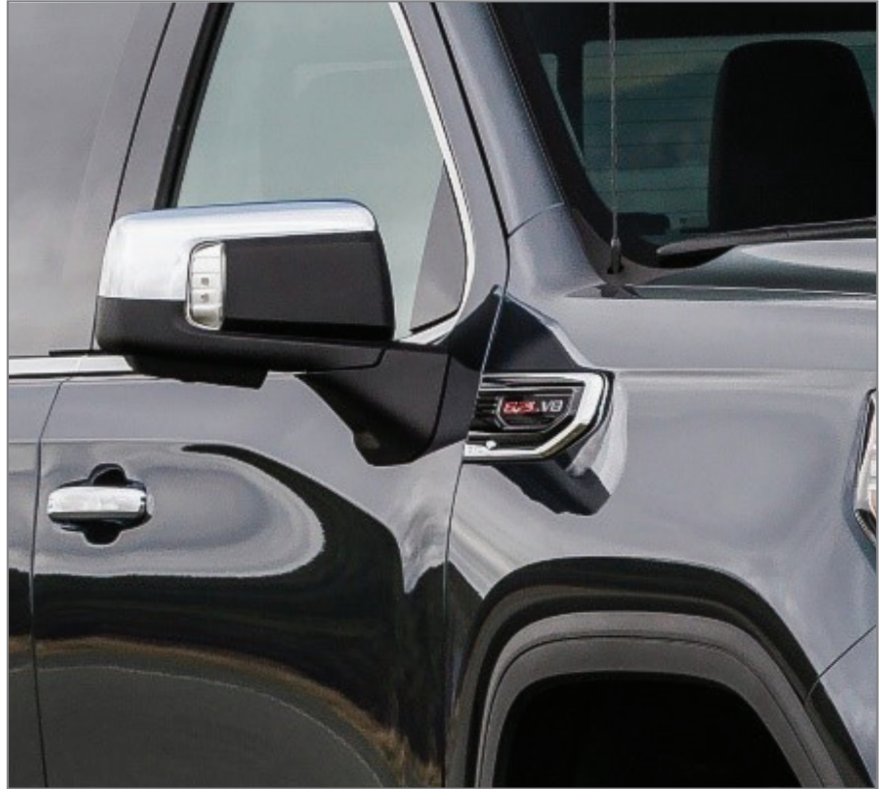
Power folding mirror

If the power folding mirrors appear to not be in sync, it's important to note that even though the power folding mechanism for the outside mirrors runs at the same speed on both sides of the vehicle, the passenger-side mirror will complete the folding maneuver faster since it has a shorter folding distance.

Do not replace the mirrors for a power folding speed concern. This is a normal operating characteristic of the power folding mirrors and the system is functioning as designed. The operating speed of the power folding mirrors should be shared with customers.
