GM TECHNICAL ASSISTANCE CENTER (TAC)

Dealer Tips and New Information Newsletter

September 16, 2022

1. FAM 0 Engine (RPO LUV) Intake Manifold Redesign Inspection and Familiarization

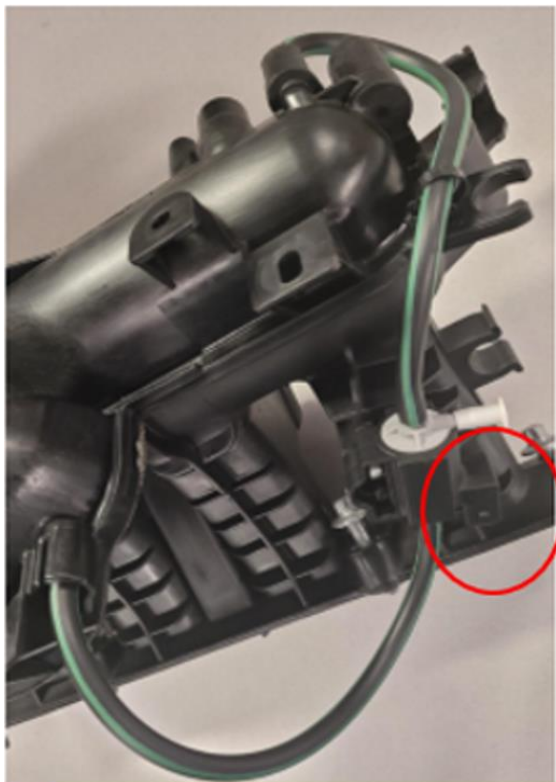
(Above) New Design - incorrect solenoid installation.

Note the electrical receptacle location. Remove and reinstall the lines and solenoid as they are retained to the intake if installed incorrectly. Tabs reversed. The solenoid is keyed and will not be seated in retainers.

If the solenoid is found to be loose, review the location of the electrical connector. If the connector is facing the cylinder head, it is installed backwards and will need to be removed and installed correctly.

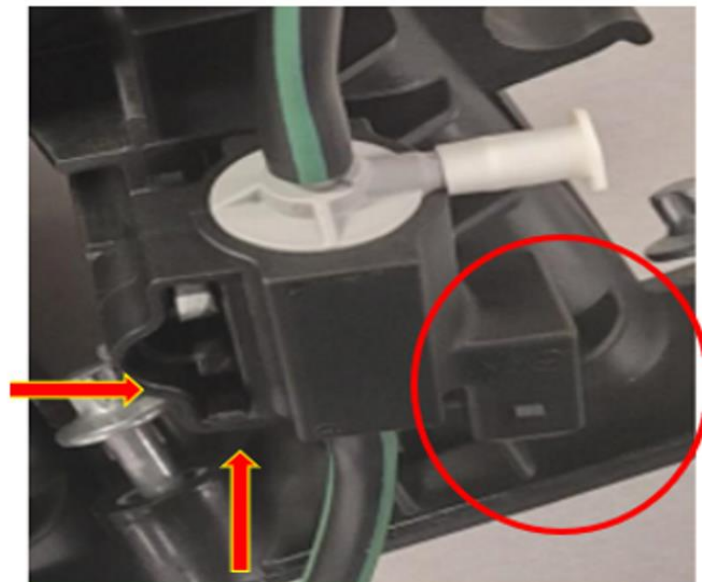
Solenoid- Incorrect install- retainers not seated connector facing cylinder head Keyed section of intake not level with solenoid body

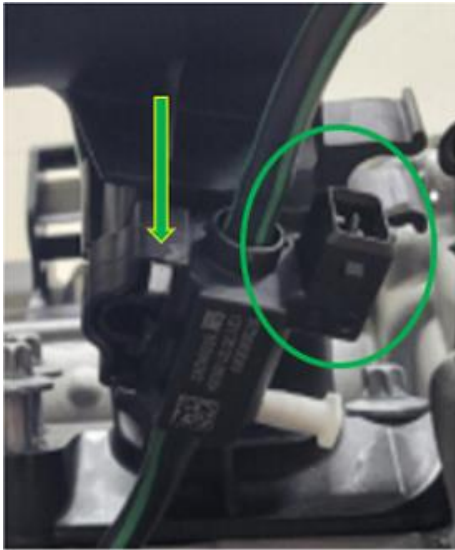
Solenoid connector correct installation retainers latched Keyed section of intake almost even with solenoid

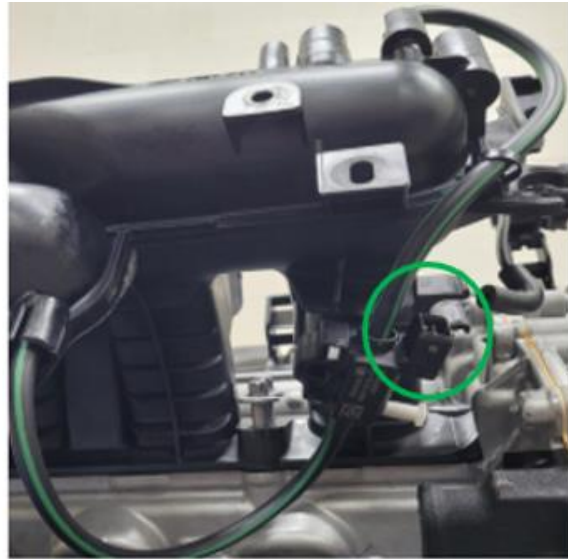
New Design - correct solenoid installation correct connector positioning

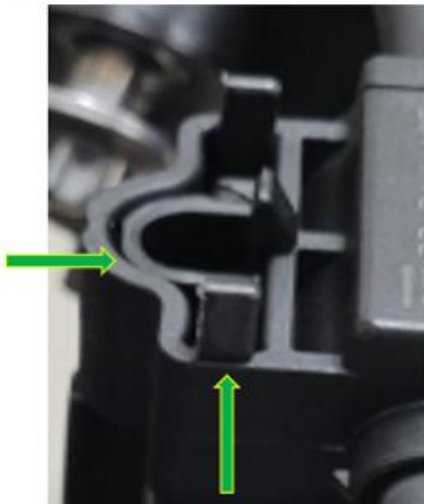
Correct and seated

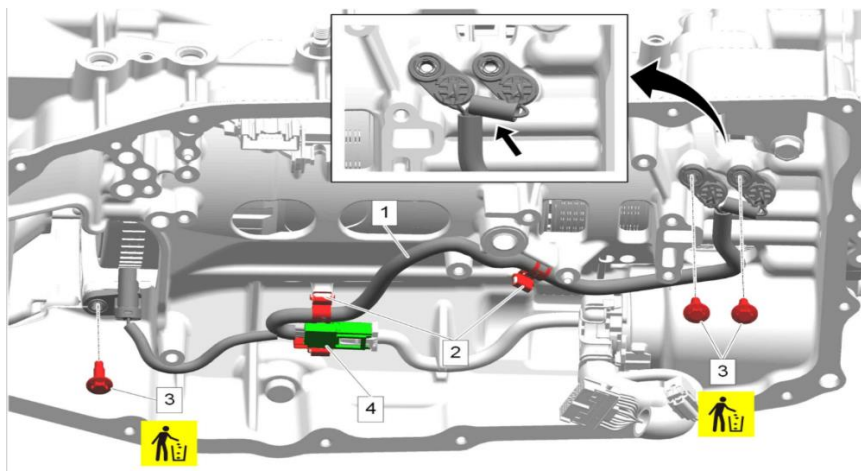
For 8LXX speed sensor wiring harnesses, SI shows different wire colors than what will likely be on the actual harness. On an 8L45 transmission, the replacement harness colors may not match what SI shows. However, the colors match up on the schematic for an 8L90 transmission. The same harness is being used in both applications.

When determining intermediate speed sensor and OSS location, do NOT use wire color, which will lead to the assumption that the incorrect harness has been installed. Instead, use the routing of the conduit as shown below.
