Checking for Exhaust System Leaks

Checking for Exhaust System Leaks..... 2

GM TechLink is published for all GM retail technicians and service consultants to provide timely information to help increase knowledge about GM products and improve the performance of the service department.

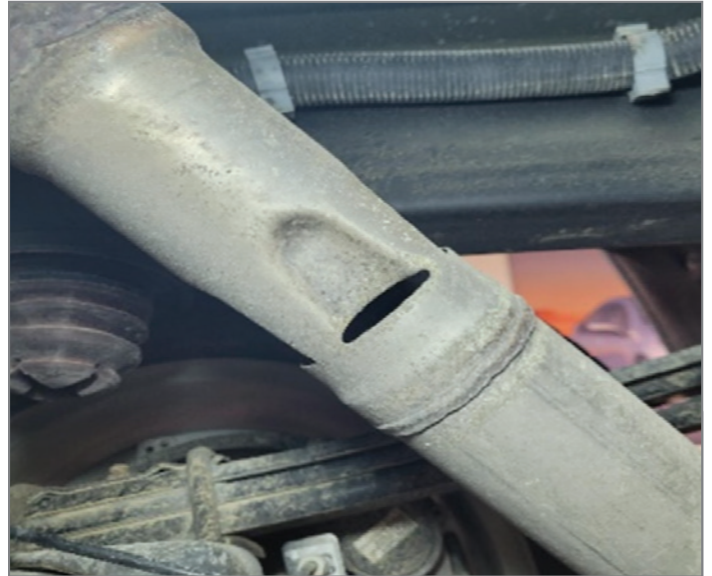
Seal the exhaust cooling ports.

Refer to Bulletin #22-NA-168 for details on using the GE-52250 High Pressure Leak Detector to locate the exhaust leak. The cooling ports in the exhaust system must be sealed off before installing the inflatable adapter from the GE-52250 machine.

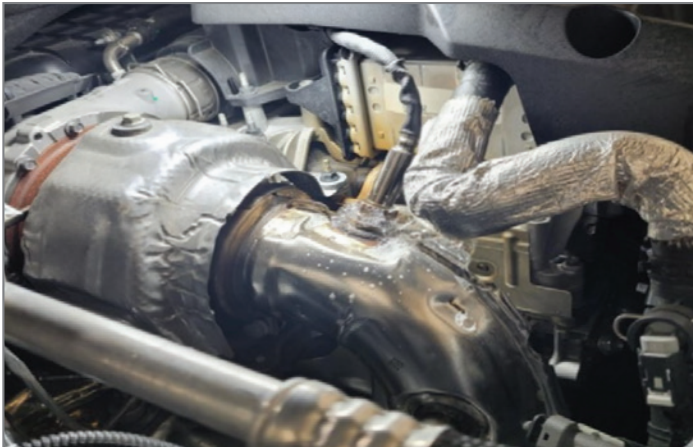
Check for exhaust system leaks.

To help identify the location of the exhaust leak on the 3.0L diesel exhaust system, perform a leak test using the GE-52250 High Pressure Leak Detector.

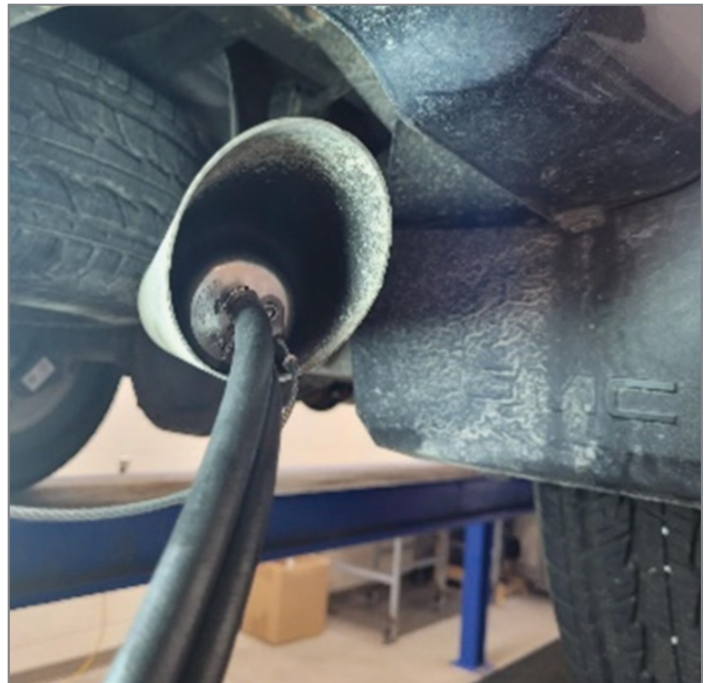
Install the inflatable adapter from the GE-52250 machine.

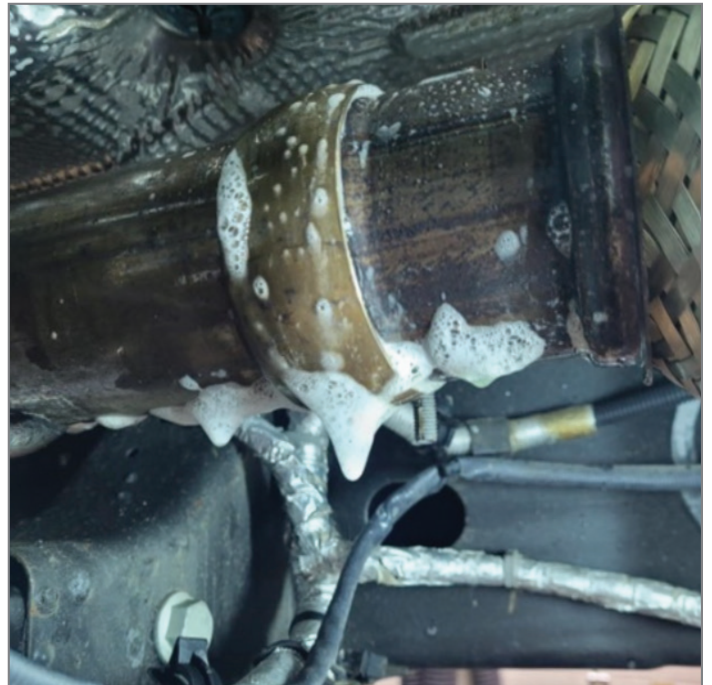
Exhaust clamp connection

Using the vapor test and the shop air supply along with a soapy water mixture, all connections, welds and sensors should be checked for air leaks. These areas include the turbocharger, NOx sensors, DEF injector and clamp connections.

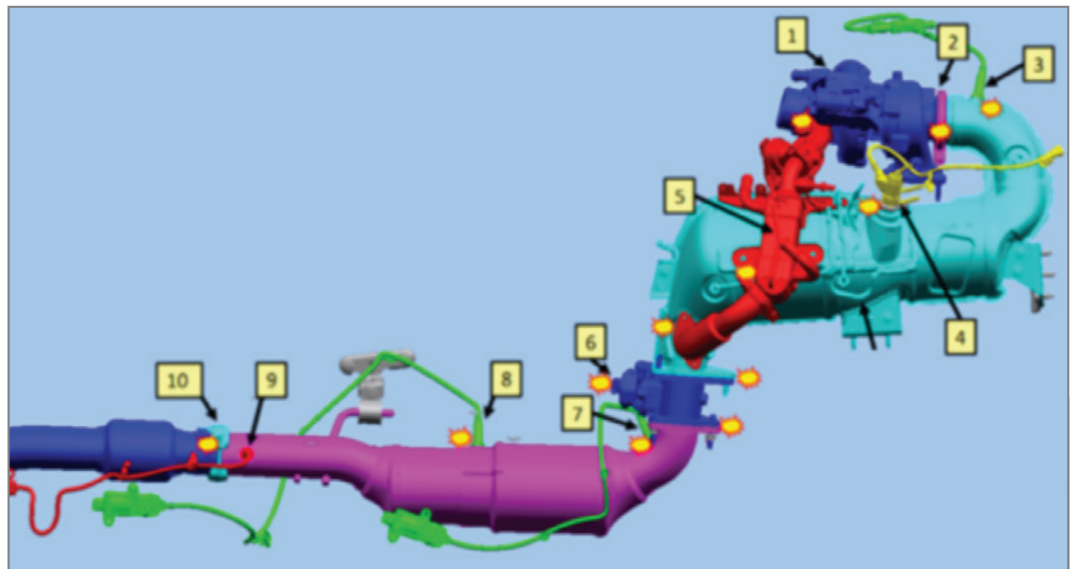
Areas that require inspection for leaks

Once all leaks have been identified and corrections to the exhaust system have been made, verify that the exhaust is sealed by retesting with the GE-52250 High Pressure Leak Detector.

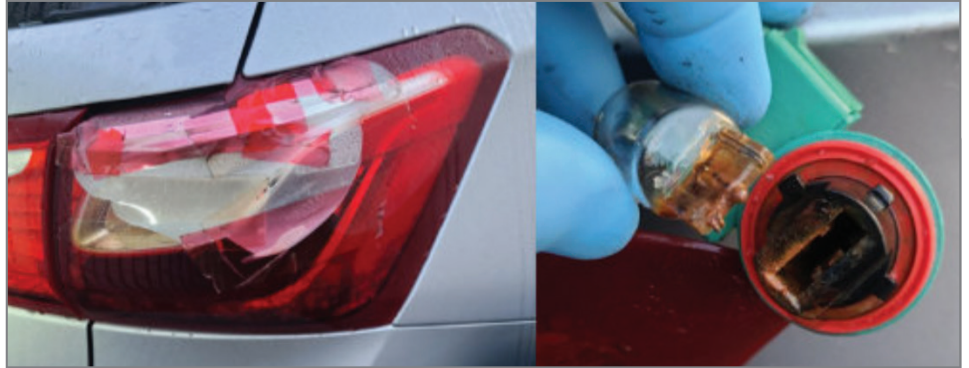
Check for damage to the right-side tail lamp lens or housing. Water in the housing may migrate through the bulb connector wire strands to the X350 connector, the X320 connector or the Body Control Module (BCM).

Tail lamp damage may lead to connector issues.

If these conditions are found, inspect the tail lamp bulb connectors for signs of corrosion or water. Replace the tail lamp and bulb connector, if corroded.

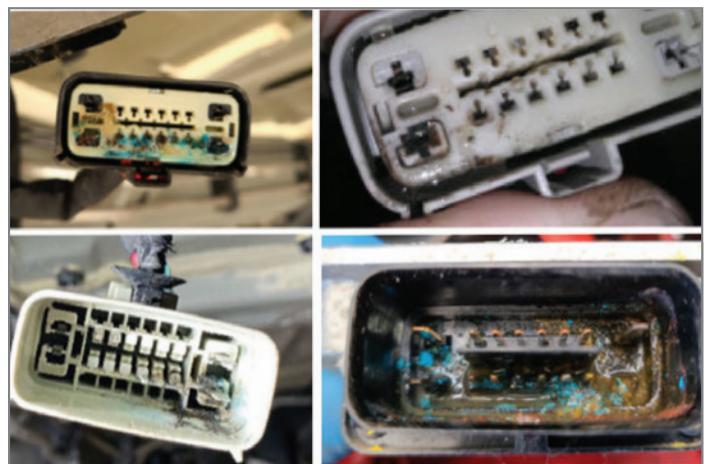
If DTC P12A6 is set, check connector X350, which is the Fuel Tank Harness to Body Harness connector under the vehicle. Corrosion in the connector may result in a no start or extended crank condition. The water intrusion also can short terminals together, which may cause the fuel pump to continue to run after the key/ignition is turned off and drain the battery.

Check for connector damage from water intrusion.

If water intrusion or corrosion is found, replace the damaged connector with terminated leads on the body harness side and/or replace the fuel pump control module harness as needed.

If there is water damage at either connector, also check the BCM connector for any signs of water intrusion. Refer to the appropriate Service Information for repairs to wiring, connectors and terminated leads.

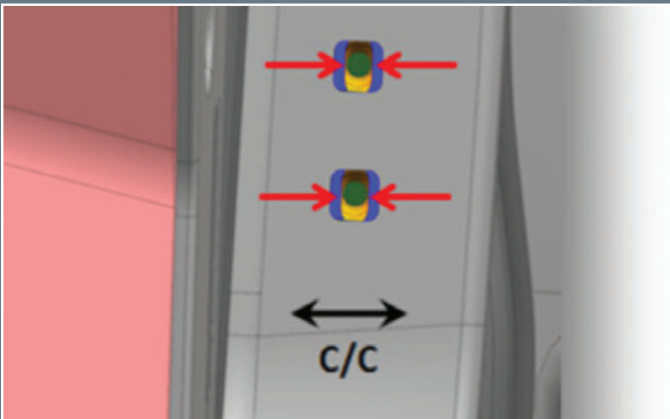
The upper and lower slots will need to be modified.

To align the rear door to specification, it will be necessary to remove the striker to gain access to the door striker net slots in the body. Both the upper and lower slots will need to be modified for proper door alignment.

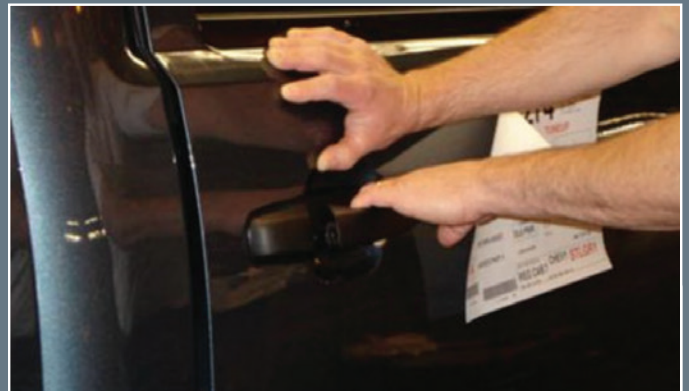
Ensure the striker is properly positioned.

The bulletin details the modification procedure along with how to reinstall the striker. The striker must be parallel to the bodyside and not rotated. Closing the door flush to the mating panel will allow the door latch to position the final location of the striker.

Once the striker is properly positioned, the bolts can be torqued to specification. Alternate torquing is recommended to prevent the striker from rotating.

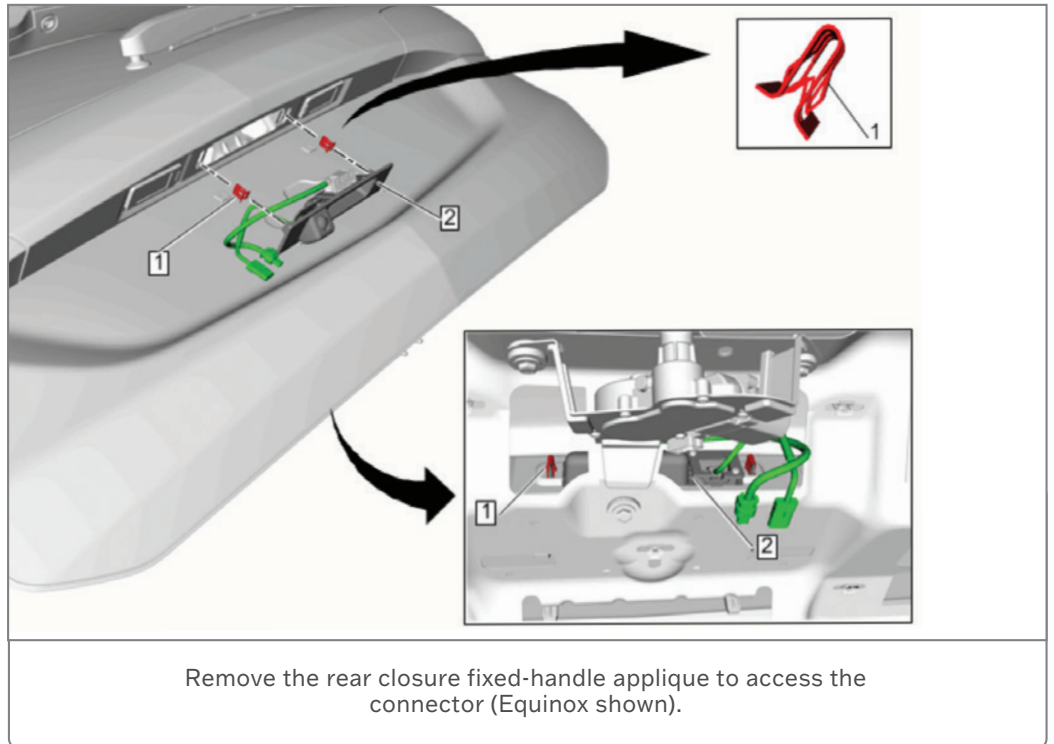
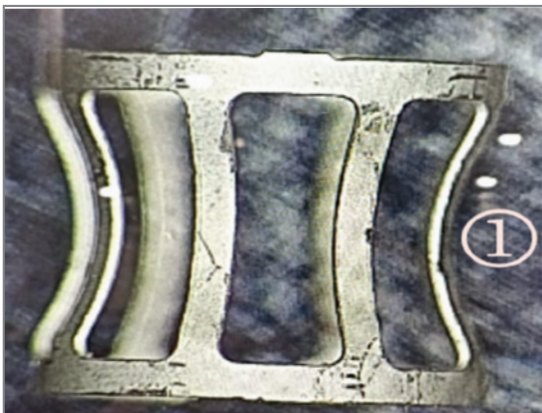
Disconnect the harness connector and inspect the connector contact area for the barrel spring. The barrel spring should be present in the cable inside the connector.

Harness connector barrel spring

If the barrel spring is not present in the cable, replace the harness. If the barrel spring is present, follow the appropriate Service Information diagnostics.

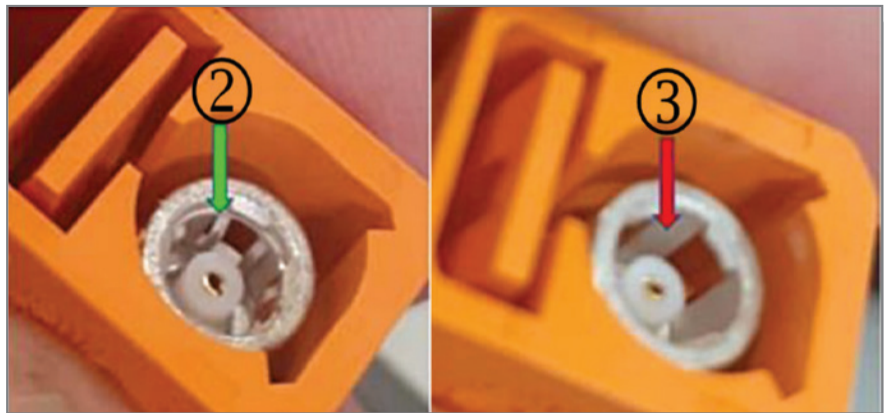
Cable connector with a barrel spring (#2) and without a barrel spring (#3).

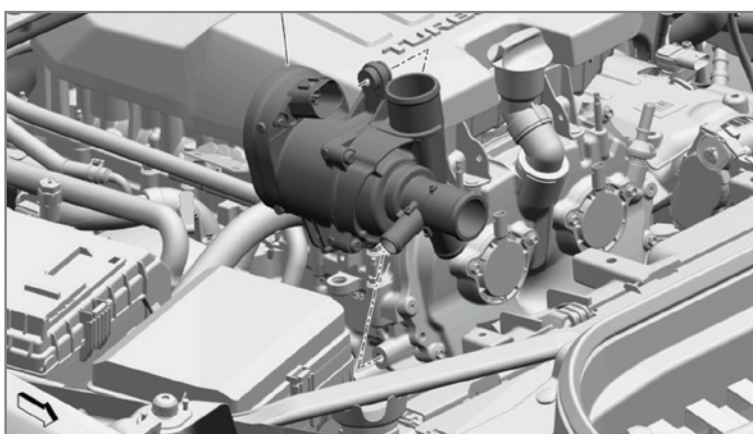
There may be a poor connection issue with the electric engine coolant pump on some 2019-2022 Silverado 1500, Sierra 1500; 2021-2022 CT4 and CT4-V models equipped with the 2.7L turbocharged engine (RPO L3B). The Check Engine MIL may be illuminated and DTC U0672 (Lost Communication with Engine Coolant Pump) may be set.

Electric coolant pump

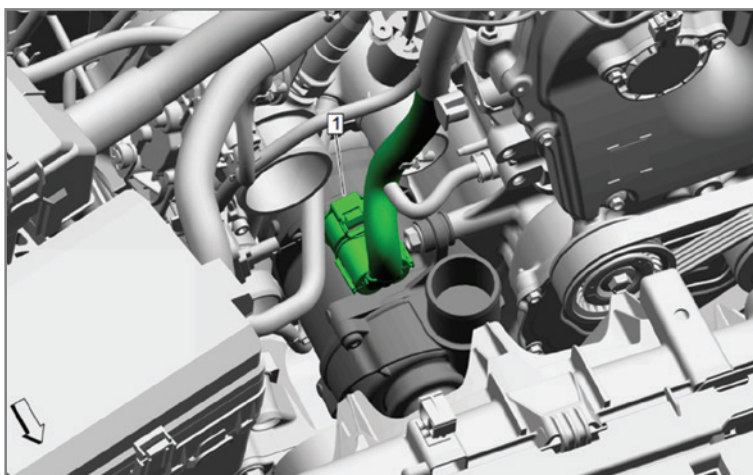
If DTC U0672 is set, check for any coolant pump-related wiring contamination, terminal tension or lock issues that may cause a poor connection and intermittent communication.

Connector at the electric coolant pump

If the inspection of the wiring harness and connector does not identify any issues, cycle the electric engine coolant pump connection and clear DTC U0672. If the code resets, refer to the appropriate Service Information to further diagnostics. If the code does not reset, release the vehicle.

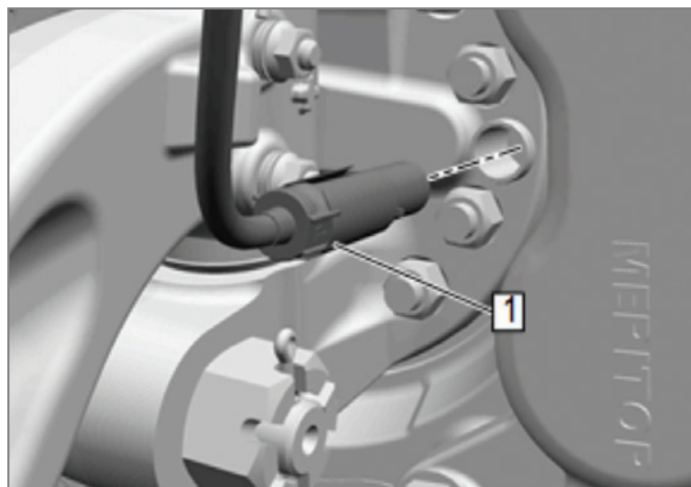
Some 2019-2022 Silverado 4500HD/5500HD/6500HD models may have an illuminated ABS, traction control and/or brake warning MIL along with several DTCs set. These conditions may be due to an out-of-adjustment wheel speed sensor air gap, loose hub bearings, debris on the wheel speed sensor or a damaged reluctor ring.

Front wheel speed sensor

- Clean any buildup of debris between the backing plate and the rotor, such as mud, ice, etc.
- Inspect for a loose wheel bearing and check the torque as specified in Service Information.
- Use an oscilloscope to look for any spikes in the wheel speed sensor pattern that may be caused by a damaged reluctor.

If no issues are found with any of these components, a new wheel speed sensor should be installed. Test drive the vehicle after any repairs to verify proper operation.
