Power Folding Top Does Not Cycle Completely

**4.2L V8 Fuel System
Components Retrofit
Procedure**

**Incorrect Headlamp
and DRL Operation
Condition**

TECH LINK

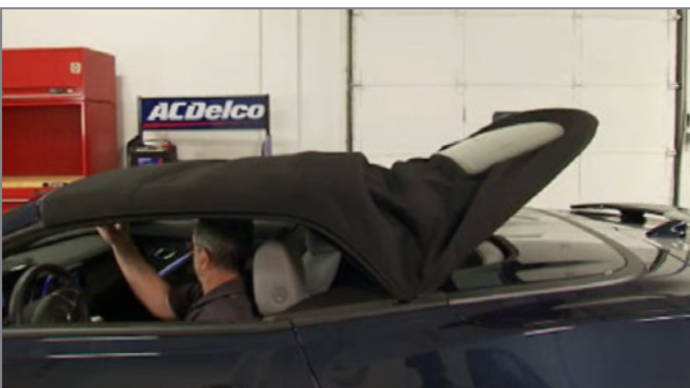
When closing the top, the tonneau cover may close, but the folding top cycle will stop.

When closing the folding top, the top will latch down onto the windshield as designed. The tonneau cover also may close, but then the folding top cycle will stop, leaving the tension bow (or 5th bow) pointing up in the air at about a 45° angle. After about five minutes, a series of rapid audible tones may be heard and the tension bow (or 5th bow) will slowly lower and come to rest gently against the body.

These opening and closing conditions may be caused by the B244L/B244R folding top stowage compartment lid position sensors not transitioning correctly when the tonneau cover has closed.

If these conditions are found, check the status of the B244L/B244R Folding Top Stowage Compartment Lid Closed Position Sensors in the scan tool data. Both sensors should read as "On" when the tonneau cover is in the closed position. Regardless of the position of the tonneau cover, both the left and right sensors should always have the same reading — On or Off — as a pair.

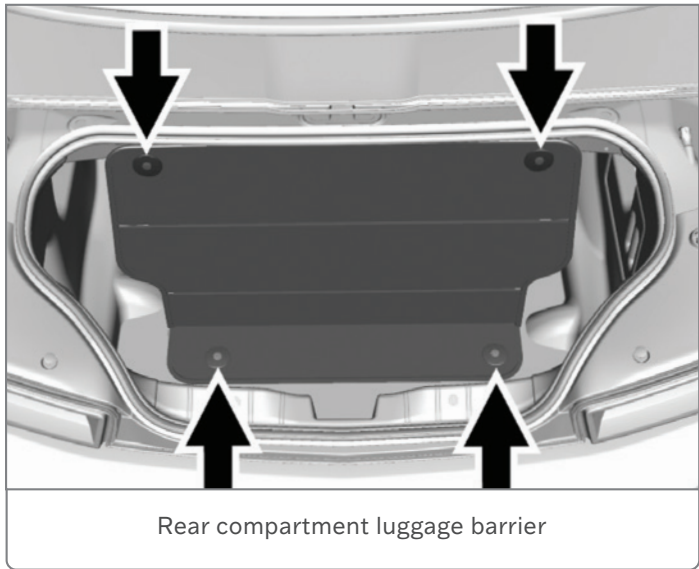
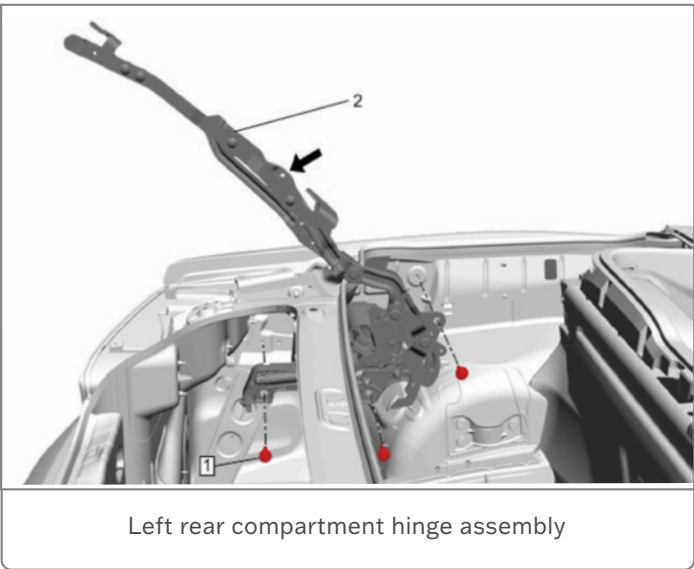
If the folding top is not cycling completely, several areas should be inspected. The first step is to determine if there is a mechanical, hydraulic, or electrical concern. Electrical issues include faulty sensors and pinched wiring, which may be more common on rental vehicles or fleet vehicles, where items may be forced into the rear compartment and may inadvertently work

their way around the luggage barrier, or trunk partition, causing damage to the folding top linkage.

Mechanical issues to check include the left and right stowage compartment lid hinge assembly for any looseness or play, as compared to the opposite side. In some cases, the linkage can be moved by hand about 1/2 inch (12.7 mm) or more, which may cause the sensor to transition back and forth. Use the scan tool to view the sensor readings while moving the linkage. With the mechanical linkage secured in place, there should not be any free movement. The linkage uses an over center/cam design that, once hydraulic pressure on the component is released, will remain secured in place and will not move. Hydraulic failures that affect the mechanical linkage are rare.

These inspections will help to determine if the folding top condition is due to a faulty sensor, pinched wiring or a damaged hinge assembly.

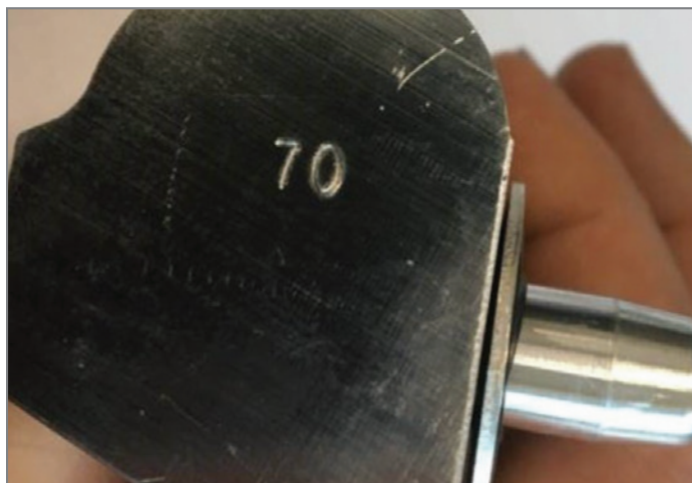
New Thermal Bypass Valve with "70" stamp

If the TBV has been replaced, the operating temperature will be lower. The previous TBV had a full-open temperature of 194°F (90°C). The new TBV has a full-open temperature of 158°F (70°C). Refer to Bulletin #21-NA-199 for more information.

The new TBV can be identified by the "70" stamped into the bottom of the valve. The "70" stamp is visible on the valve when it is installed on the transmission.

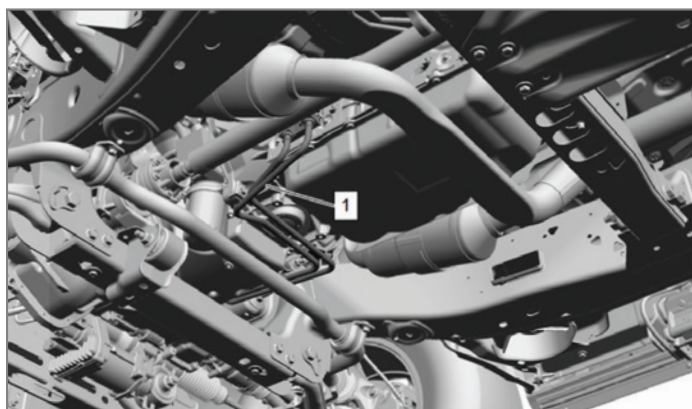
Also use an infrared thermometer to check the temperature of the TBV as well as the cooler lines at approximately 6 inches (15 cm) from TBV. If the cooling system is operating properly, the cooler return line will be a lower temperature than the line going to the

Check the temperature of the TBV as well as the cooler lines (#1).

cooler. If the TBV is not opening, both cooler line temperatures will be lower than the transmission pan temperature and the TBV temperature will be higher than the pan temperature.

In addition, compare the transmission pan temperature to the transmission temperature displayed on the Driver Information Center (DIC). If the DIC temperature is more than 15°F (9°C) higher than the pan temperature, the temperature sensor may be at fault. The sensor is part of the TEHCM (Transmission Electro-Hydraulic Control Module).

If the cooler line and TBV temperature points are above the engine coolant temperature, there may be an auxiliary cooler flow issue and the flow should be checked. Also check the cooler to ensure there is not a restriction to the air flow across it.

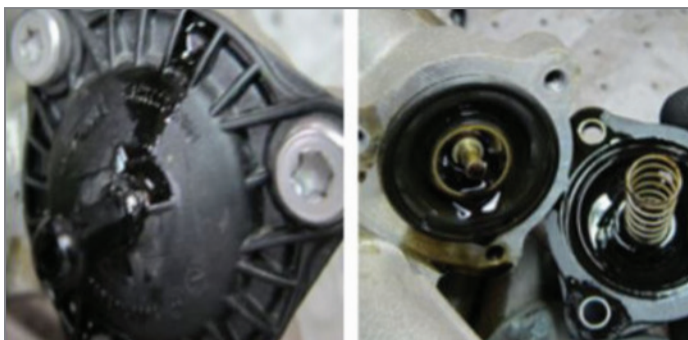
Charge air bypass valve

If the performance and drivability issues are present, check for ice blocking the crankcase vent tube, ice accumulation in the intake manifold blocking the PCV passage in the cylinder head, ice accumulation in the charge air cooler restricting air flow to the throttle body and contamination, such as water, oil or sludge, at the charge air bypass valve.

Disassemble and clean the charge air bypass valve if any contamination is found. Replace the intake manifold and, if necessary, the charge air bypass valve.

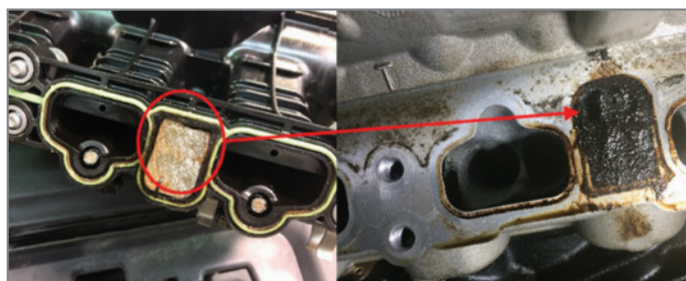
In addition, inspect for any sludge/water/ice from the cylinder head, cam cover and PCV pipes, such as ice build-up blocking the cylinder head. If any contamination is found, replace the intake manifold.

Inspect the PCV intake runner for build-up blocking the cylinder head

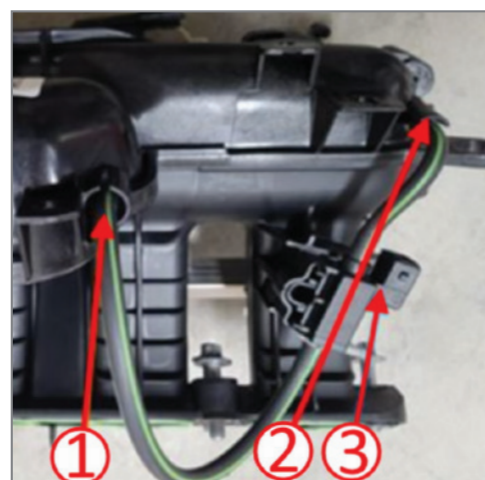
The new intake manifold has a redesigned intake positive pressure port location. Solenoid location is forward of the electrical connector. The bypass valve vacuum feed is in the same location.

New design intake manifold:
1. Bypass valve vacuum
2. Intake positive pressure port
3. Solenoid/electrical connector

If the solenoid is loose, review the location of the electrical connector. If the connector is facing the cylinder head, it is installed backwards and should be removed

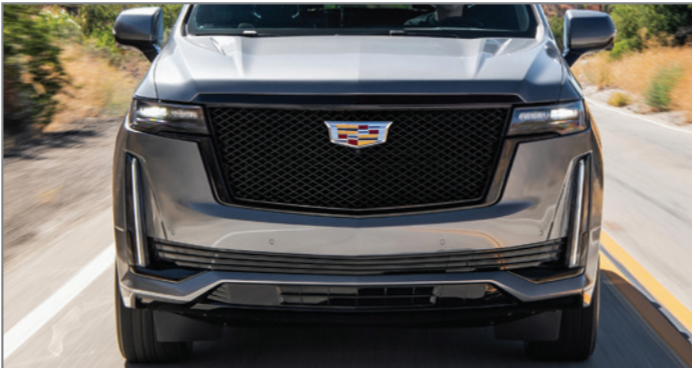
Headlamps may turn on automatically during daylight conditions.

The headlamps may be turning on automatically during daylight conditions instead of the Daytime Running Lamps (DRL) on some 2022 Tahoe, Suburban, Yukon, Escalade and 2022-2023 Corvette models. DTC B108E (Ambient Light Sensor Signal) also may be set.

If the headlamps and DRL concern is present, do not replace the ambient light sensor or any other parts. Updated software is

available to reprogram the BCM for 2022 model year vehicles to address the lighting operation.

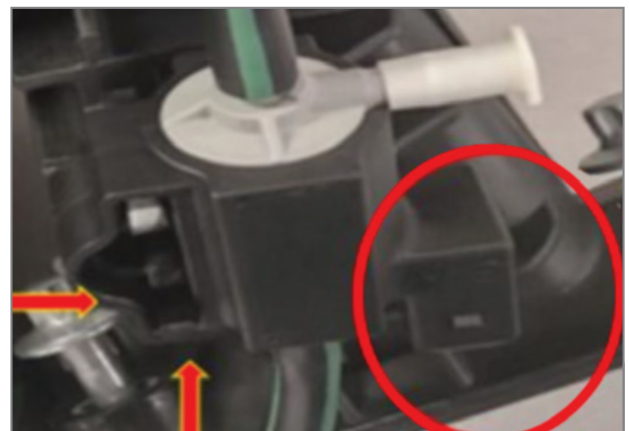
and installed correctly. The solenoid is keyed and, if the tabs are reversed, the retainers will not be seated.

New design intake shown with incorrect solenoid installation.

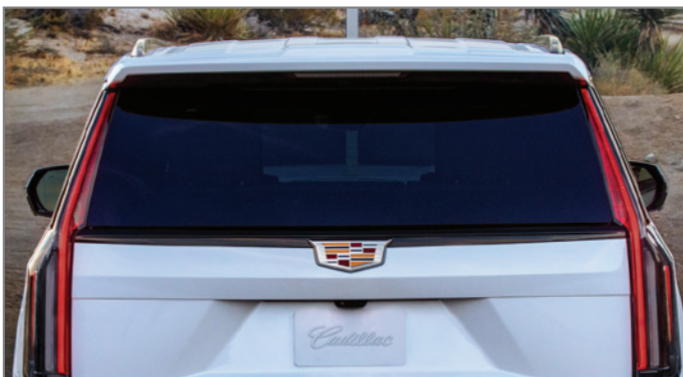
The rear window glass on the liftgate of some 2021-2022 Tahoe, Suburban, Yukon and Escalade models may not open when using the switch on the liftgate or the Remote Keyless Entry transmitter (key fob) button. In some cases, the rear wiper arm may not be fully moving to the park position, even though the rear wiper arm looks to be in the correct position, which prevents the back glass from opening.

The rear window glass may not open properly.

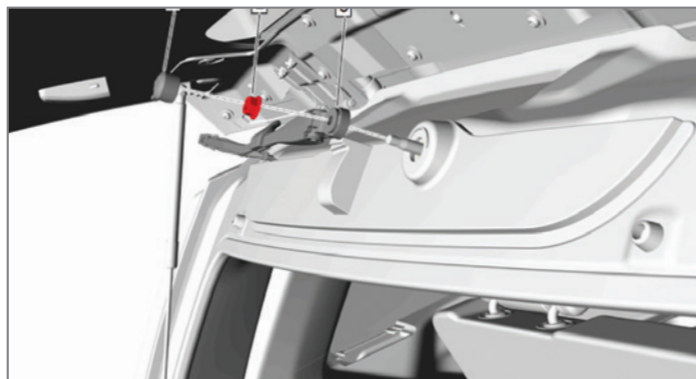
Remove the wiper arm and operate the rear wiper.

If the rear window glass will not open, remove the wiper arm and operate the rear wiper. Turn on the rear wiper switch, allow the wiper motor to cycle and then turn off the switch.

Next, reinstall the wiper arm and check that the wiper arm is in the full park position with the arm on the park ramp, allowing the back glass to open properly.
