**TECH LINK** 2023

# Incorrect Tire Size

## May Lead to Damaged Fuel Pump Harness

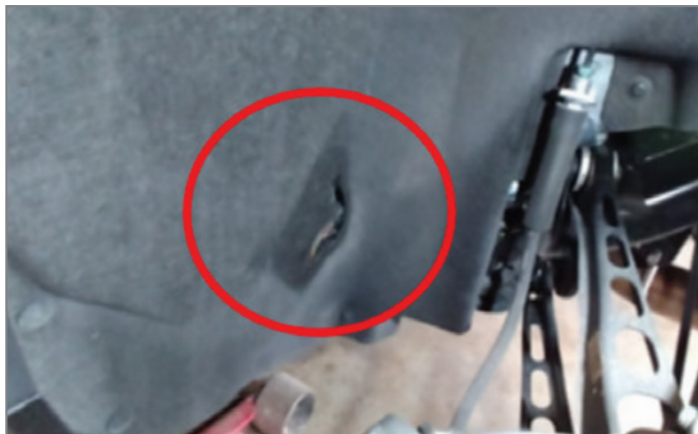
If these conditions are present, inspect the left-rear wheelhouse liner for a rub-through condition caused by the installation of larger, incorrect tires. These conditions may be difficult to diagnose, so it's important to check the tires installed on the vehicle. Some customers may have installed larger, aftermarket tires.

Inspect the left-rear wheelhouse liner.

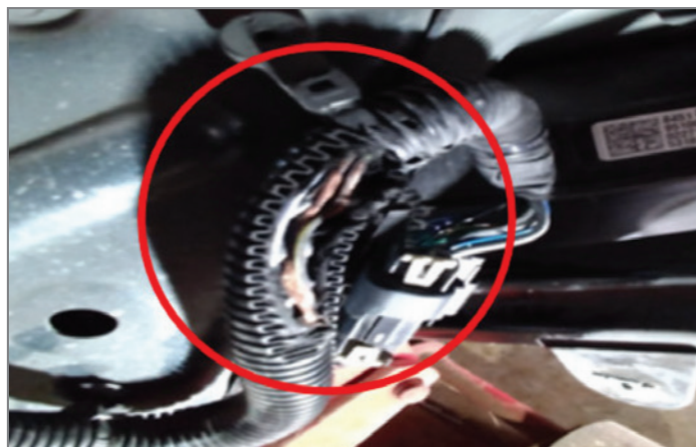
The oversized tires may damage the body-to-fuel pump harness and the chassis module-to-fuel pump connector X350. In addition, the damaged harness may cause an intermittent short during heavy acceleration and the F35RA fuse may be blown in the rear fuse block.

Damaged body-to-fuel pump harness

If the concern is caused by a rub-through condition and the vehicle is not equipped with the original equipment (OE) tires, advise the customer of the importance to use the same tire size and manufacturer with which the vehicle was originally equipped. Damage caused by incorrect, oversized tires is not covered by the New Vehicle Limited Warranty.

If the engine performance concerns are caused by a rub-through condition at the left-rear wheelhouse liner, yet the vehicle is equipped with the OE tires, repair the harness and submit a field product report. Be sure to include photos and tire information in the report.

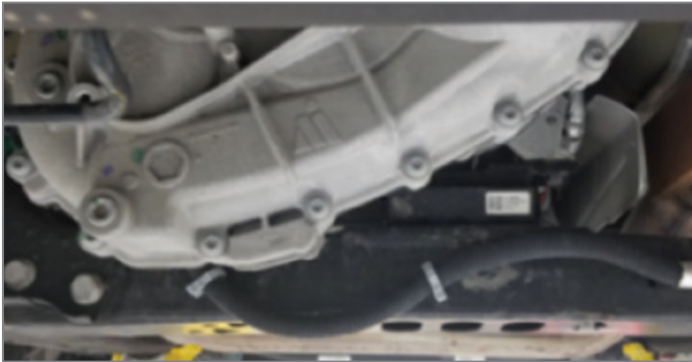
A transmission fluid leak may be seen on some 2022 Silverado, Tahoe, Suburban, Sierra, Yukon and Escalade models equipped with the 10L80 10-speed automatic transmission (RPO MHS, MHT, MQB, MQC). One or more of the rear case plugs on the transmission may be leaking.

Inspect the rear of the transmission for evidence of transmission fluid at the case plugs. To help confirm the leak source is the case plug, use a light looking from the right side of the transmission between the transmission crossmember and the transmission case.

Rear case plugs on the transmission (4WD shown)

If one or both case plugs are found to be leaking, remove the transmission crossmember support and mount to gain access to the plugs (4WD shown). Only replace a plug if it is leaking. Refer to the appropriate Service Information for the complete service procedure.

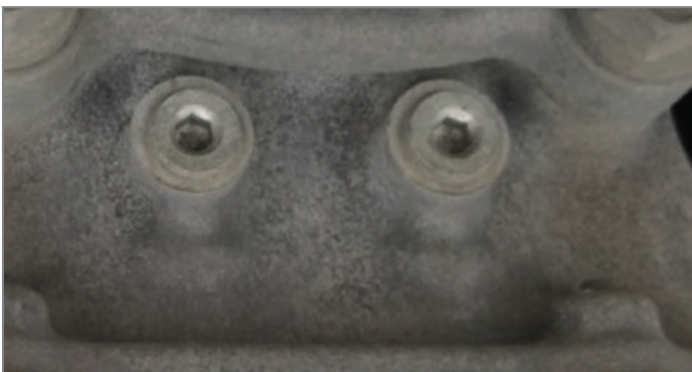
Rear case plugs

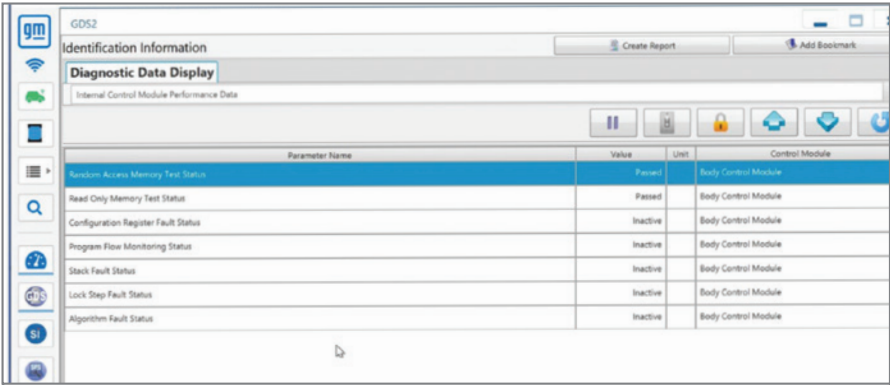
These conditions may be due to the BCM software or an incorrect BCM Program Flow Monitoring Status parameter. DTC P0606 will set if there is an internal malfunction or system programming malfunction in the BCM.

Check the Program Flow Monitoring Status parameter using GDS2.

To review the parameters using GDS2, select the following path: Module Diagnostics > Body Control Module > Identification Information > Internal Control Module Performance Data. If the Program Flow Monitoring Status parameter is “active” and all other parameters are “inactive,” update the BCM with the latest calibration using SPS.

- If the Program Flow Monitoring Status parameter is still listed as “active” and all other parameters are listed as “inactive,” clear all codes. No other repairs are necessary. DTC P0606

- If the Program Flow Monitoring Status parameter and all other parameters are listed as “inactive,” clear any codes. Repairs are complete.
- If the Program Flow Monitoring Status reads “active” or “inactive” while any other parameters read “active,” follow the diagnostic procedures for DTC P0606 in the appropriate Service Information.

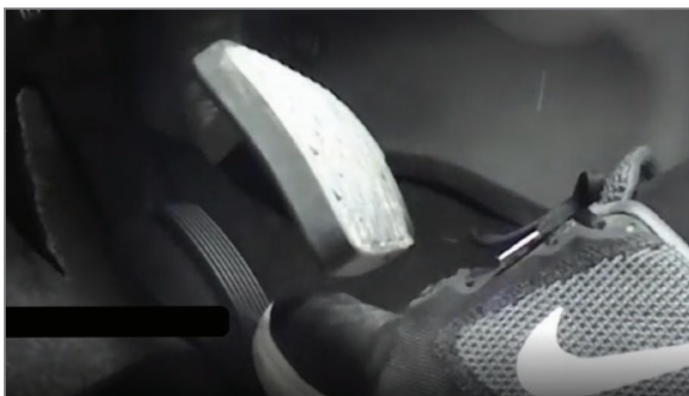
If the brake pedal moves rearward during acceleration, it may cause an inaccurate Learned Release Position in the Engine Control Module (ECM) and the ECM Brake Pedal Position Sensor will show a value of 6% pedal travel or greater. As a result, the parameter for Cruise Control Inhibit Reason will show Brake Pedal Applied, causing cruise control to be disabled.

The brake pedal may move rearward during acceleration.

If these conditions are found, the brake and accelerator pedal assembly should be replaced.

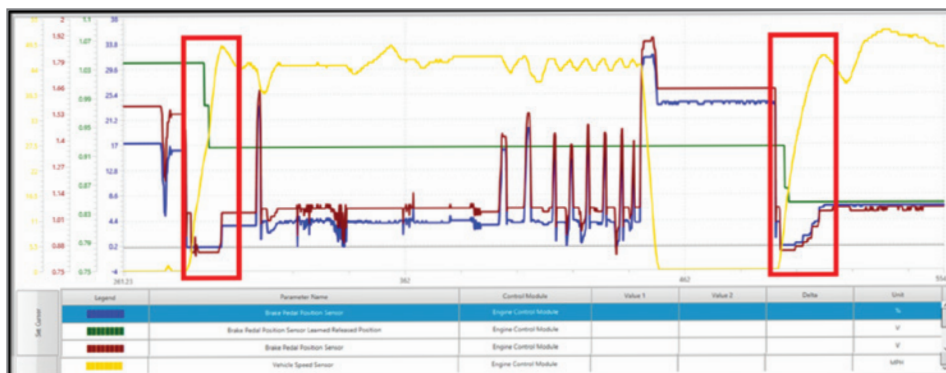
Vehicle Speed Sensor (yellow line), Brake Pedal Position Sensor (red line), BPPS Learned Released Position (green line) and Brake Pedal Position Sensor (blue line)

While performing a test drive, accelerate several times from 0-50 MPH. In the GDS 2 data, while the vehicle is accelerating (yellow line), the Brake Pedal Position Sensor (red line) will drop to a lower value than the normal release position, which causes a corresponding drop in the BPPS Learned Released Position (green line) value. The ECM will show some percentage of travel greater than zero when traveling at a steady speed with the pedal released (blue line). Under these circumstances, the parameter for Cruise Control Inhibit Reason will show Brake Pedal Applied.

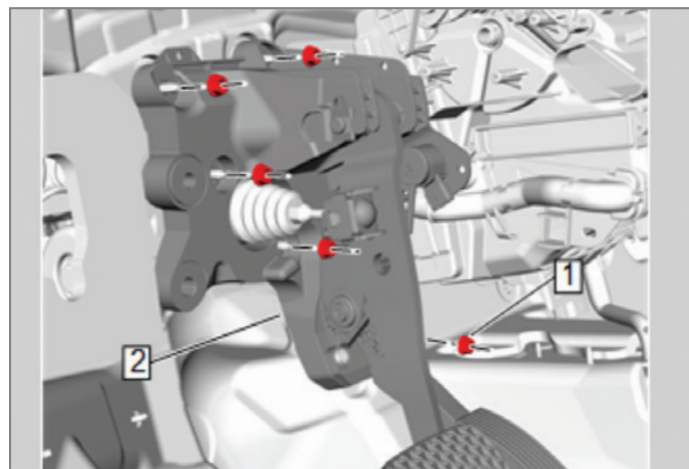
Brake and accelerator pedal assembly

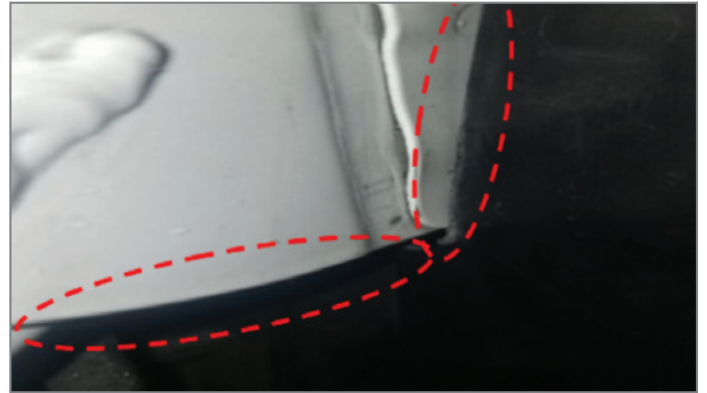
The squeak sound on these engines may be caused by the radiator air baffle on the right side of the vehicle contacting the core support.

The radiator air baffle may be contacting the core support in two areas.

If this sound is heard, verify that the radiator air baffle is rubbing on the core support. There are two common areas where contact may occur. If there is contact, material should be trimmed from the air baffle in order to create more clearance between the baffle and the core support.

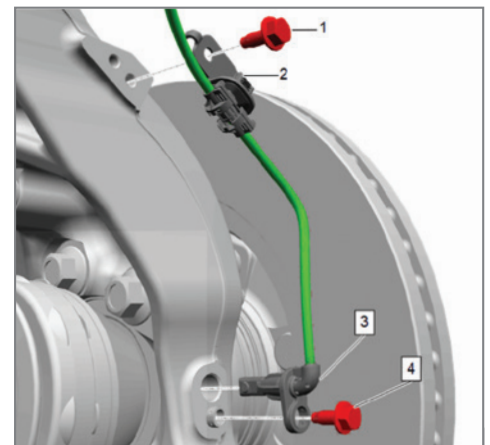
Incorrectly installed sensors will not properly sense the magnetic encoder ring located on the wheel bearing assemblies. As a result, a right front wheel speed sensor cannot be installed on the left side of the vehicle, or vice versa.

Front wheel speed sensor (#3) shown on the left side of the vehicle.

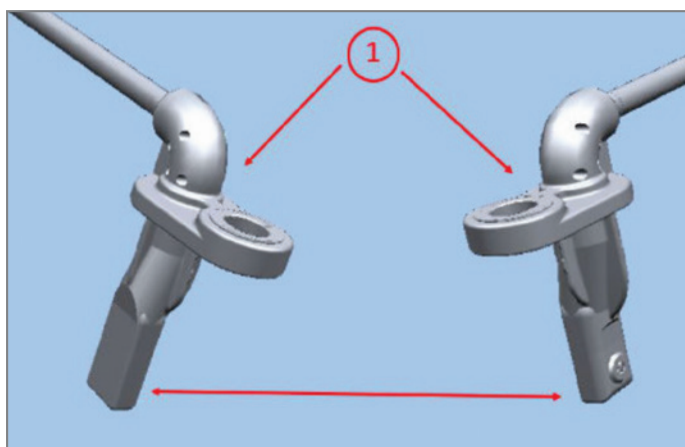
Right front wheel speed sensor (#1)

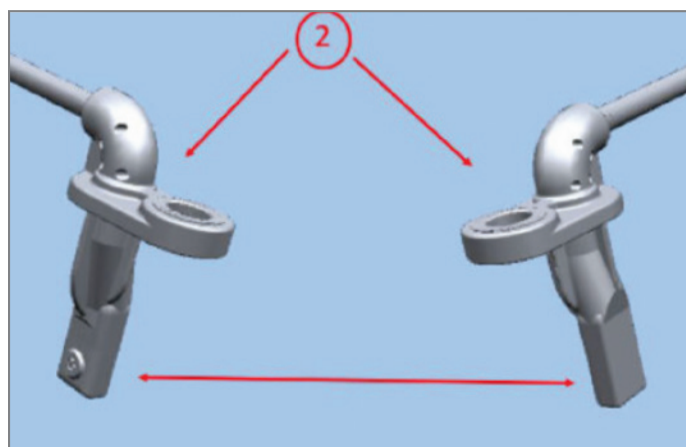
Left front wheel speed sensor (#2)
