Remote Keyless Entry Transmitter

Warranty Replacement Update

GM TechLink is published for all GM retail technicians and service consultants to provide timely information to help increase knowledge about GM products and improve the performance of the service department.

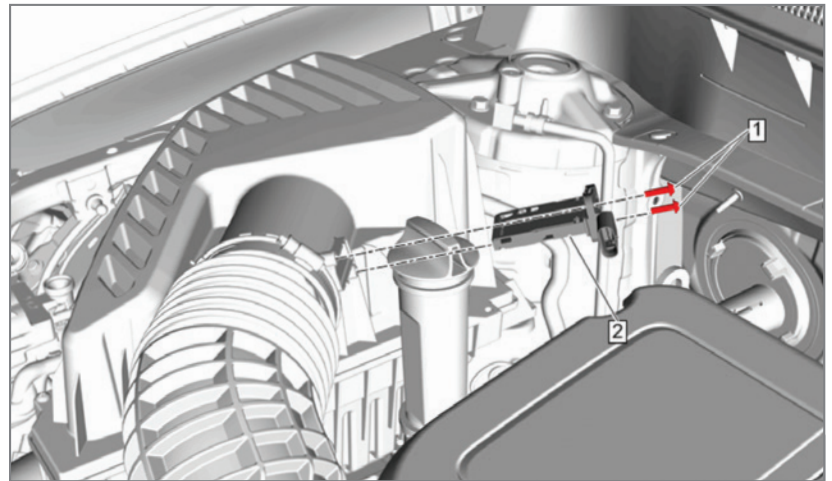
After replacing the Engine Control Module (ECM) on some 2020-2023 Encore GX and Trailblazer models equipped with the 1.3L turbo engine (RPO L3T) and 2022 XT4, XT5, XT6; 2022-2023 Blazer and Acadia models equipped with the 2.0L turbo engine (RPO LSY), DTCs P227C (Barometric Pressure (BARO) Sensor 2 Circuit Low Voltage) and P10BC (Barometric Pressure Sensors 1-2 Not Plausible) may set. A change in the Mass Air Flow (MAF) sensor design may require an ECM calibration update after ECM replacement.

MAF sensor on the 2.0L engine

Based on which MAF sensor is installed in the vehicle, reprogram the new ECM with the correct calibration. Follow all programming guidelines as instructed in the appropriate Service Information. In addition, when the ECM is replaced, the Intake System Learned Values Reset must be performed.

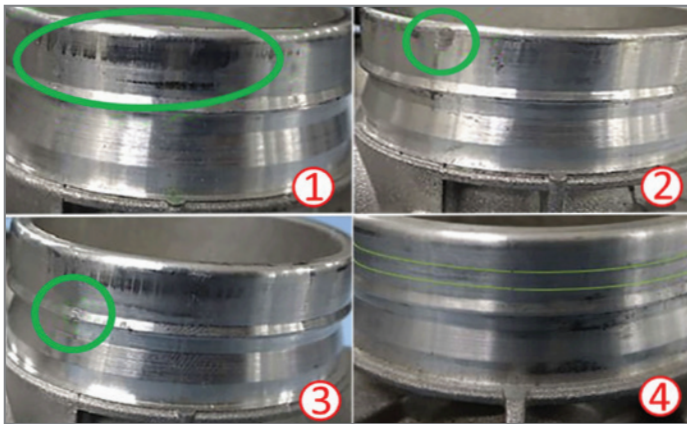
Normal witness marks

Normal witness marks on the throttle body do not require replacement.

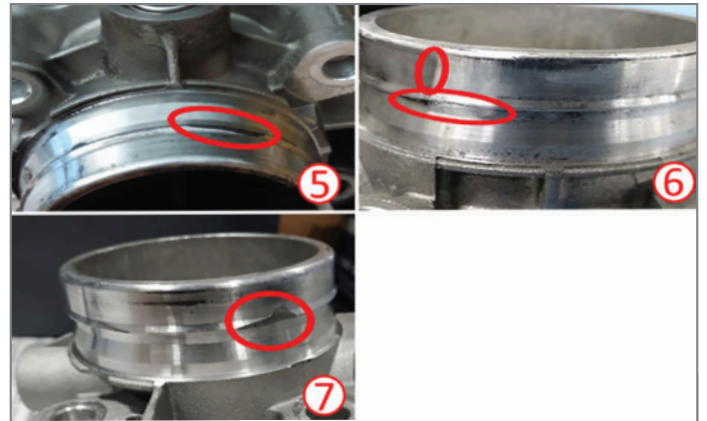
Reduced engine power may occur on some 2018-2022 Malibu, Equinox and Terrain models equipped with the 1.5L engine (RPO LYX) along with one or more of the following DTCs set in the Engine Control Module: P0101 (Mass Air Flow (MAF) Sensor Performance), P0172 (Fuel Trim System Rich), P0299 (Engine Underboost), P0506 (Idle Speed Low) and P1101 (Intake Air Flow System Performance). These conditions may be caused by the Charge Air Cooler (CAC) outlet tube being separated from the throttle body.

Look for abnormal marks or damage, which indicate the throttle body to be replaced.

Damage to the throttle body

If these conditions are found, check the CAC outlet tube connection at the throttle body. If the tube is disconnected, inspect the CAC tube, tube retainer clip and throttle body for any damage. In some cases, there may be damage that requires replacement of the CAC tube or throttle.

If the CAC outlet tube is disconnected from the throttle body, also check the tube end for contact damage or a missing O-ring seal. Replace the tube assembly if the tube is damaged or the O-ring seal is missing.

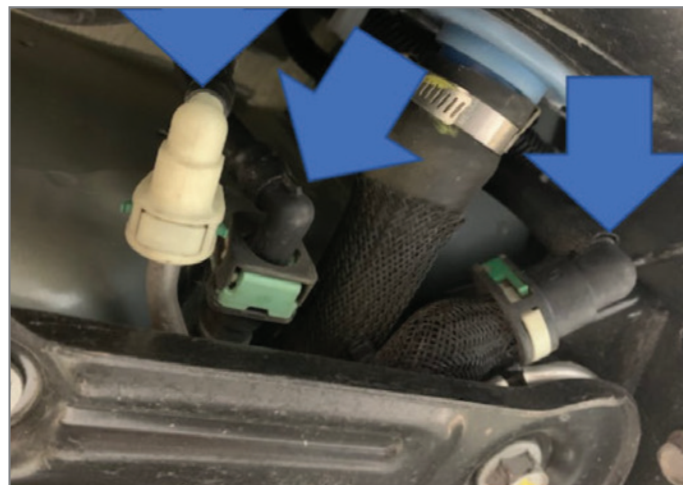
Overfilling the fuel tank during refueling can lead to several engine performance issues and possible damage to the fuel system. If the fuel station fill nozzle automatically shuts off (clicks off), and the customer continues to try to add more fuel beyond three clicks, liquid fuel can enter the vapor lines of the evaporative emissions (evap) system. The fuel may block the recirculation line and cause issues with the fuel tank pressure sensor readings.

On some 2019-2023 XT4 and 2021-2023 Envision models equipped with the 2.0L engine (RPO LSY), the fuel tank overfill may illuminate the Check Engine MIL and set DTC P0451 (Fuel Tank Pressure Sensor Performance). These vehicles have a capless refueling system and do not have a fuel cap.

Vapor lines near the fuel tank

If these conditions are found, inspect the vent lines at the fuel tank for damage and drain any fuel or remove any contamination from the evap vent lines. There are three vapor lines near the fuel tank.

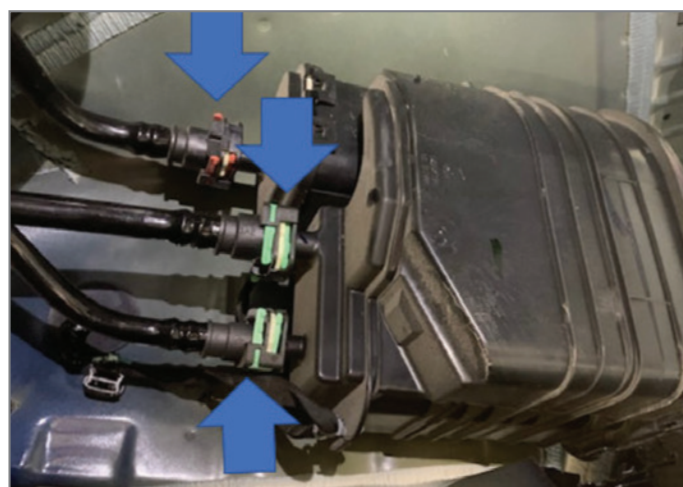
Vapor lines (green quick connectors) at the evap canister

The vapor lines (shown with green quick connectors) also should be disconnected from the evap canister to clear the lines of any liquid fuel. To access the evap canister, remove the right-hand rear wheel and wheel liner. Lightly blow shop air into each line to clear any fuel.

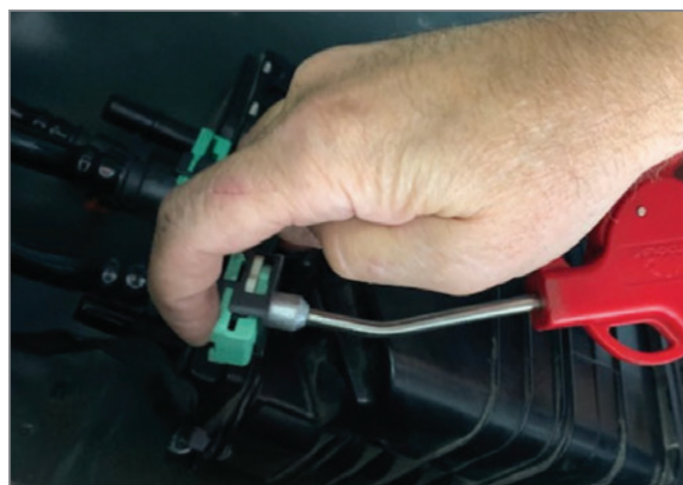
Clear the lines of any liquid fuel.

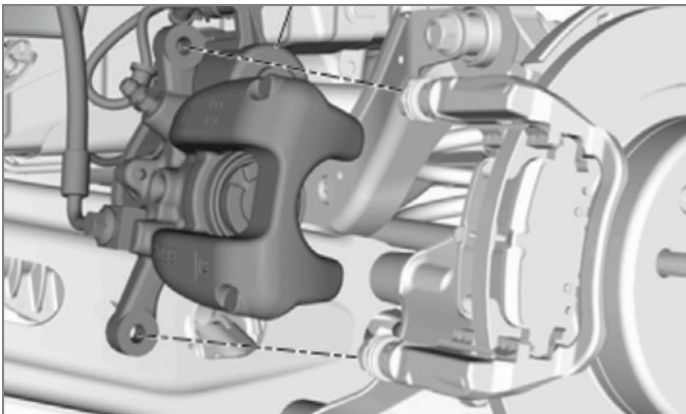
If this occurs and then the piston is manually pressed in the rest of the way so that the caliper can be reinstalled, the excess fluid pressure will damage the pressure sensor(s) in the Electronic Brake Control Module (EBCM).

Typically, the park brake data for one or both of the pressure sensors will show the default value of 14,400 NM. If a pressure sensor(s) is damaged, it will be necessary to replace the EBCM. Due to the nature of this damage, EBCM replacement is not a warrantable repair.

Do not manually compress the brake caliper piston.

The service procedure instructs to check the fluid level in the brake master cylinder reservoir. The brake fluid level in the master cylinder reservoir must be at 1/2 or lower between the maximum/full point and the minimum level to allow sufficient space for the fluid to return to the reservoir when the rear caliper retract is commanded. If the fluid level is higher than 1/2, brake fluid should be removed before continuing with repairs.
