GM TECHNICAL ASSISTANCE CENTER (TAC)

Dealer Tips and New Information Newsletter

NOVEMBER 21, 2022

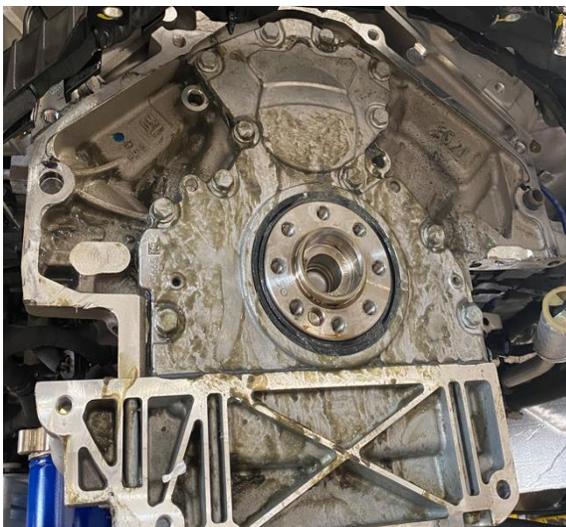
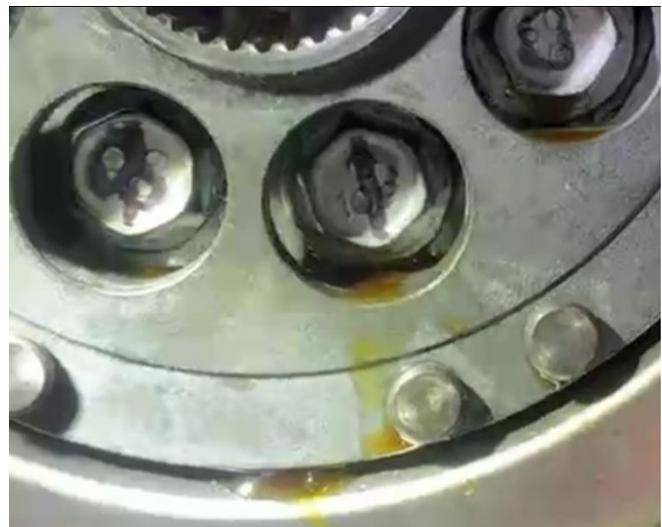
1) 2020-2023 Corvette Fluid Leak from the Bell Housing Area.

The leak will have the appearance of either red transmission fluid or engine oil. When touching the fluid, it will have a sticky, thick or viscous feeling and will not feel like oil or transmission fluid. Review the photos below to see how the fluid can appear to be red, golden brown or yellowish clear depending on the light.

The fluid may appear to be a transmission leak or possibly a rear main seal, However, the leak is coming from the flywheel and the current cause of the leak is under investigation. In the interim, replace the flywheel and clean the area. Also replace the rear main seal as there have been instances where the grease/fluid appears to degrade or soften the seal.

If the cause or location of the leak cannot be determined, add dye to the engine oil and check the possible leak locations.

Note: It is possible that when inspecting the flywheel bolts that the paint marks or the Loctite to fluoresce when using a black light. Use care to not confuse the two.
