New System Reset and Connector Reconnect Labor Codes

DTC Sets After Turbocharger Replacement

Maintaining Power to a Module Sent in for Warranty Analysis

Sticking Charge Air Bypass Valve

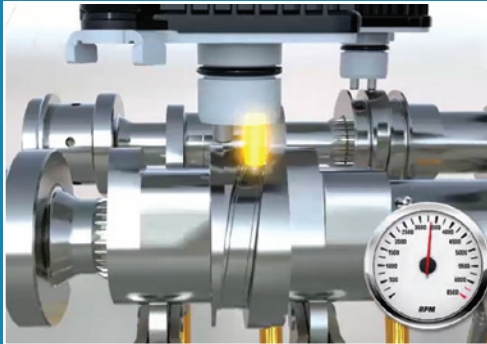
In cold ambient conditions (10°F / -12°C), DTCs P30C3 and/or P30BF, P30C7 and P30CB may set on some 2019-2022 Silverado, Sierra; and 2020-2022 CT4 models equipped with the 2.7L engine (RPO L3B). These DTCs may be caused by a binding or sticking intake

camshaft sliding lobe pack. This condition is most likely to occur on vehicles with less than 10,000 miles (16,000 km).

Intake camshaft sliding lobe pack

wiring, replace the cam lobe position actuators, based on the DTCs set.

Replace the cam lobe position actuators for:

- P30BF – intake cylinders 1 and 2
- P30C3 – intake cylinders 3 and 4
- P30C7 – exhaust cylinder 2
- P30CB – exhaust cylinder 3

If the cam lobe position actuators were replaced previously and the fault returns, replace the intake camshaft (for DTC P30BF or P30C3)

or exhaust camshaft (for DTC P30C7 or P30CB).

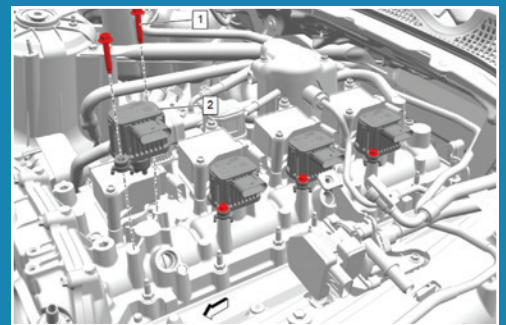
Intake camshaft lobe position actuators (#2)

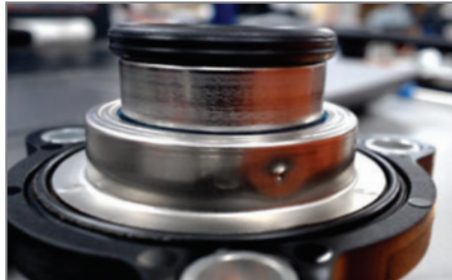
If diagnosis does not identify the source of the condition, inspect the charge air bypass valve (shown in the fully extended, or closed, position).

Charge air bypass valve in the closed position

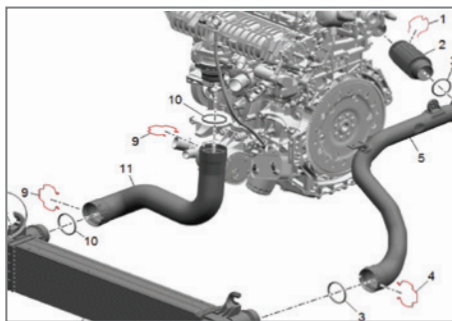
Charge air cooler inlet hose (#5)

First remove the charge air cooler air inlet hose adapter from the turbocharger. Using a bore scope, check the compressor wheel for any signs of damage. If there is damage to the compressor wheel, it will be necessary to replace the turbocharger.

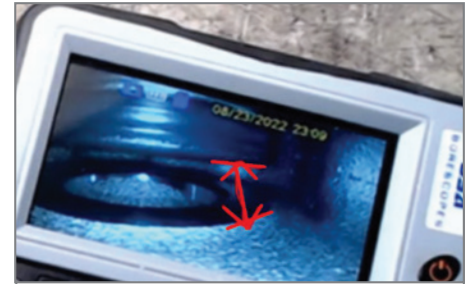
If there isn't any damage seen on the compressor wheel, use the bore scope to inspect if the charge air bypass valve is stuck in the open position.

TIP: Be sure to use a bore scope to inspect the charge air bypass valve. The valve may stick open intermittently (plunger is fully retracted) and attempting to remove it may cause the valve to return to a normally closed position.

Use a bore scope to check if the charge air bypass valve is in a stuck-open position.

If the charge bypass valve is found stuck open or is causing DTC P0299 to set intermittently, replace the charge air bypass valve. After replacement, clear any DTCs and evaluate engine operation.

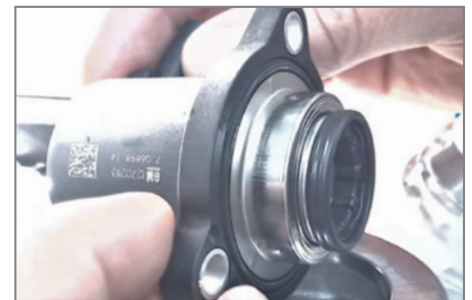
Valve stuck open with plunger fully retracted
