## Latest Techline Connect Tips Shared by the TCSC

**The Techline Customer Support Center (TCSC) has released their latest tips for Techline Connect and the Service Programming System.**

# Transfer Case Actuator Alignment

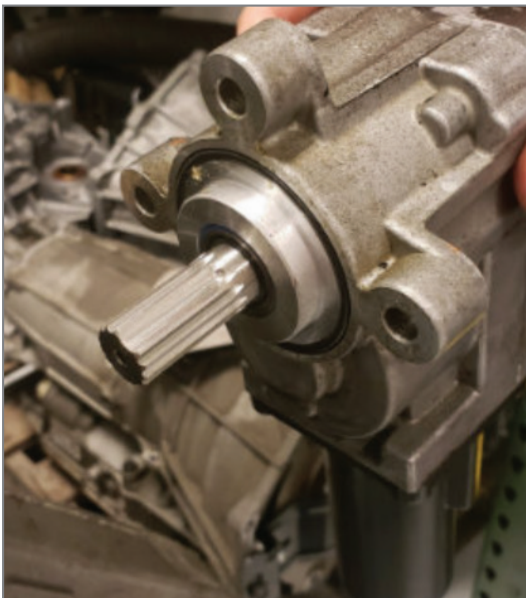
When installing the transfer case actuator, the actuator keyway spline must be in the proper location. When aligned correctly, the keyway spline on the internal shift shaft and the transfer case actuator will be approximately in the 10 o'clock position. The actuator should slide fully into position without any need to move the actuator

When installing the transfer case actuator, the actuator keyway spline must be in the proper location.

If the actuator is in the proper position and the transfer case shaft is not, the shift shaft can be moved using a suitable tool to adjust it to the 10 o'clock position.

**TIP:** If the alignment spline on the transfer case is not located in the 10 o'clock position, do not attempt to move the actuator using the scan tool. Instead, using a fused jumper wire on the

bi-directional transfer case actuator circuits and a suitable power supply or battery, jump the control circuits of the actuator motor to move the spline into the correct location. Over movement of the actuator motor may cause damage to the internal sensor, so care should be taken to not allow more than 360 degrees of rotation in either direction.

Do not twist or move the actuator to line up the bolt holes. Moving the actuator may cause the internal gears of the transfer case to bind as

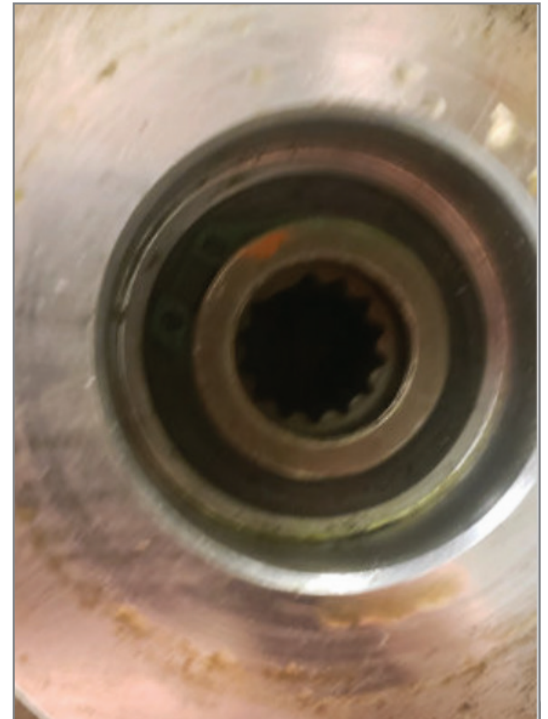
If the alignment spline is not in the 10 o'clock position, the bolt holes will not align the actuator to the transfer case.

The alignment spline on the transfer case should be in the 10 o'clock position.

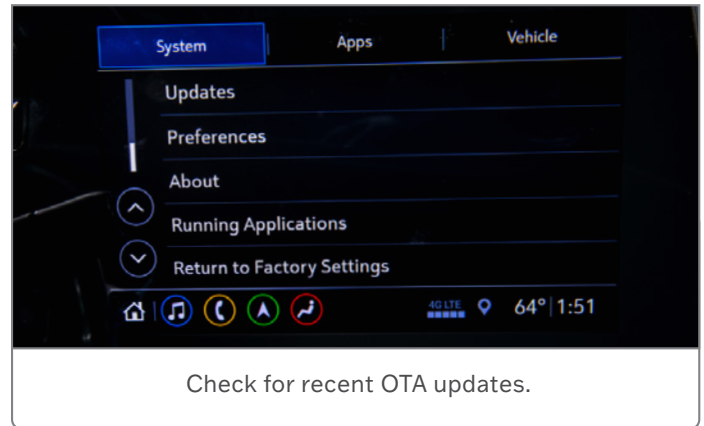
After an Over-the-Air (OTA) software update on some 2021-2022 Corvette and 2022 Envision models, the radio may not turn off after the vehicle's ignition has been turned off and the driver's door has been opened, leaving Retained Accessory Power still active. If the vehicle is left in this state for an extended amount of time, the battery may become discharged.

These conditions may be caused by a failed OTA update for the Serial Data Gateway Module (SDGM)

To address this concern, check to see if the vehicle has recently received an OTA update. On the infotainment screen, select Settings > System > Updates. If the OTA update failed, it may not show under the updates history on the infotainment screen.

Also check the condition of the battery following the procedures in the appropriate Service Information. After recovering the battery following the Battery Inspection/Test procedure, perform the Battery Electrical Drain/Parasitic Load Test procedure to confirm there is not a parasitic drain present on the vehicle.

Once the condition of the battery and electrical system components have been confirmed, check the SDGM for the latest software using SPS2. Program the SDGM if an update is needed.
