Communication DTCs Set ON 3.0L DURAMAX DIESEL ENGINE

Communication DTCs Set on 3.0L Duramax Diesel Engine

TECH LINK

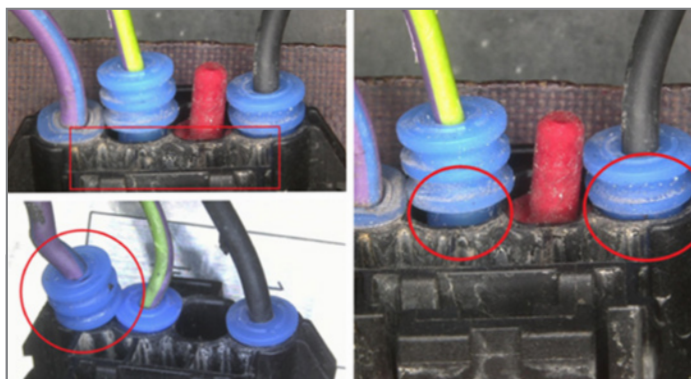
DTCs U02A9 and U1345 may be caused by an unsealed pump electrical connector allowing water leakage into the (M10) connector. Moisture introduced into the charge air cooler pump electrical connector may lead to communication failure.

Unsealed pump connector

Check the CAC Pump connector sealing. Be sure to look for any corrosion at the pump due to possible water leakage.

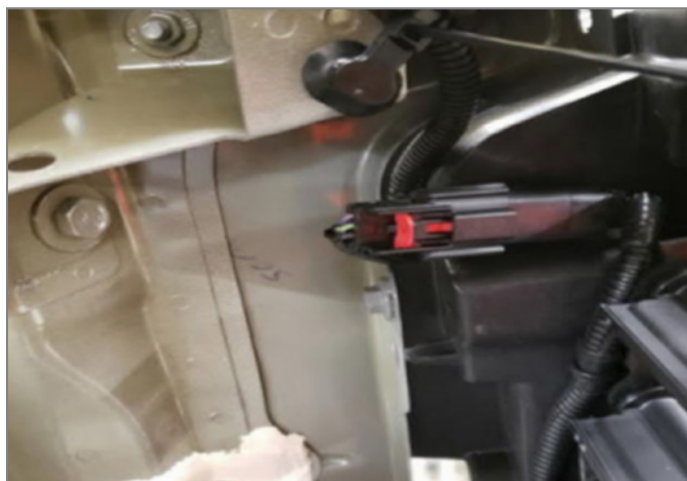
DTCs U1345, U0284 and U0285 may be caused by the engine wiring harness-to-active grille air shutter actuator in-line connector. The connector may not be properly connected, not properly held in place by the rear clip, or may be grounded on the radiator. Check the connection of circuit 4621 for any these possible concerns.

Check the circuit 4621 connection.

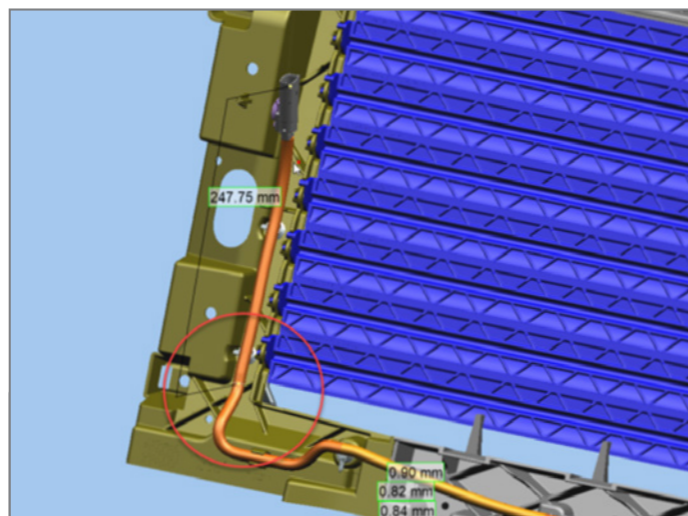
DTCs U1345 and U0284 may be caused by the active grill air shutter wiring being pinched at the radiator support.

Possible location of pinched wiring

Check the routing of the active grill air shutter wiring, especially at the lower-left corner of the shutter, to determine if there are any possible damaged points in the wiring. Repair the wiring as needed.

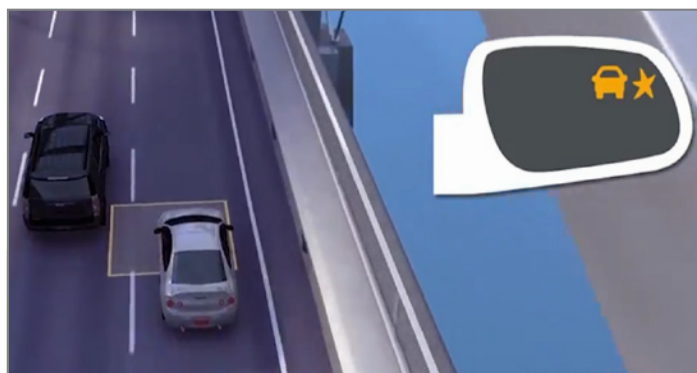
After a rear side SRR module has been replaced, the Side Blind Zone Alert (SBZA) indicator may not illuminate in the side mirrors when the customer drives past a vehicle. However, the alert indicator will illuminate when another vehicle is passing the customer. This condition will only be present after an SRR module is replaced using part number 84907387.

To address the Side Blind Zone Alert indicator condition, the system should be reset. On the infotainment screen, go to Settings > System > Return to Factory Settings.

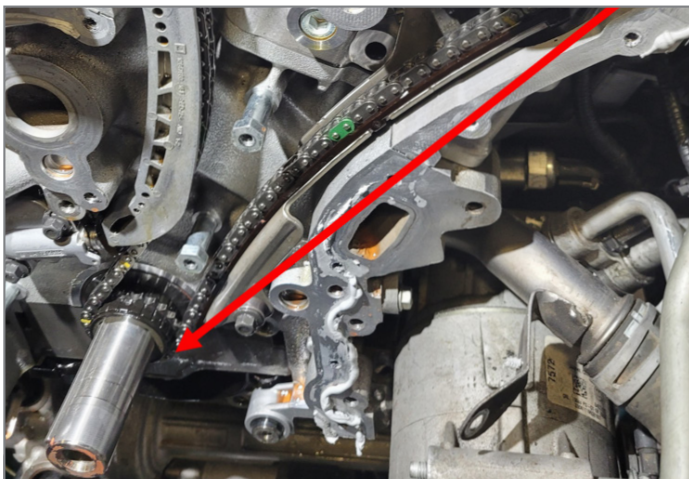
A common error when setting the chain timing is not looking straight on at the crankshaft sprocket, especially Stage 1.

From a high angle (as shown), it is very difficult to see if the chain link is properly set on the crank sprocket timing mark.

Angle makes it difficult to see the chain link on the crank sprocket timing mark.

Viewing the crankshaft at the correct angle — either visually or by using a camera — is critical to properly installation of the chain on the crankshaft drive sprocket.

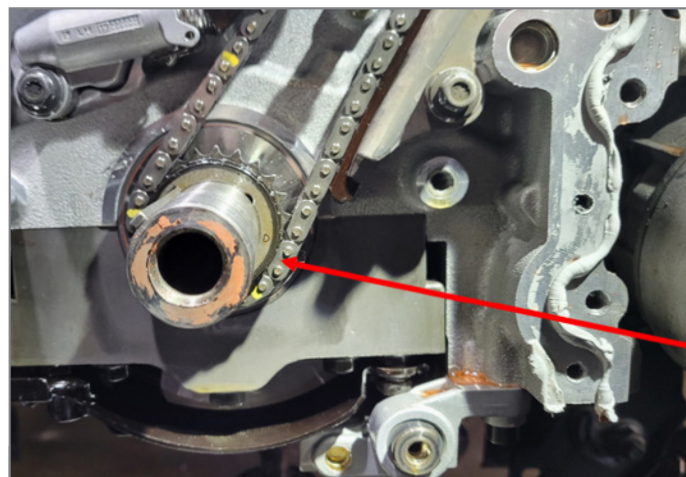
Even with the green-colored links not lined up prior to Stage 1 chain removal, counting the links can show that link number 30 is off one tooth from the timing mark, as shown below.

From a higher angle, the chain may look correct, but with a straight-on view, it is easy to see it is off. Improper timing as shown may set Stage 2 DTCs P0018, P0019 and P0021.

Straight-on view shows timing chain is one tooth off

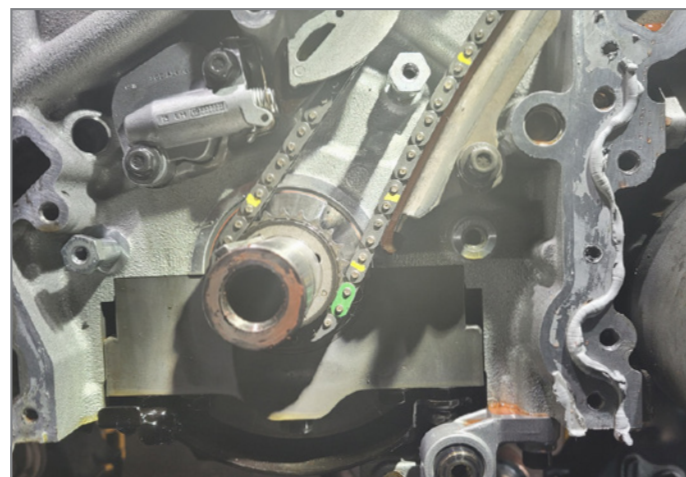
When viewing the crankshaft straight on, it's easy to see if the green-colored link is in the correct position to the sprocket timing mark.

Green-colored link in the correct position to the sprocket timing mark.

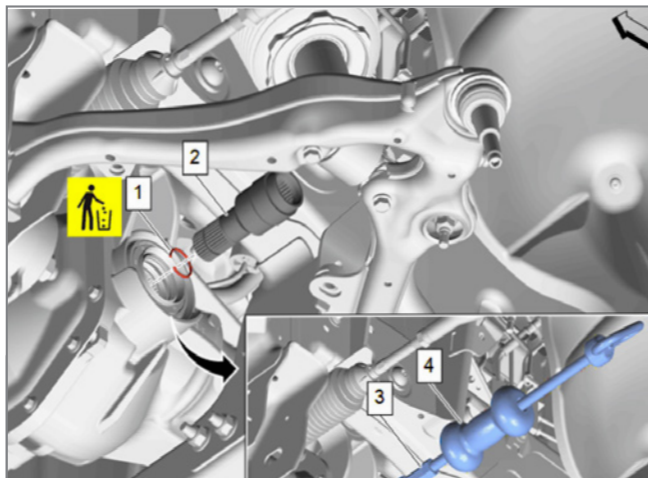
Left-side front axle output shaft (#2)

If the sound is heard, it may be caused by the left-side front axle output shaft. The sound does not affect the durability or operation of the vehicle.

After confirming the sound is present and isolated to the front-left axle seal area, replace the left-side front axle output shaft (or front-wheel drive shaft). A new part number is available, which includes the slinger and retaining ring. The slinger and retaining ring are single-use parts.
