GM TECHNICAL ASSISTANCE CENTER (TAC)

Dealer Tips and New Information Newsletter

FEBRUARY 16, 2023

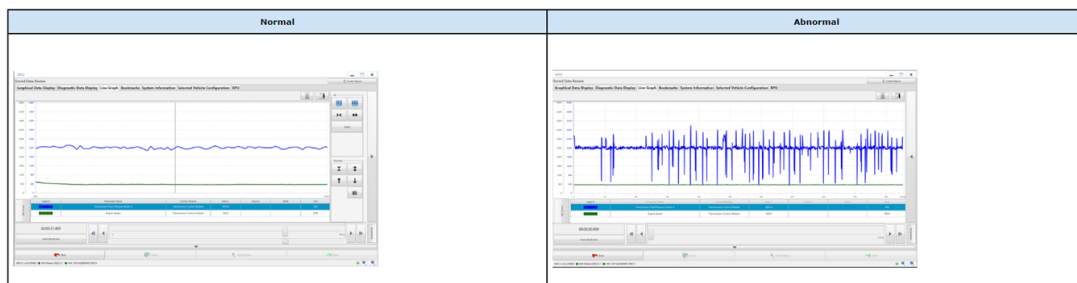
1) **M1L and M1M Line Pressure Testing**

When performing transmission service diagnostic testing and getting a failure where line pressure is checked, many cases indicate that pressure is within specs. Instead of checking the data list and looking at the hard number, look at the line graph as shown below. The line graph shows the variation that is causing the issue, which may not be obvious in other views. We are seeing a lot of transmission replacement recommendations where the codes set are related to the main control valve, but line pressure looks within specifications. This is very important on vehicles setting DTCs P0868, P2853, P2854, P2855, P2856.
