# GM TECHNICAL ASSISTANCE CENTER (TAC)

## Dealer Tips and New Information Newsletter

JANUARY 16, 2023  
HAPPY NEW YEAR!

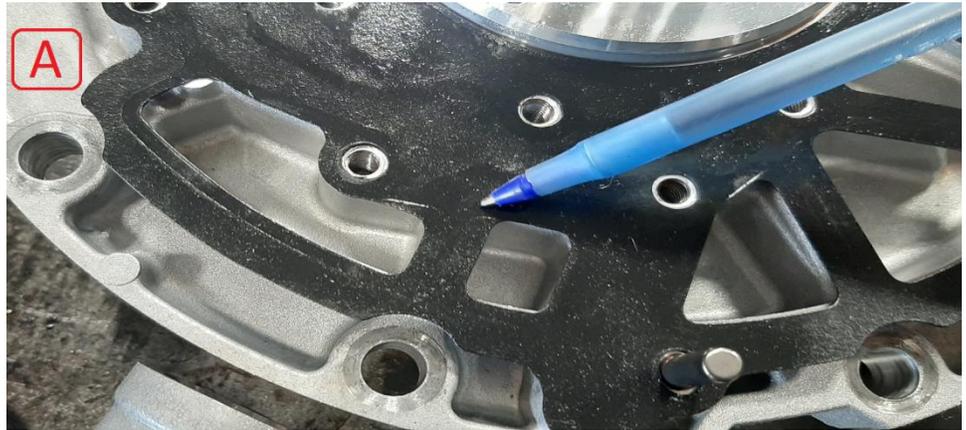
**Photo A** shows the previous 8L90 front cover support gasket in position.

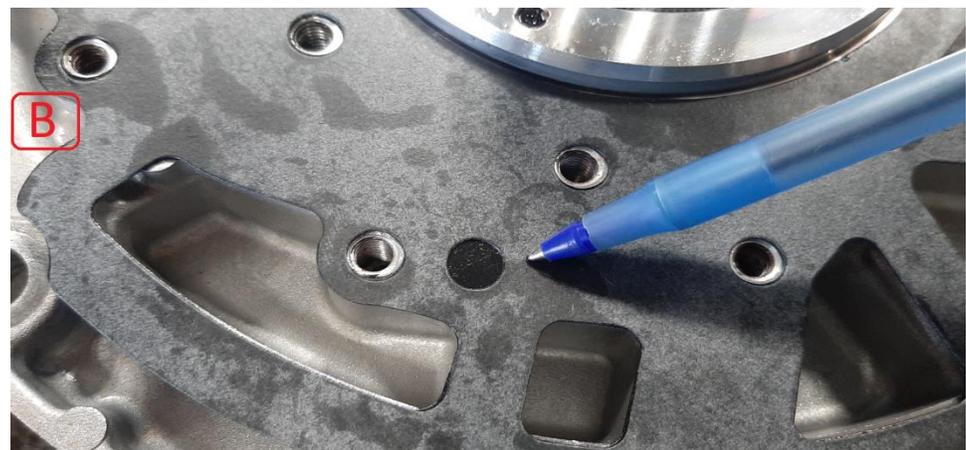
And **Photo B** shows the new gasket lying over the top of the prior gasket. The pen points to an extra hole in the new gasket. The extra hole does not affect the sealing function of the gasket.

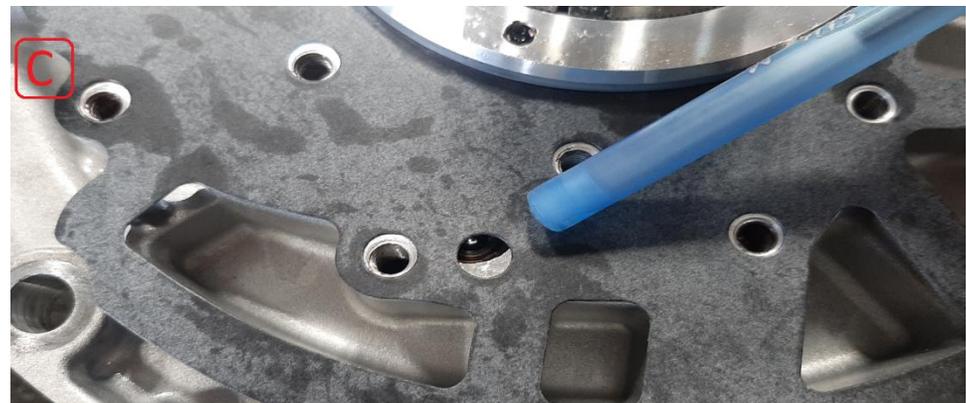
In **Photo C**, the pen points to what will be seen when the new gasket is installed properly.
