Active Grille Shutter Front-End Noise

Active Grille Shutters Front-End Noise

TECH LINK

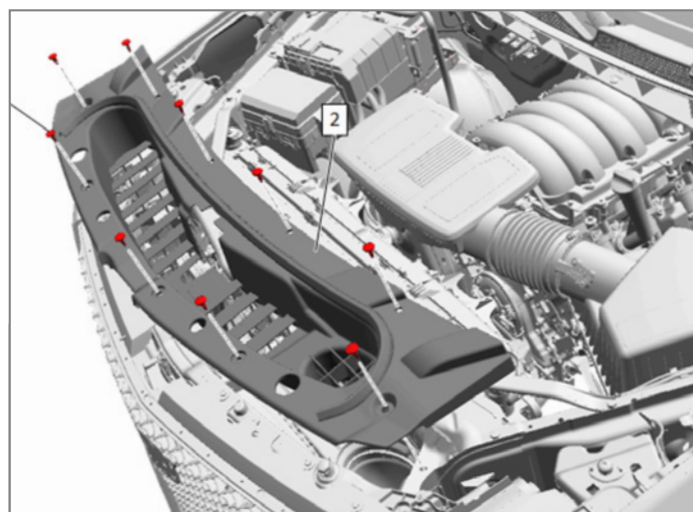
Intake air splash shield (#2)

If the noise is not present, remove the intake air splash shield and inspect the active grille shutters for any items that may be making contact.

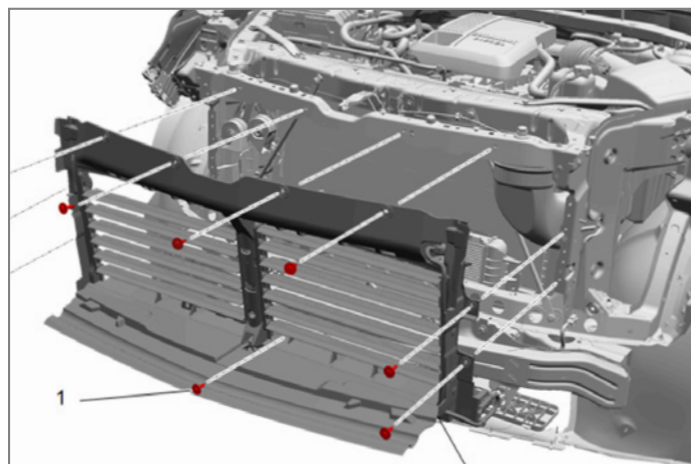
Active grille shutter (#2)

The front-end noise condition may stem from road debris or a component coming in contact with the active grille shutters as they open and close.

Possible items, such as road debris, stones, ice, or a mispositioned horn bracket or unsecured intake air duct, may be contacting the shutters and causing the noise.

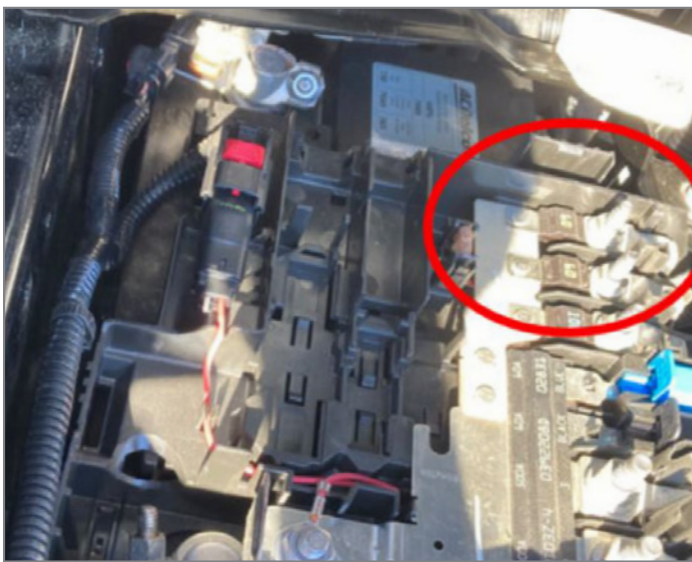
Inspect the BDU for a blown fuse.

An open fuse F5 (F5BA) will result in cylinders 1, 4, 6 and 7 all setting DTCs P066A, P067A, P067E and P068C simultaneously. And an open fuse F6 (F6BA) will result in cylinders 2, 3, 5 and 8 all setting DTCs P066C, P066E, P067C and P068E simultaneously.

Before replacing or disturbing any glow plugs, check the Battery Distribution Unit (BDU) Fuse Assembly for any blown fuses. Be sure to check for 12V on the BDU ring terminal while wiggling the cable. Some blown fuse conditions will intermittently make contact.

If a fuse is intermittent or open, replace the BDU assembly. Be sure to torque all fasteners to specification. Do not over torque. The 10 mm nut should be torqued to 6 Nm; 13 mm nuts should be torqued to 15 Nm.

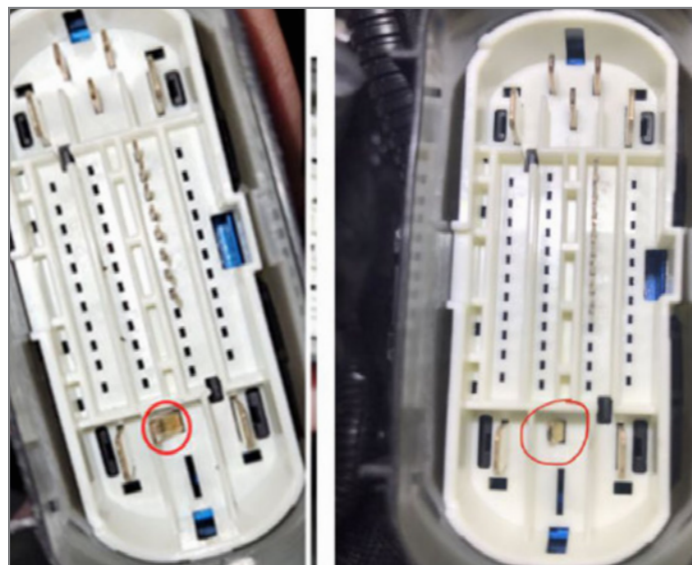
In addition, terminal damage in the X950D 55-way connector may result in Glow Plug Control Circuit DTC P0671, P0672, P0673, P0674, P0675, P0676, P0677 or P0678 setting.

Check for a bent terminal.

Also check for any bent terminals in the X950D 55-way connector. The X950D connector can be separated by disengaging the red CPA and squeezing the corners of the connector.

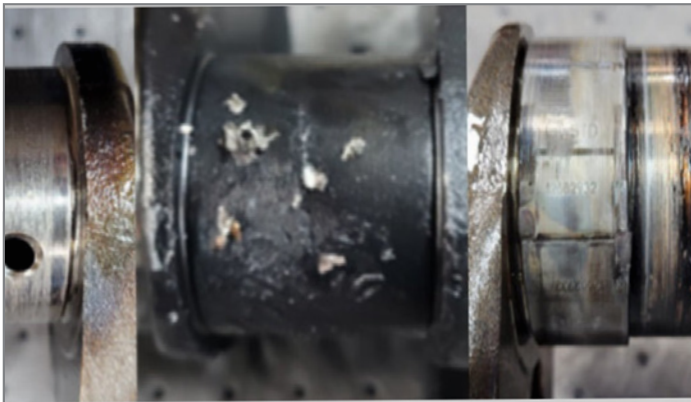
A no crank condition may be found on some 2019-2023 Silverado, Sierra; 2021-2023 Tahoe, Suburban, Yukon and Escalade models equipped with the 6.2L V8 engine (RPO L87). The no crank condition may be due to a seized engine with an open starter fuse. Various engine sounds, such as a thumping, knocking or rattling, may be present. These conditions may be the result of crankshaft bearing failure.

Inspect the crankshaft for damage.

If bearing material is identified, remove the engine oil pan and inspect the crankshaft rod and main bearings for any damage. Component replacement or, depending on the extent of damage, engine replacement may be necessary.

The amount of bearing damage determines if the engine should be replaced. Bulletin #18-NA-073: Repair Guidelines for Engine Component Wear provides details about wear characteristics of engine components and replacing worn components, including the crankshaft main bearings and journals. Engine assembly replacement should be based on the extent of the damage to individual components.

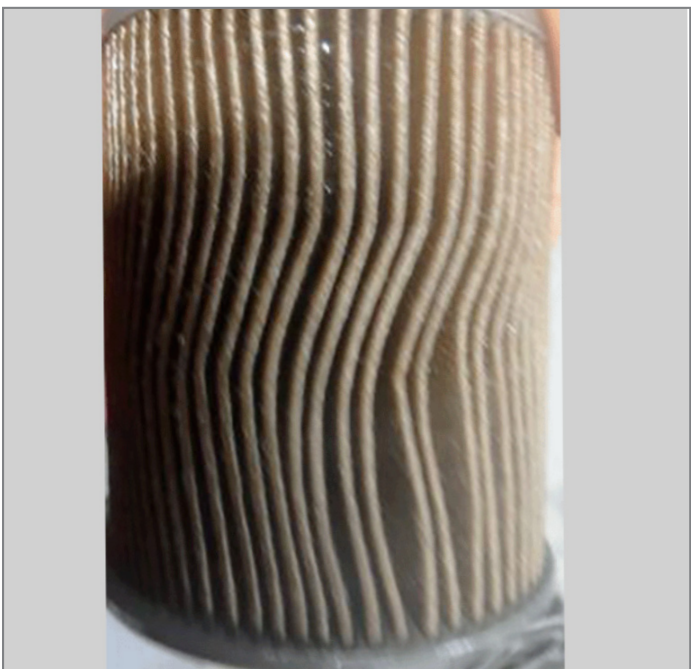
Look for visible metal particles in the oil filter pleats.

In cases involving suspected bearing failure, first check the engine oil and filter for excessive metal debris and bearing material. Inspecting the oil filter for excessive debris and damaged pleats can be a helpful indicator of the amount of material that has been displaced through the engine and lubrication circuits.

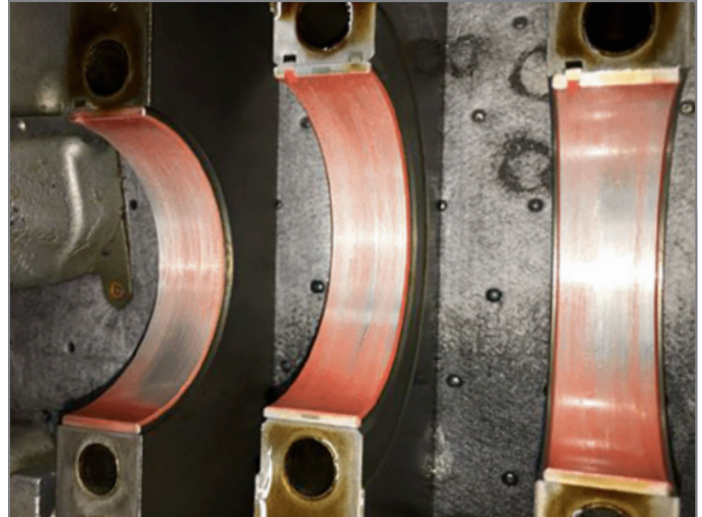
Some components can be replaced without the need for engine replacement.

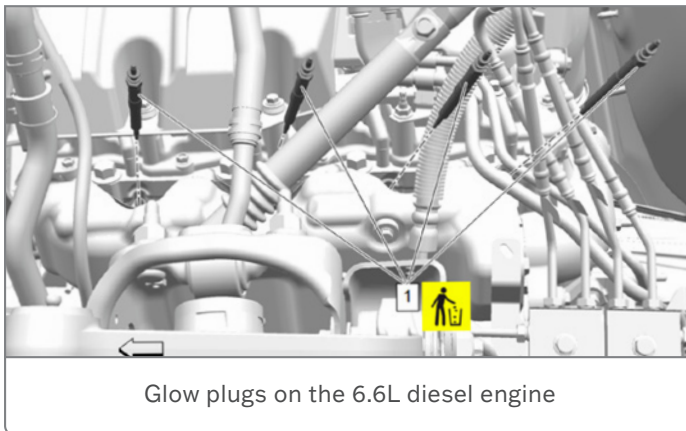
As the engine runs during normal operation, soot builds up between the outside of the glow plug and the inside of the glow plug hole. Once a glow plug is removed, this soot that collected in the bore must be removed. If the soot is not removed before installing a new glow plug, the soot could "side load" the new glow plug and induce a premature failure.

The recommended tool for cleaning the glow plug holes on the 1.6L, 3.0L and 6.6L diesel engines is the EN-52074 Glow Plug Bore Reamer.

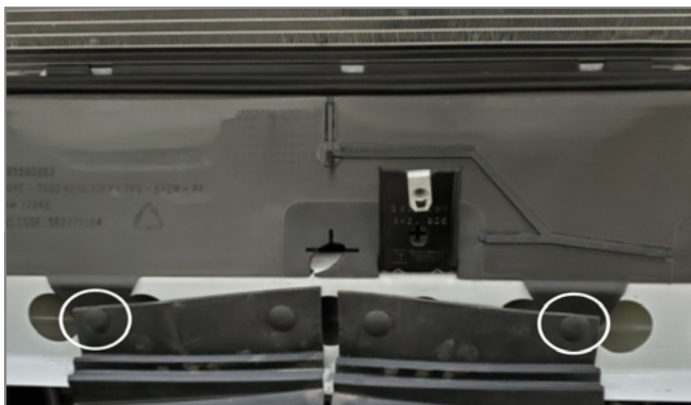
These conditions may result from ambient or PCV moisture freezing where ice or sludge can accumulate in the Charge Air Cooler (CAC). An updated ECM calibration is available to address operating conditions in colder weather. In addition, a lower air baffle should be installed to help reduce CAC icing.

Install a lower air baffle to help reduce CAC icing.

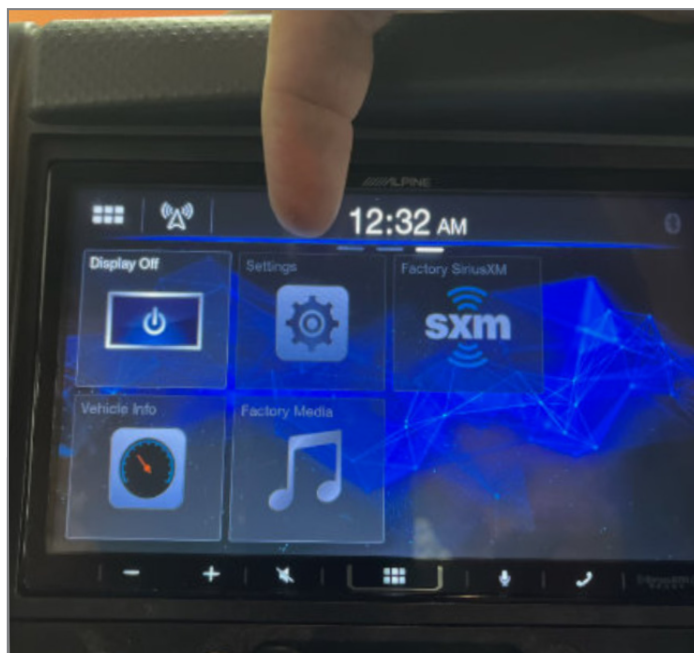
LCF model with Alpine radio

The Settings menu on the infotainment screen may not be accessible on some 2021-2023 LCF 3500HD, 4500/4500HD, 5500/5500XD, 6500XD and 7500XD models equipped with the optional Alpine radio (RPO UIZ). When trying to select the Settings menu on the touchscreen, it may be greyed out and cannot be accessed.
